### **Shotcrete Corner**

# **The South Side Market House**

By Ted Sofis

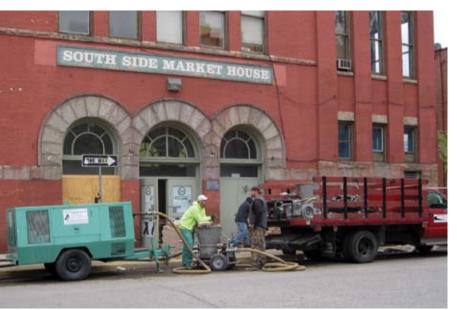
Fig. 1: The shotcrete crew prepares to start in front of the South Side Market House in Pittsburgh, PA. The structure, which was built in 1893, is listed on the National Register of Historic Places

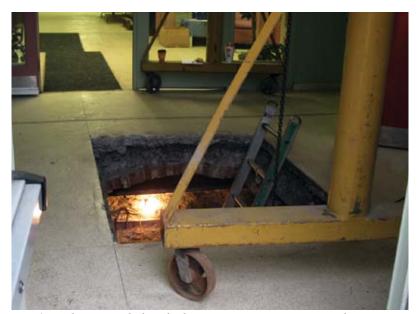
Fig. 2: In this access hole, which was cut to gain access into the building's basement, a side view of a supporting brick arch is visible

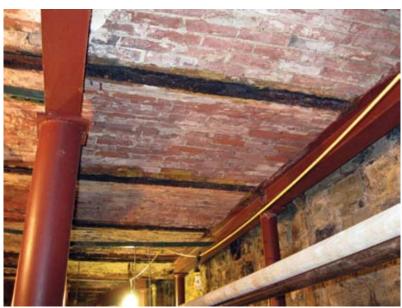
Fig. 3: These brick arches are in one of the open sections of the supporting floor system

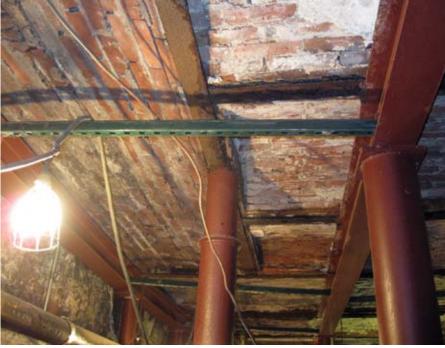
The Market House was closed in March 2011 when the City Public Works Department discovered structural problems with the floor system on the front side of the building. The floor system, as was common for the period, is supported by a series of shallow brick arches. Over time, the mortar joints of the brick arches deteriorated (Fig. 2 to 4). We encountered a similar problem with the damaged terra cotta tile arches supporting the floor system of Union Station in Washington, DC. On the Union Station project in 1987, we repaired the damaged terra cotta arches with a dry-process, shotcrete-applied repair mortar, gunned overhead to restore the integrity of the supporting structural arches.

Fig. 4: The general condition and configuration of the brick arches. There were also places with holes or missing bricks

place overhead, the repair could be accomplished from the underside without removing the existing floor. Shotcrete would conform to the existing shape of the arches and, by spraying the repair mortar in place, we would fill any holes and voids where there were missing bricks and gaps (Fig. 4). By gunning a monolithic overlay over the brick arches, the shotcrete would fill in all the deteriorated mortar joints, tightening up and stabilizing the floor system support. With a sprayed shotcrete installation, we could efficiently work around all obstructions, piping, conduit, and supports, which would not be possible with a formed repair and would be much more productive than hand troweling (Fig. 5). Parging the arches with troweled in-place material would be a slow, laborious undertaking and would have to be applied in multiple layers (Fig. 6). With a shotcrete application, the pneumatically applied mortar could be gunned to full depth in one pass. The nozzleman has more control with dry-process shotcrete and he can easily make the sensitive adjustments that are necessary for placing material overhead. In dry-process shotcrete, material is conveyed by air through the hose in a dry or slightly dampened state, and water is injected into the material stream in the nozzle with fully wetted material impacting the receiving surface. An additional advantage of using dry-process shotcrete is that it is easier to stop and start shooting without worrying about wet material in the hose setting up. This was particularly important when contending with the various obstructions on this particular project.

Prior to the shotcrete placement, the brick arches were water-blasted to remove loose mortar and remove dust, dirt, and other particulates from the receiving surface. A galvanized 3 x 3 in. (76 x 76 mm) No. 11 gauge (MW5.6/5.6) steel mesh was installed and anchored in place with expansion-sleeve J-hook anchor bolts. Shotcrete MS, a microsilica-enhanced repair mortar manufactured by Quikrete, was used for the overhead shotcrete work. The material was gunned in place quickly and efficiently and provided a very inexpensive yet durable method of repairing the floor system.

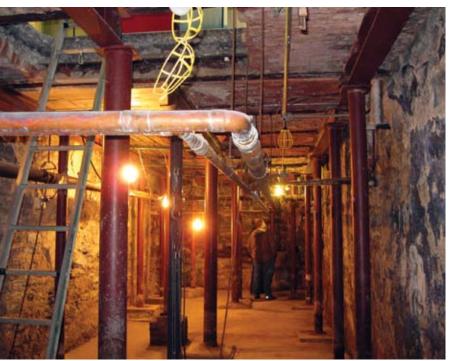
Fig. 5: Working around the structural supports, piping, conduit, and other obstructions added to the difficulty of the overhead shotcrete placement

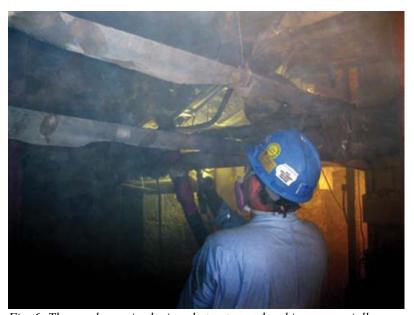
Fig. 6: The nozzleman is placing shotcrete overhead in an especially congested area of the basement behind the elevator shaft
