Shotcrete Saves the Day— Restoring a Crumbling Rock Face

PS #6 - Rock Stabilization

Bronx, NY

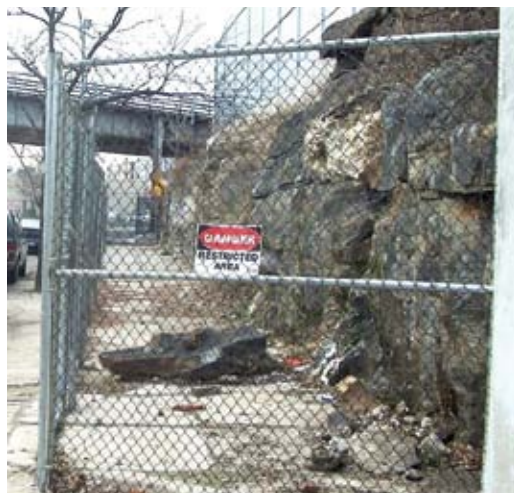
Fig. 1: Initial condition—fallen rock

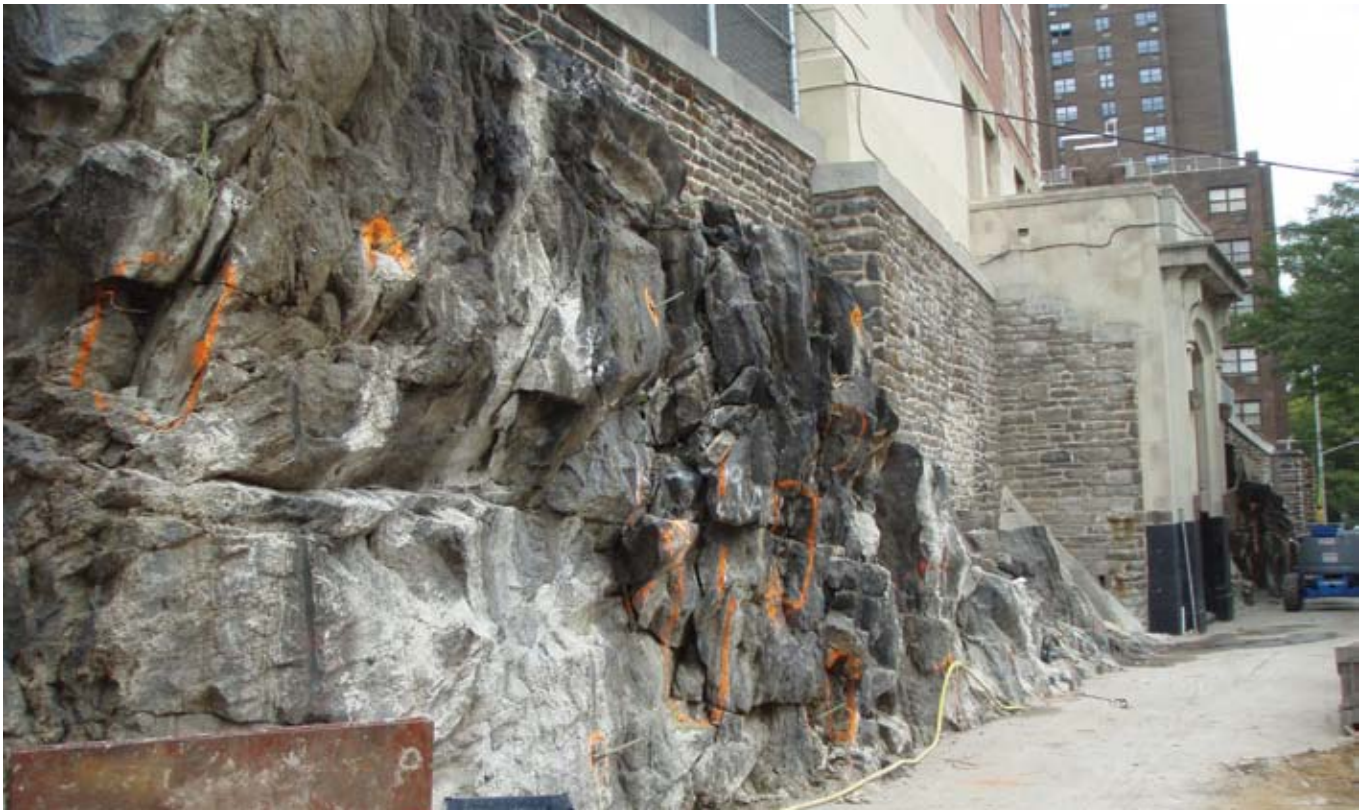
Fig. 2: Unstable rock

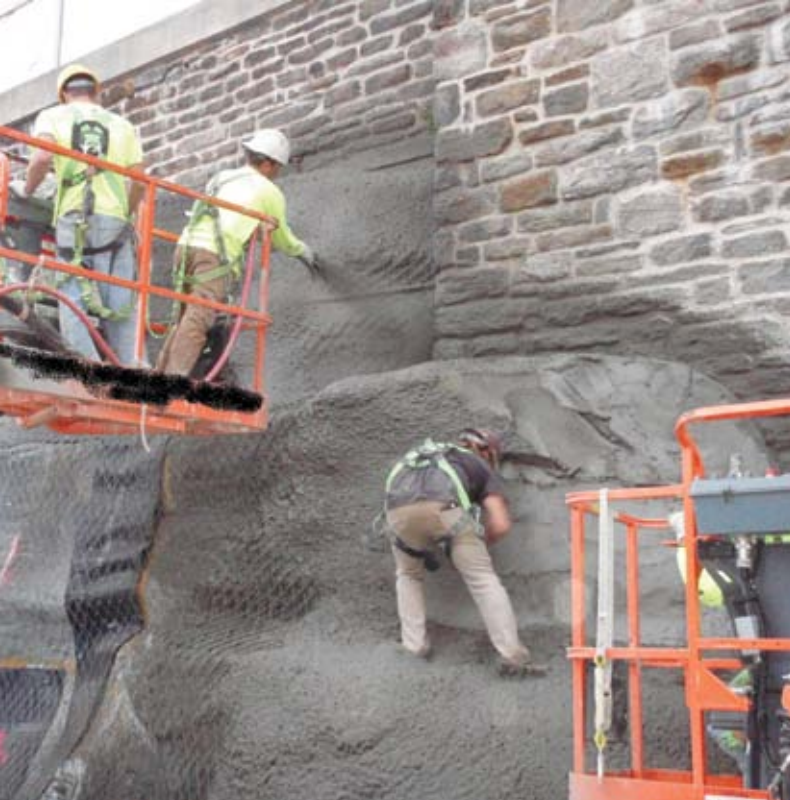
Fig. 4: Applying and sculpting shotcrete

After installing the high-strength steel netting, one to two layers of wet-mix shotcrete with a total thickness of 6 to 8 in. (150 to 200 mm) was applied and finished (refer to Fig. 4 and 5). The final face surface was sculpted and tinted to match the rock's original appearance. "Jointing" was carved in the final surface to replicate the natural appearance of the rock. After an initial curing period of 24 hours, the shotcrete was stained to match the original rock surface (refer to Fig. 6). Final site work consisted of removing and replacing the site sidewalk and curb.

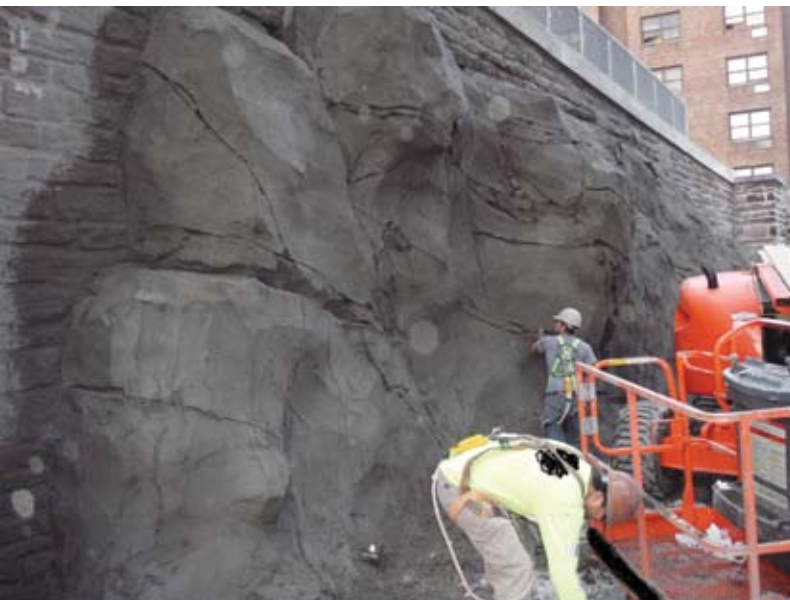
Fig. 5: Sculpting shotcrete

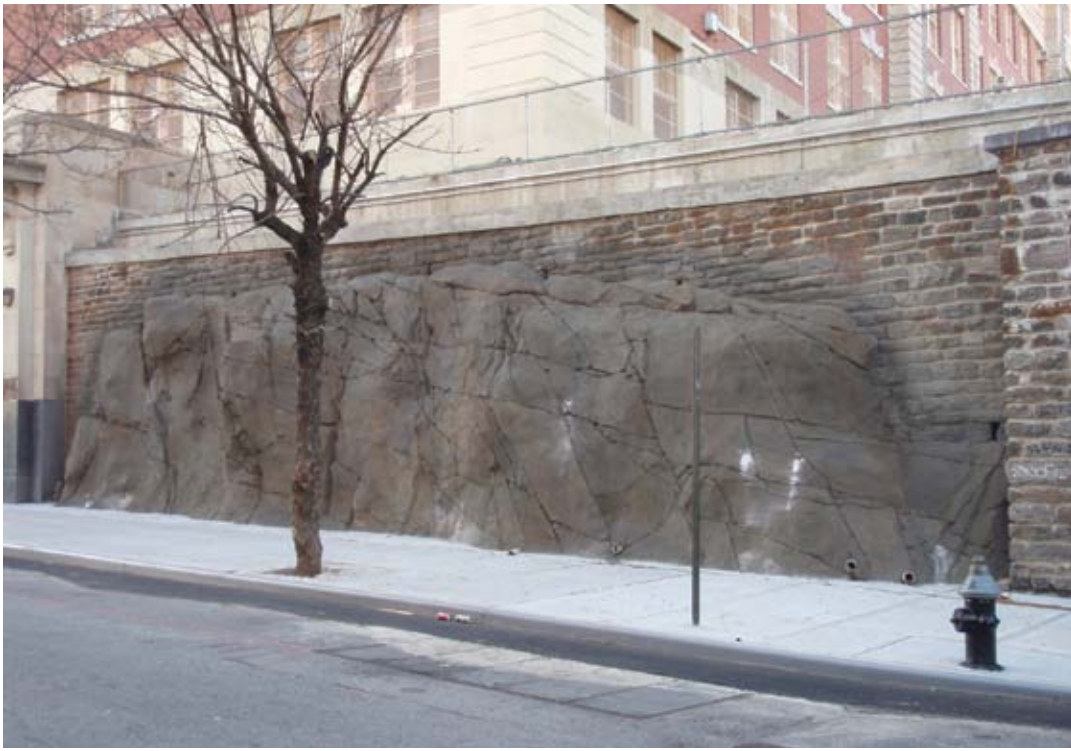
Fig. 6: Final stabilized rock mass
