Marine Structures: Pier Projects

By Tommy Pirkle and Randell Ogburn

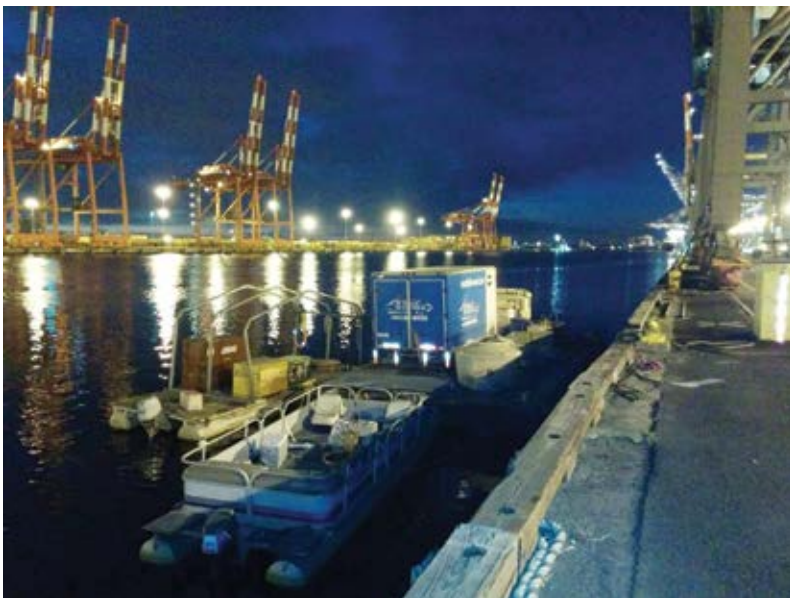
Fig. 1: Night work as a result of the constantly changing schedules

amount of marine repair work requires physically being on the water underneath the structure itself, the ever-changing tides cause a number of issues not confronted on more conventional job sites, including shortened work days and a work schedule that is constantly changing according to the tide (Fig. 1).

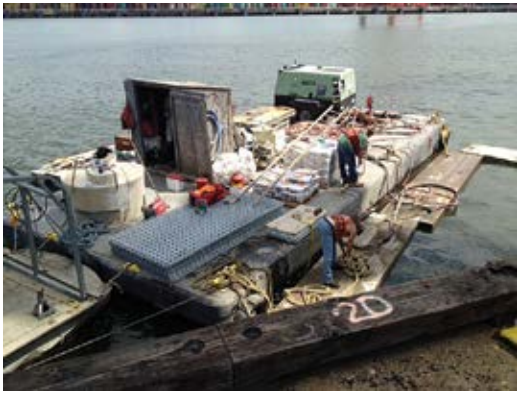
Fig. 2: Preparation of the work barge

Another key factor to take into consideration during the bidding process for pier work is access. Using work floats to navigate throughout the site is preferred, but simple, provisional decking made out of lumber or cables and scaffold boards works well on higher-volume jobs or where the work is too high to reach safely from the float stage. Float platforms are the most cost effective if the work is accessible at both low and high tide. However, many times a wide float will not be able to get around the existing piles or can become grounded on unseen impediments in the water as the tide lets out. This is especially true in situations where additional piles were installed to support today's heavy cranes that are necessary to unload the ships' cargo (Fig. 2).

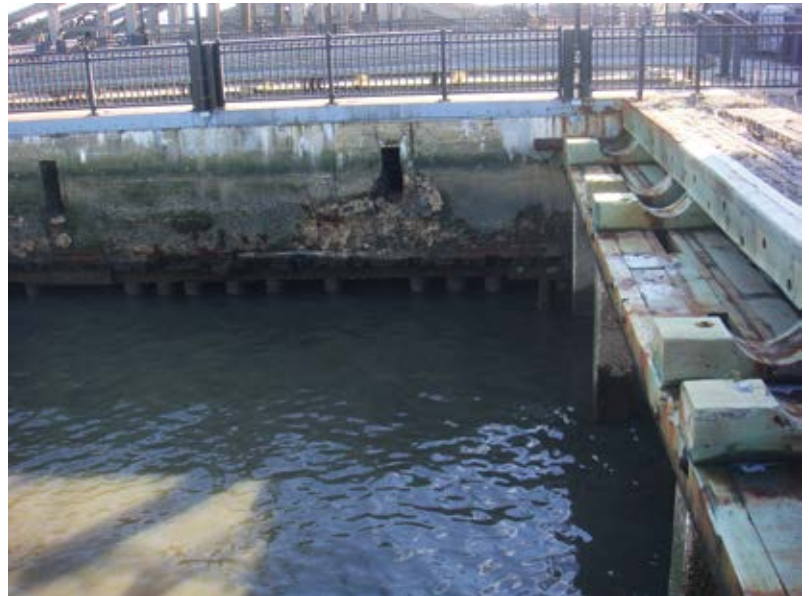
Fig. 3: Spalls along the outside wall of the Ferry House Platform #2

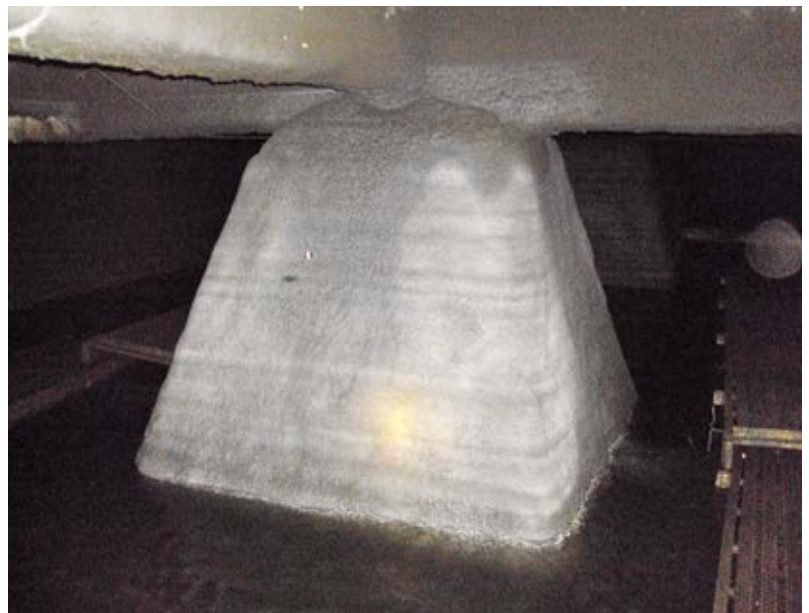
Fig. 4: Triangle-shaped piles and underdeck beams repaired and encased with shotcrete

work is not visible, a natural gun finish is specified. Another typical, yet more difficult repair is the total encapsulation of the top of a support pile to a concrete pile cap with shotcrete. The piles have to be recentered underneath the pile cap using a come-along and wedges to secure it in place. After the removal of barnacles and other contaminants, any unsound concrete is removed and welded wire reinforcement is wrapped around the pile cap and the support pile, thus “bridging” or “locking” them together. Expansion anchor bolts are installed to secure the welded wire reinforcement and shotcrete is then applied with a minimum thickness of 6 in. (150 mm). This jacket type of repair is extremely tidal-affected, as the top of the pile and pile caps are often completely submerged during certain high-tide cycles.

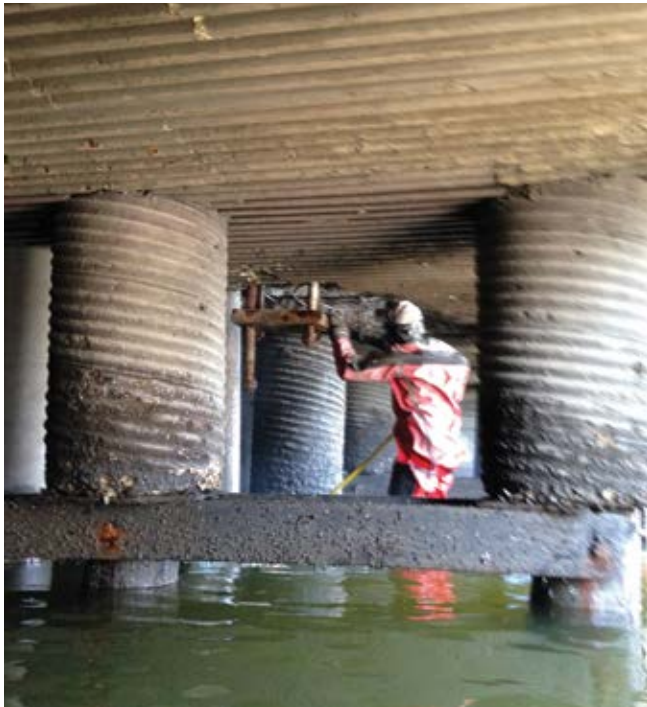
Fig. 5: Unsound concrete removed with pneumatic chipping hammers

work because the only access was limited by the small hatch door. Surprisingly, the inside walls of the structure were in decent shape, with minor spalling but with substantial concrete erosion. The spalls were chipped, walls pressure-washed, and galvanized welded wire reinforcement installed and supported with expansion anchor bolts attached to the substrate. Shotcrete was then applied to a thickness of 3 in. (75 mm) to fill the spalls and add additional coverage over the existing reinforcement on the eroded sections of the walls (Fig. 5).
