Controlling Efflorescence

By Jonathan E. Dongell and Jerry B. Werner

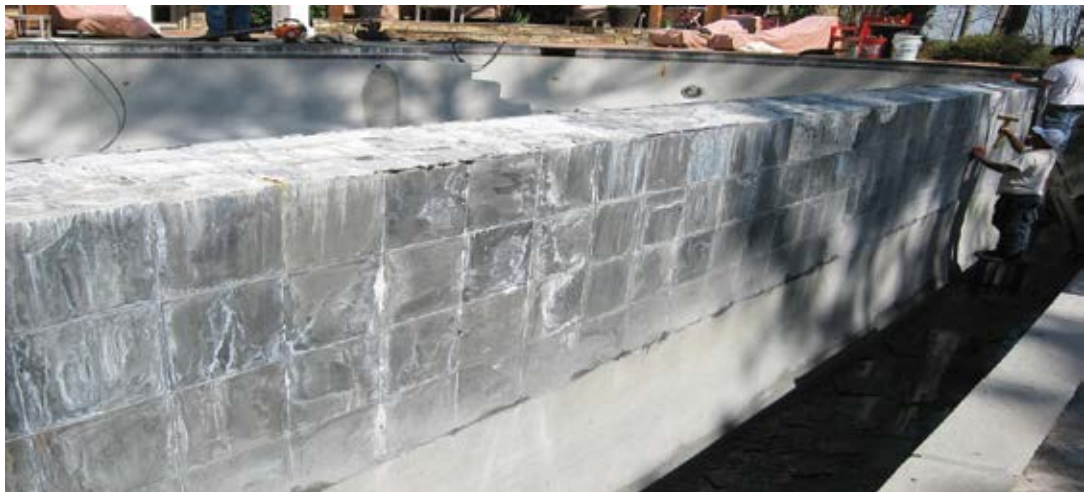
Fig. 1: Infinity edge (water-retaining wall) of swimming pool—2-year-old pool with no specific integral waterproofing or densifier controls

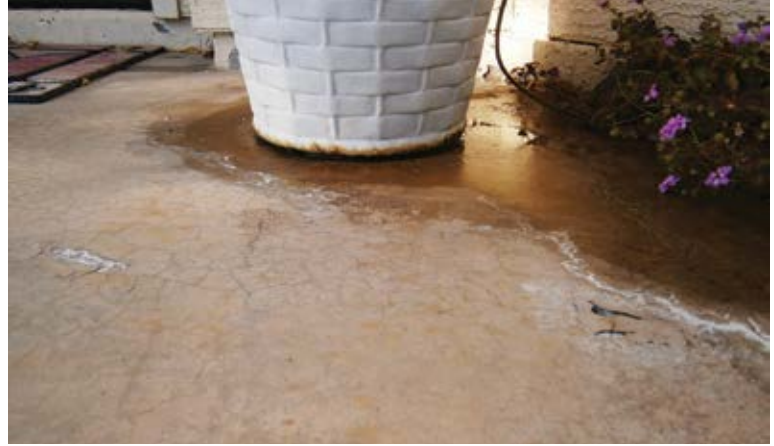
Fig. 3: Aged concrete slab deterioration

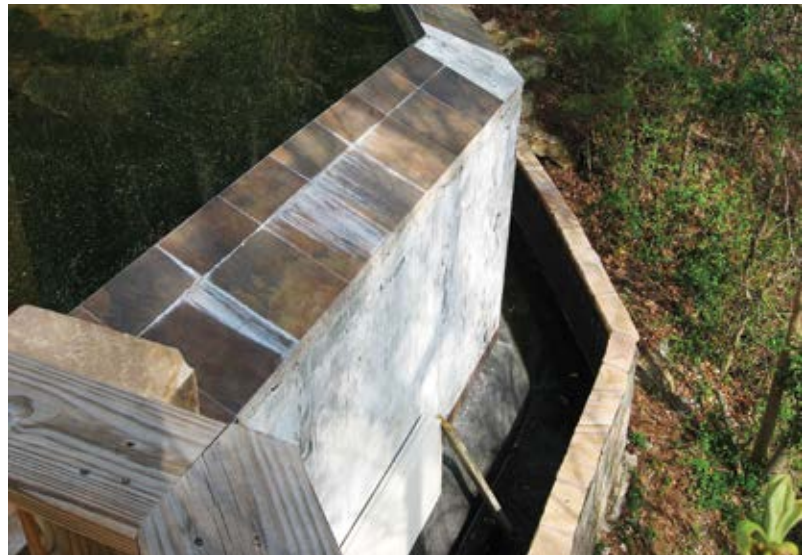
Fig. 4: Efflorescence buildup that caused delamination of tiles; more than just an aesthetic problem

A similar buildup, known as sub-efflorescence, can develop at the interface of the structure surface and surface coatings, tile, or other coverings; or just below the upper finished surface of the structure. If this buildup continues unimpeded, a form of salt attack can cause the deterioration and weakening of the binder system. Ultimately, this may lead to a complete failure of the binder system, causing the debonding of the coating or covering from the substrate, or the delamination or peeling away of the upper surface of the cementitious structure. Structures such as swimming pool vanishing edges, retaining walls, basements, and tanks can be especially vulnerable. Methods of preventing the migration of moisture, as mentioned previously, should be considered in the initial design and construction.

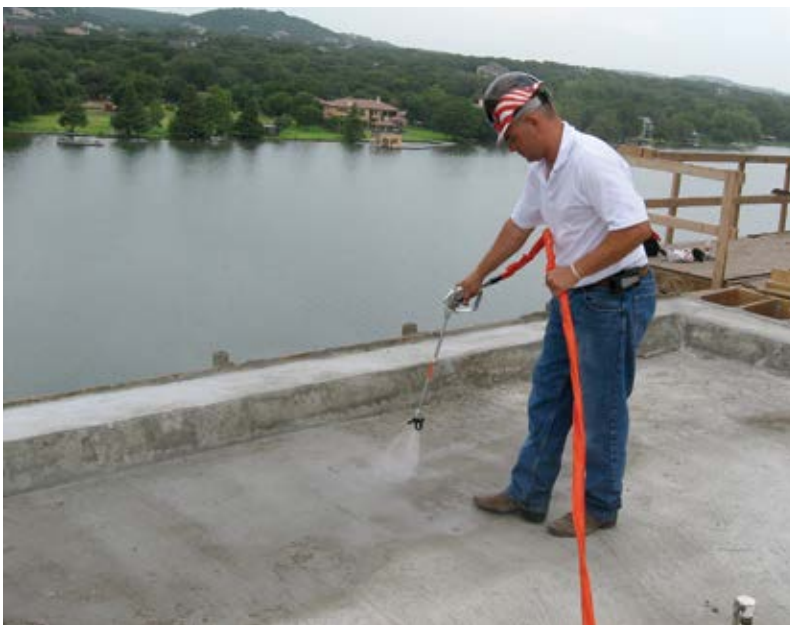
Fig. 6: Example of spray-applied densifier

7. Integral waterproofing or other densifiers can be sprayed on, or applied as a slurry coat, to the surface of the cementitious structure; and
8. Incorporating methods of application, finishing, and curing that optimize consolidation of the matrix and produce a dense upper surface.
