Shotcrete Use in the Gold King Mine Rehabilitation

By Christoph Goss

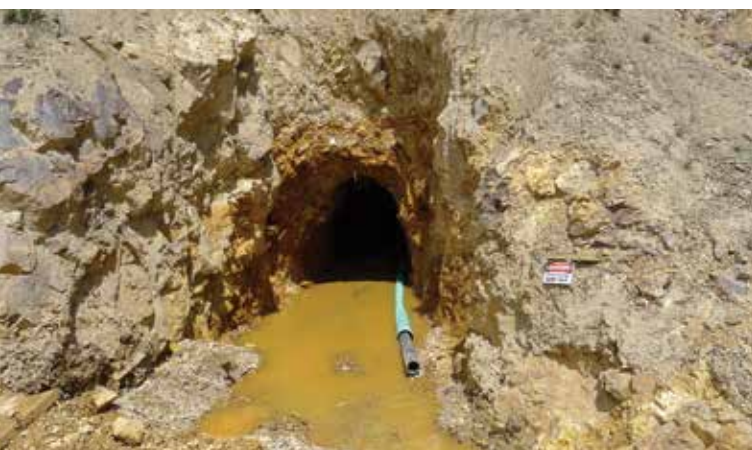
Figure 1 shows the portal area shortly after the 2015 release. The jointed, strongly altered rock hung precipitously over the open channel where timber sets had once stood. Looking into the old workings, one could see failed rock bolts, rusty mine straps, and a high "cathedral" in the back (roof). Given the instability of the ground and the short time before winter would arrive, it was critical to design a rehabilitation that was flexible, resistant to mine water, and used "off the shelf" material. A system of shotcrete and rock bolts was quickly selected. The underground contractor, Harrison Western out of Lakewood, CO, mobilized to the site a few weeks later. They laid back the slopes around the portal and installed temporary split set rock bolts along with welded wire fabric. They continued the work into the underground, scaling and bolting their way past the cathedral.

Fig. 1: Portal before rehabilitation

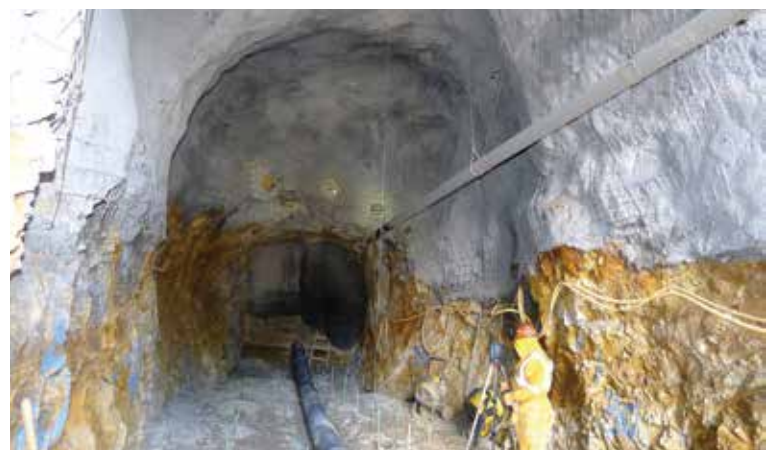
Fig. 2: Portal area excavated and initial support in place

The next phase of work was shotcrete around the portal. Harrison Western chose to use the dry-mix process. The material was provided in supersacks by Thiessen Team. The mixture consisted of 650 lb (295 kg) Type II/V cement, 100 lb (45 kg) fly ash, 65 lb (29 kg) silica fume, sand, pea gravel, and accelerator. Some bags came with polypropylene fibers at 12 lb/yd³ (7 kg/m³). Given the high altitude of the site, an 825 ft³/min (23 m³/min) air compressor was needed.

The shotcrete application went very well thanks to skilled miners with significant shotcrete experience. The crew hand nozzled and used a manlift to access the slope. The final support consisted of an initial shotcrete layer 2 in. (50 mm) thick, followed by No. 8 Dywidag resin bolts, and a second layer of shotcrete 4 in. (100 mm) thick.

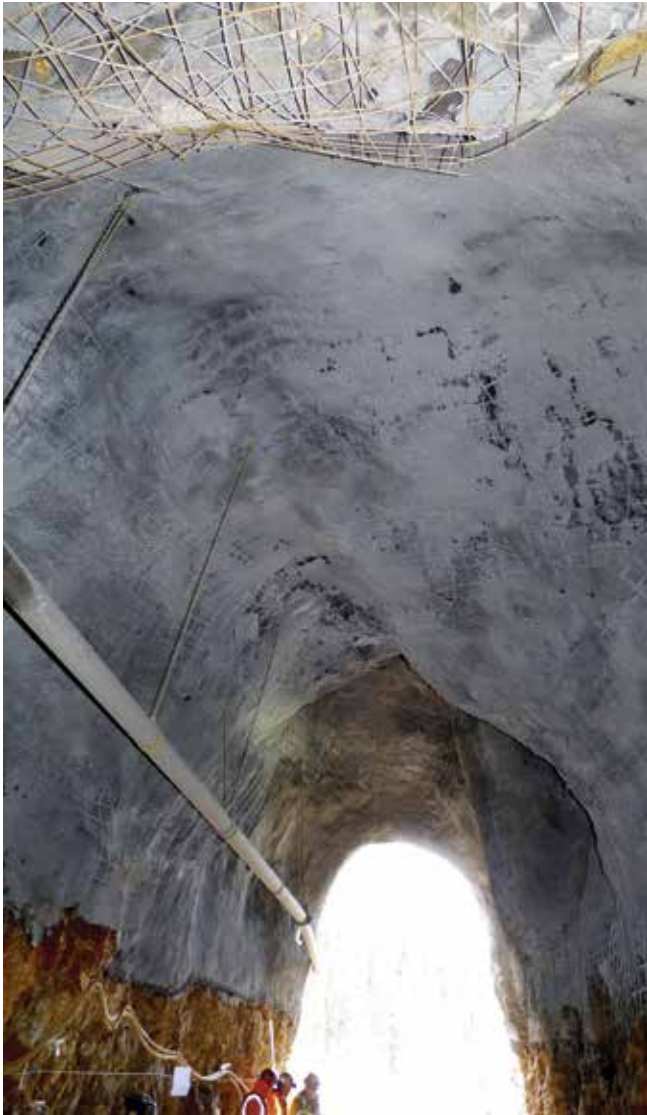
Fig. 3: View into cathedral behind portal

The initial design for the underground support was the same shotcrete and bolting used at the portal. Based on requests by the client, the final underground support in the first 64 ft (20 m) was changed to fully lagged steel sets backfilled with cellular concrete. To allow safe construction of the steel sets, 2 in. of shotcrete was applied to the upper ribs and back to reinforce the bolts and mesh. This is shown in Fig. 2, 3, and 4. Note the 30 ft (9 m) high cathedral back in Fig. 3. For comparison, the original dimensions of the adit were approximately 10 x 10 ft (3 x 3 m).

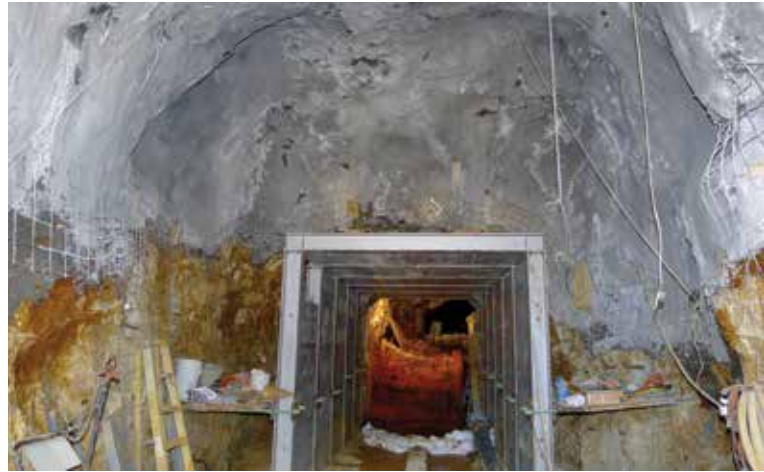
Fig. 4: Installing steel sets under initial shotcrete support

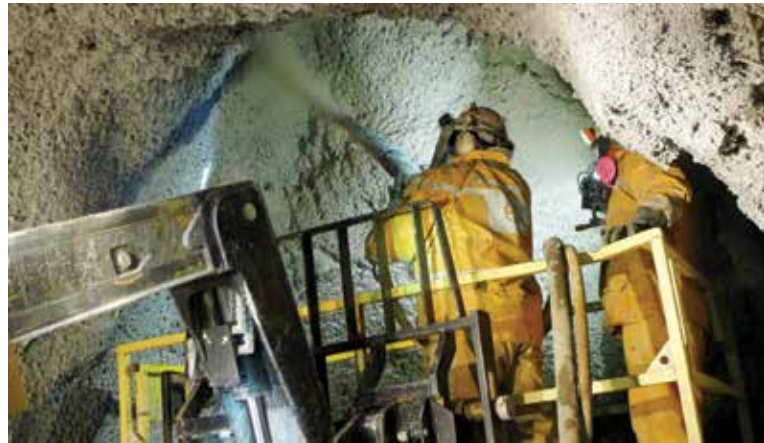
Fig. 5: Shotcrete placement in high back

Figure 5 shows the shotcrete placement in the second high back area. Figure 6 shows the initial layer of shotcrete

sets and backfill. Concurrently, the team evaluated ground conditions further in the mine. Approximately 100 ft (30 m) into the mine, another high back cathedral 27 ft (8 m) high was discovered. Failed mine straps and rock bolts were visible around it. To avoid a new collapse in this area, it was decided to fully support the mine to just past this point. Advance was difficult due to the presence of sludge and debris 5 ft (1.5 m) thick on the floor. The material consisted of sand, gravel, cobble sized rock blocks, old pipes and cables, and orange metal precipitate with a pudding-like consistency. Harrison Western mucked out this material, scaled the ground, and installed No. 8 Dywidag resin bolts with welded wire fabric. Next, they placed 4 in. of shotcrete in two lifts. This time they elected to use the wet-mix process. Alpine Mobile Crete (AMC) from Durango, CO, mobilized a volumetric mixer truck to the mine portal. During the initial shotcrete placement, AMC adjusted the mixture design until they had a mixture that pumped well and stuck to the back and ribs without requiring an accelerator. The final mixture included 790 lb (360 kg) Type II/V cement, 165 lb (75 kg) fly ash, 72 lb (33 kg) silica fume, sand, and pea gravel.

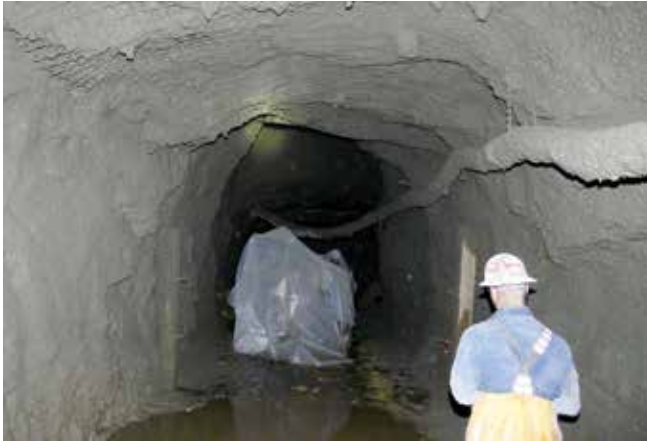
Fig. 6: Initial layer of permanent shotcrete support

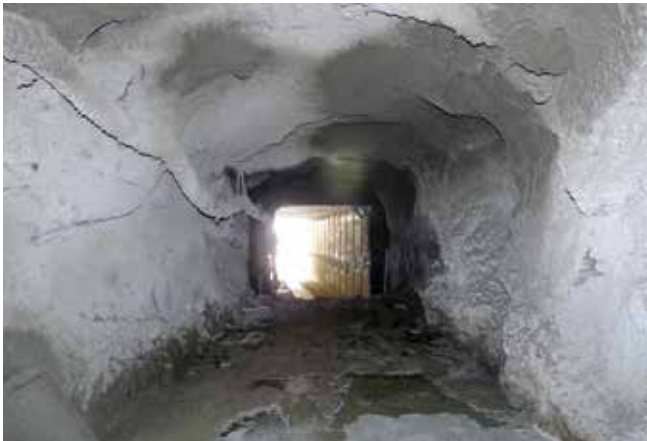
looking in while Fig. 7 shows the final layer looking out. In Fig. 8 one can see the final shotcrete in the second high back cathedral area along with wood/concrete cofferdams to hold back the sludge and debris. Also visible in the figures is the hose from the bypass pump that pumped water from the mine pool to the treatment plant, keeping the work area dry. Figure 9 shows the portal area at the completion of the project. Thanks to the skilled nozzle men who used a good mixture and appropriate equipment, the shotcrete placement went very well, meeting all design specifications.

Fig. 7: Final layer of permanent shotcrete in place

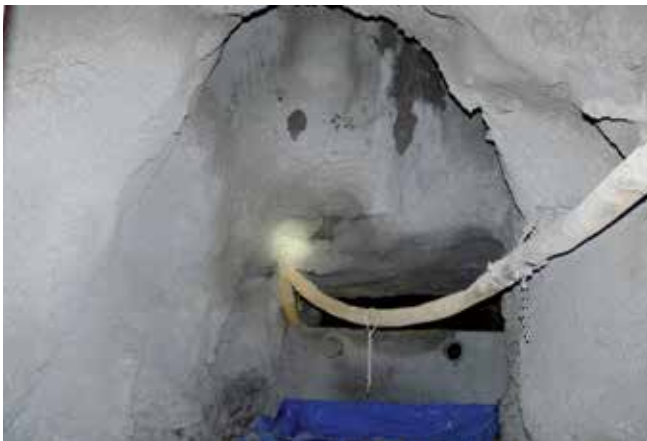
Fig. 8: Final shotcrete in place at high back
