# Swimming Pool Renovation with Shotcrete

By Bill Drakeley

## THE CONNECTICUT PROJECT

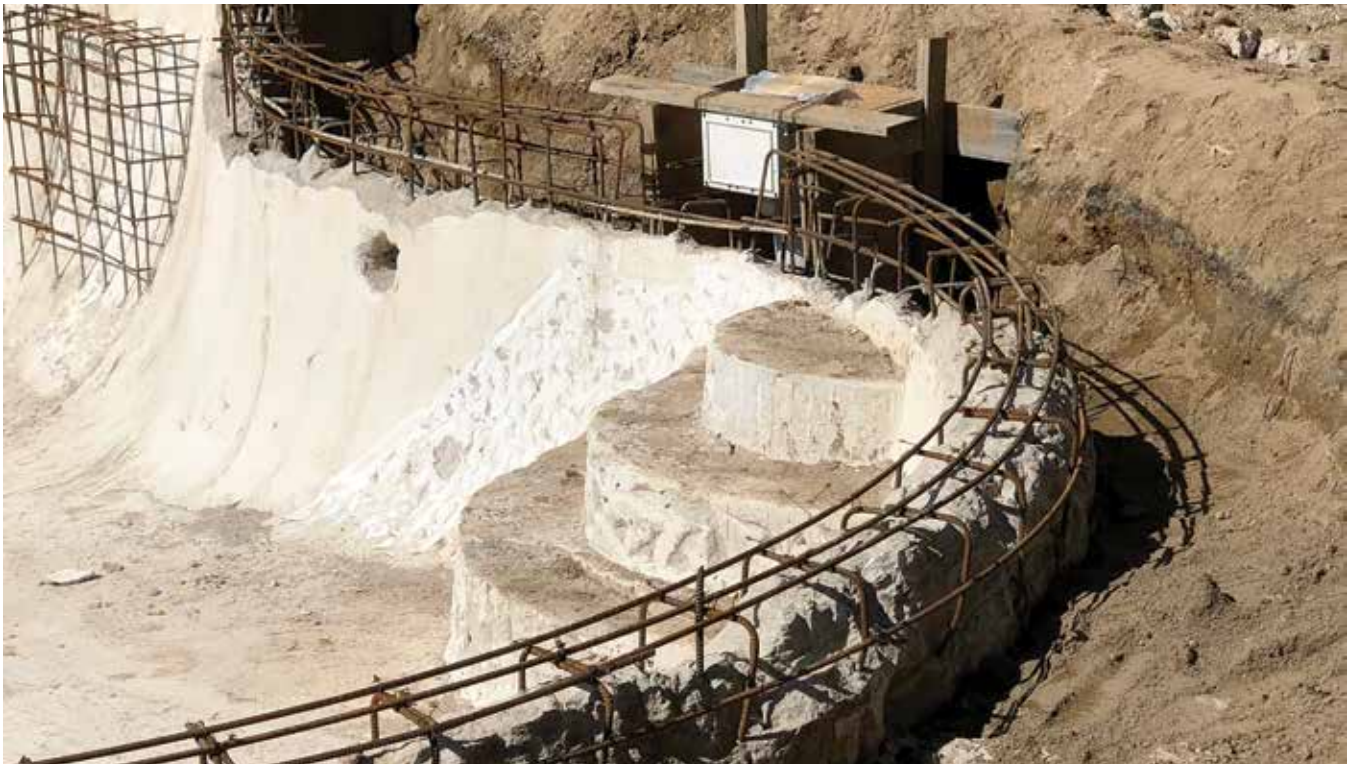
Fig. 1: Close-up of raised bond beam with supplemental reinforcing and roughened substrate

Once existing concrete was exposed, we inserted steel pins and tied No. 4 bars to supplement reinforcing in the existing concrete. We also added new steps and deep end benches to help ease access for the client and their new grandchildren. Knowing the old pool elevations, we took advantage of the existing riser heights on the adjacent back porch steps and raised the depths and bond beam elevations of the pool which helped with concrete coverage and pool water depths. This added approximately 8 in. (200 mm) to the top of the pool walls.

The pool bond beam was roughened to create an excellent surface for the paste-rich, high-impact shotcrete materials to create an excellent bond. Once the reinforcing steel and substrate were prepped and the concrete in a saturated surface dry (SSD) condition, wet-mix shotcrete was placed. The concrete mixture design specification was 6000 psi (41 MPa) compressive strength at 28 days (refer to

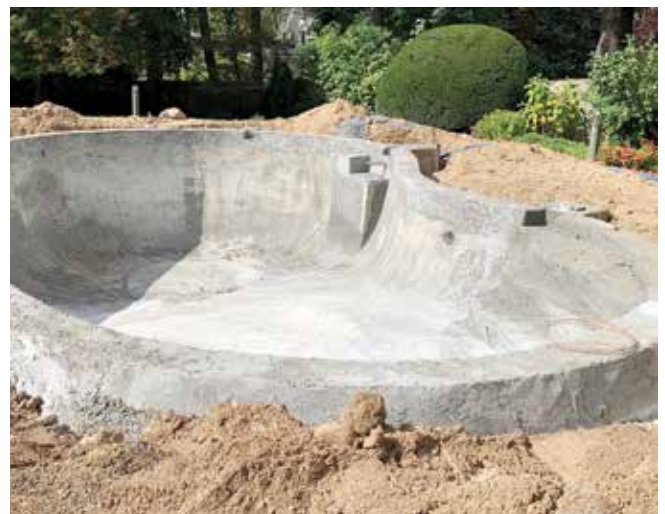
Fig. 2: Kidney-shaped pool during restoration

The original project estimate included an average of 1 ft<sup>3</sup> (0.03 m<sup>3</sup>) of concrete removal in the pool bond beam. This was estimated due to the fact that the pool held water up to the bottom of the tile line. Interior concrete degradation followed this line around the perimeter. However, once exposed, the back of the pool walls (installed at an angle more than 11 degrees from vertical) was essentially deteriorating from the backside. The moist soils and more than 50 years of frost pressures had penetrated the back of the bond beam, exposed and corroded the No. 3 reinforcing steel, and deteriorated the concrete. This deterioration was shown to the owner and we explained that this was not expected based on our original findings. However, the majority of the shell was still a fit for renovation and we agreed to proceed with our current plan. We continued to chip and remove concrete on the backside of the pool shell, leaving a distance of 6 in. (150 mm) in thickness into the old bond beam and extending down to the walls between 2 and 4 ft (0.6 and 1.2 m).

For the pool hydraulic system, new fittings, skimmers, main drains, PVC piping, and an updated filter system were installed to improve hydraulic flow. We continued by leveling off the pool area, then setting grades and pitch. A new granite coping was installed directly to the new bond beam, and the surrounding area included matching granite decking sitting on the new sub-base and connected to the new pool coping. Drainage was installed for the decking, and new anchors for oversized shade umbrellas were set in the decking. Our tile installer then prepped the bond beam area,

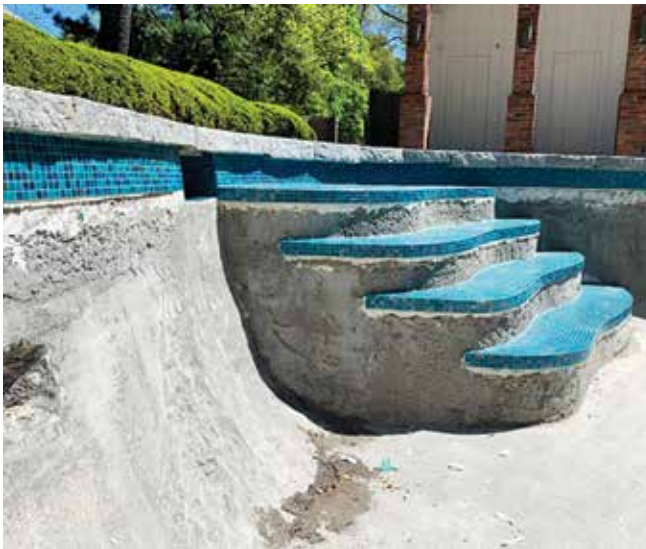
Fig. 3: Interlocking three-dimensional bond plane between new shotcrete and existing shotcrete

It was important for both us and the client to examine the results from the first winter freezing pressures against the pool shell. We removed the pool cover to inspect the connection and bond plane between the old pool concrete and the new shotcreted sections. The connection was intact and withstood all the pressures from the tough northeast winter weather. This was a key point not only of the pool shell's future durability, but also to highlight what we teach each year in industry classes and seminars. Watershape education needs to be precise and thorough, paying close attention to the details, and clients need to have confidence in their contractor. As a point person for our company, anything that I claim or promote to the client needs to be proven. This answers any questions and assures all parties involved that the investment was worth the time and money spent.

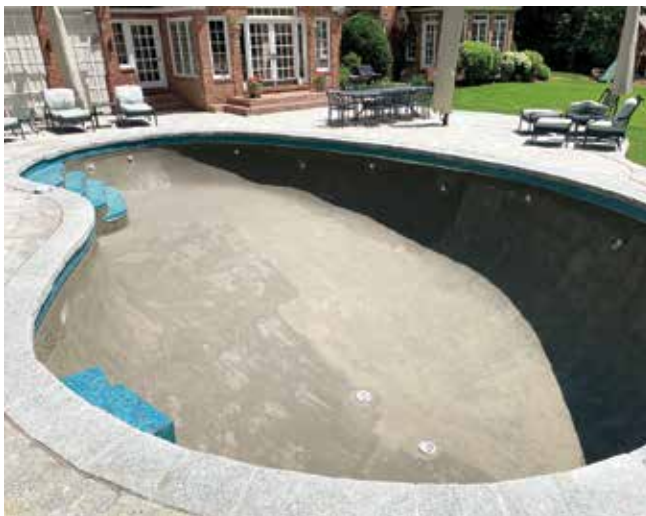
Fig. 4: Installation of waterproofing coat

and roughening of the existing substrate significantly increases the surface area and thus enhances the grab or bond of new hand-applied coatings. In this case, we will install a surface waterproofing agent to the entire shell as a redundant system. I am a huge proponent of not using these additives on top of high-quality concrete produced by the shotcrete process, particularly on new pools with surface texture consistency. Our current shell now has two different surface textures: the new wet-mix shotcrete with 3/8 in. (9 mm) aggregate, and the existing pool surface of dry-mix shotcrete with 1/4 in. (6 mm) aggregate. Applying a cementitious waterproofing membrane (like Basecrete) was done to bridge the textures and allow the final plaster coat to adhere and cure consistently over 100% of the pool interior. We are not using this technique for watertightness, but rather for aesthetics and plaster uniformity only.

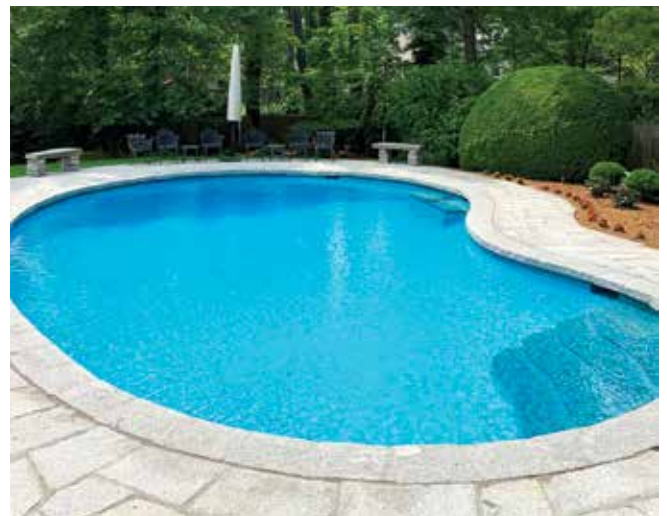
Fig. 5: Finished pool after renovation

The pool will be plastered and started up in the coming weeks, and our clients will most likely be enjoying their new space at the time of publication. As it stands now, the pool lacks a seam between the two concrete installations and acts together monolithically, providing complete watertightness prior to any surface application (refer to ASA Position Statement #4 at [www.shotcrete.org/media/pdf/ASAPositionPaper\\_PoolRec\\_4.pdf](http://www.shotcrete.org/media/pdf/ASAPositionPaper_PoolRec_4.pdf)). Chronicling phases of implementation as they happen always seems to keep us on our feet, and hopefully does the same for those of you reading this. Stay tuned for the final result as we restore this pool's former title of neighborhood jewel.

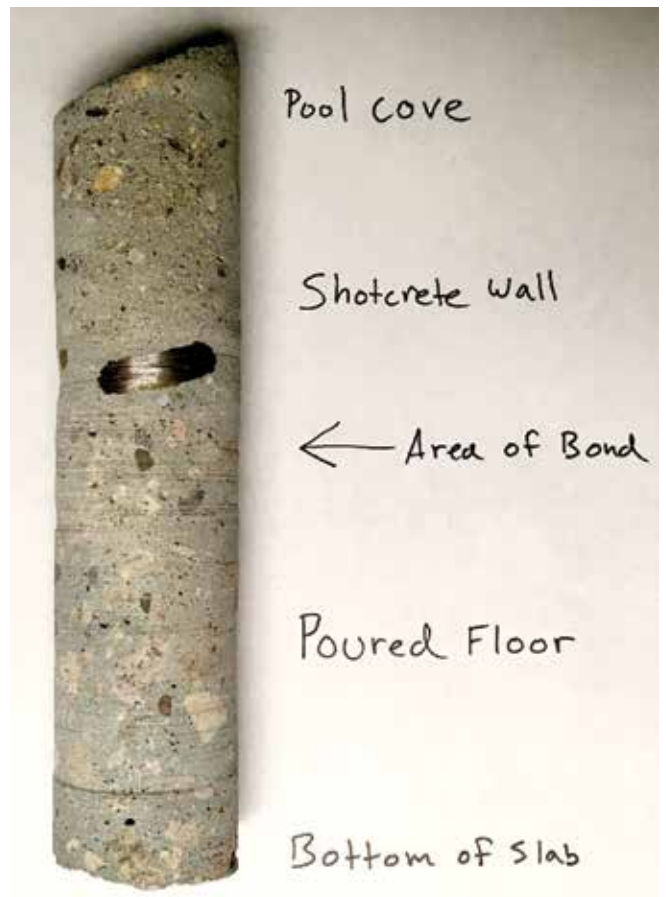
Fig. 6: Core demonstrating excellent bond of shotcrete to a poured floor
