# Concrete Repairs of the Wright Memorial Bridge

By Michael LaPrade

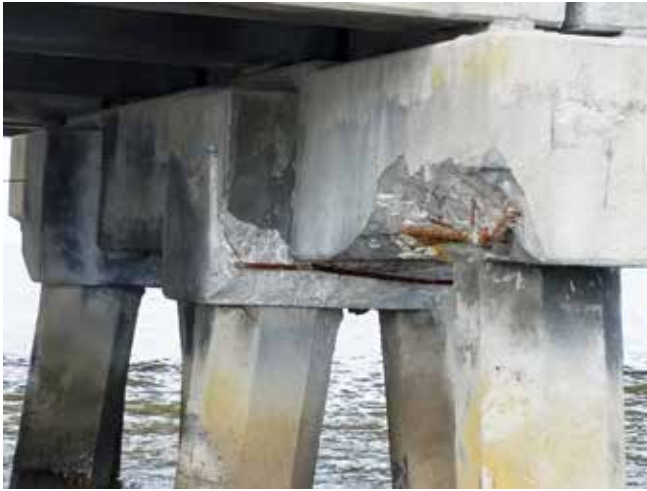
Fig. 2: Repair location on bent cap

Spalled concrete and damaged reinforcing steel were prevalent throughout the entire structure. Indeed, the need for repairs was far more extensive than originally determined. Coastal Gunite and the NCDOT agreed that shotcrete was a superior method of repair for all the damaged concrete including the prestressed girders that were originally specified to be repaired using form-and-pour methods. This change allowed for a more efficient and cost-effective high-quality repair.

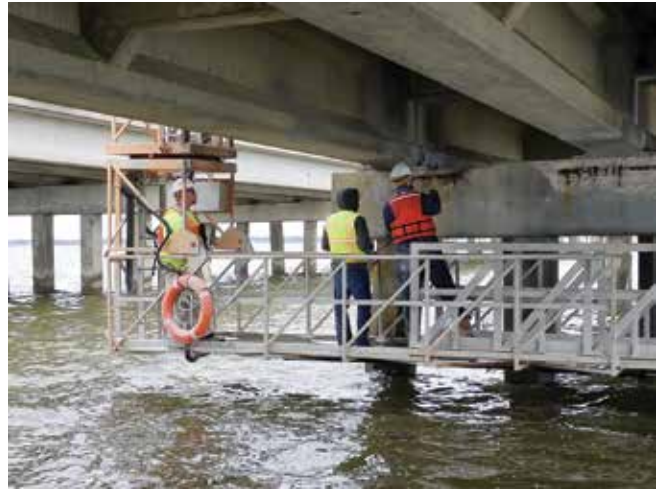
Fig. 4: Coastal Gunite Construction Company and Inspector testing for continuity

The cathodic protection for the bent caps was installed in three phases after completion of the underlying concrete repairs. First, electrical continuity had to be established to each reinforcing bar in the bent cap. Using a reinforcing bar finder, every reinforcing bar was located, and a hole drilled through the concrete to it. An electrical multimeter was then used to determine if each bar was electrically continuous

with the others in the cap. If not, the bars were connected by resistance welding steel wire between the individual members until continuity could be established throughout the cap reinforcement. To establish an electrical connection between the existing reinforcing steel and the zinc coating to be installed in the metalizing, threaded rods were tapped into selected reinforcing bars on each side of the cap and fitted with a metalized plate. These locations will also be used to test for electrical continuity and to observe the condition of the reinforcing steel in the future. The second phase consisted of applying a 16 to 18 mil (0.4 to 0.5 mm) coating of zinc using thermal spray equipment to project

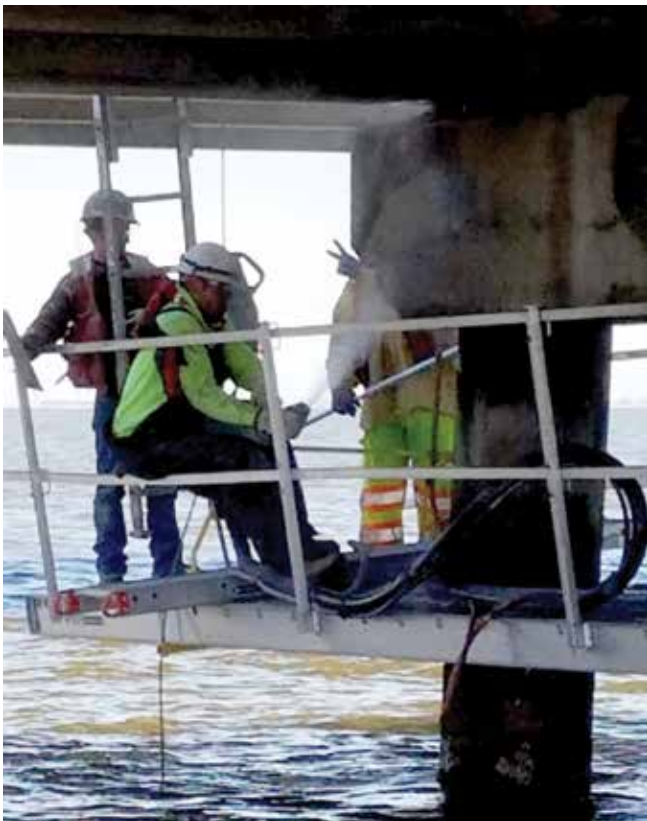
Fig. 3: Nozzlemen shooting back damaged bent cap

US Concrete Products, operating out of Timonium, MD, provided a dry-process shotcrete mixture that was specifically designed to work with cathodic protection systems. A reduction in fly ash in its standard prebagged dry-mix shotcrete product allowed for increased permeability while maintaining an acceptable design strength. This mixture was used to repair the concrete of the bent caps prior to surface metalizing operations. The metalizing operations had a strict 10-day waiting period after a cap was shot, before molten

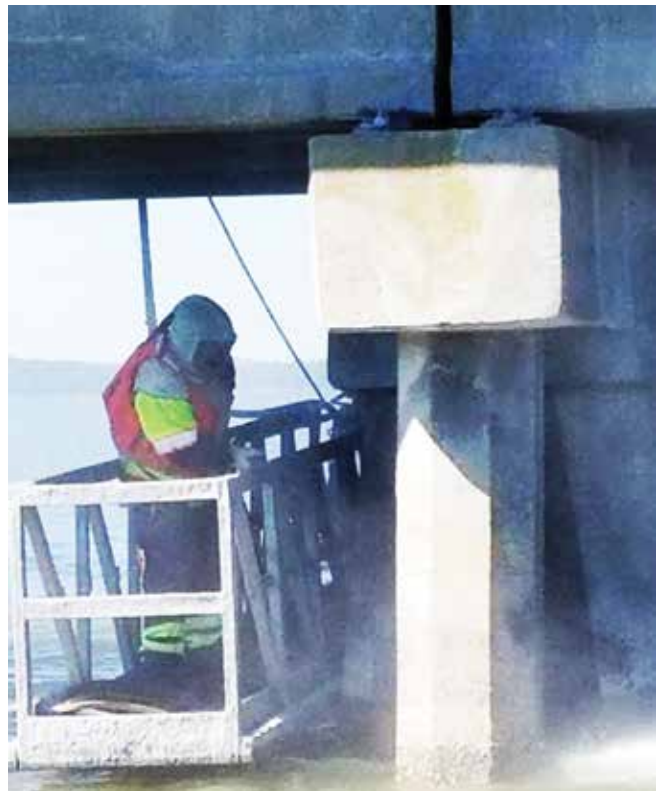
Fig. 5: Preparing to apply zinc anode

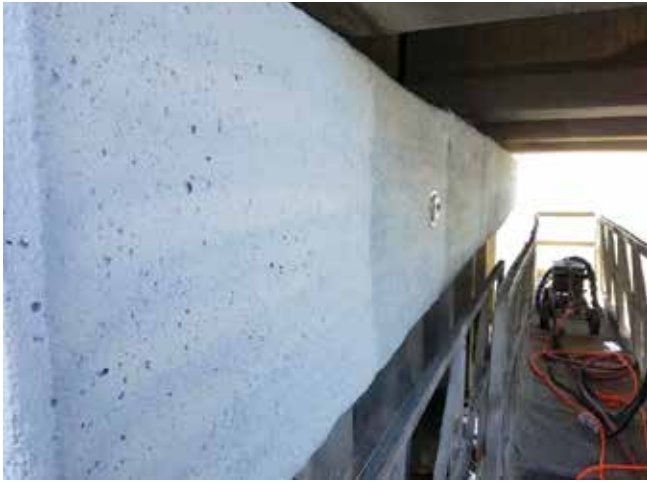
Fig. 6: Finished application of zinc anode and testing plate

atomized zinc onto the surface where it cools in a uniform coating. The third and final phase was to apply a zinc silicate topcoat, applied with paint spraying equipment.

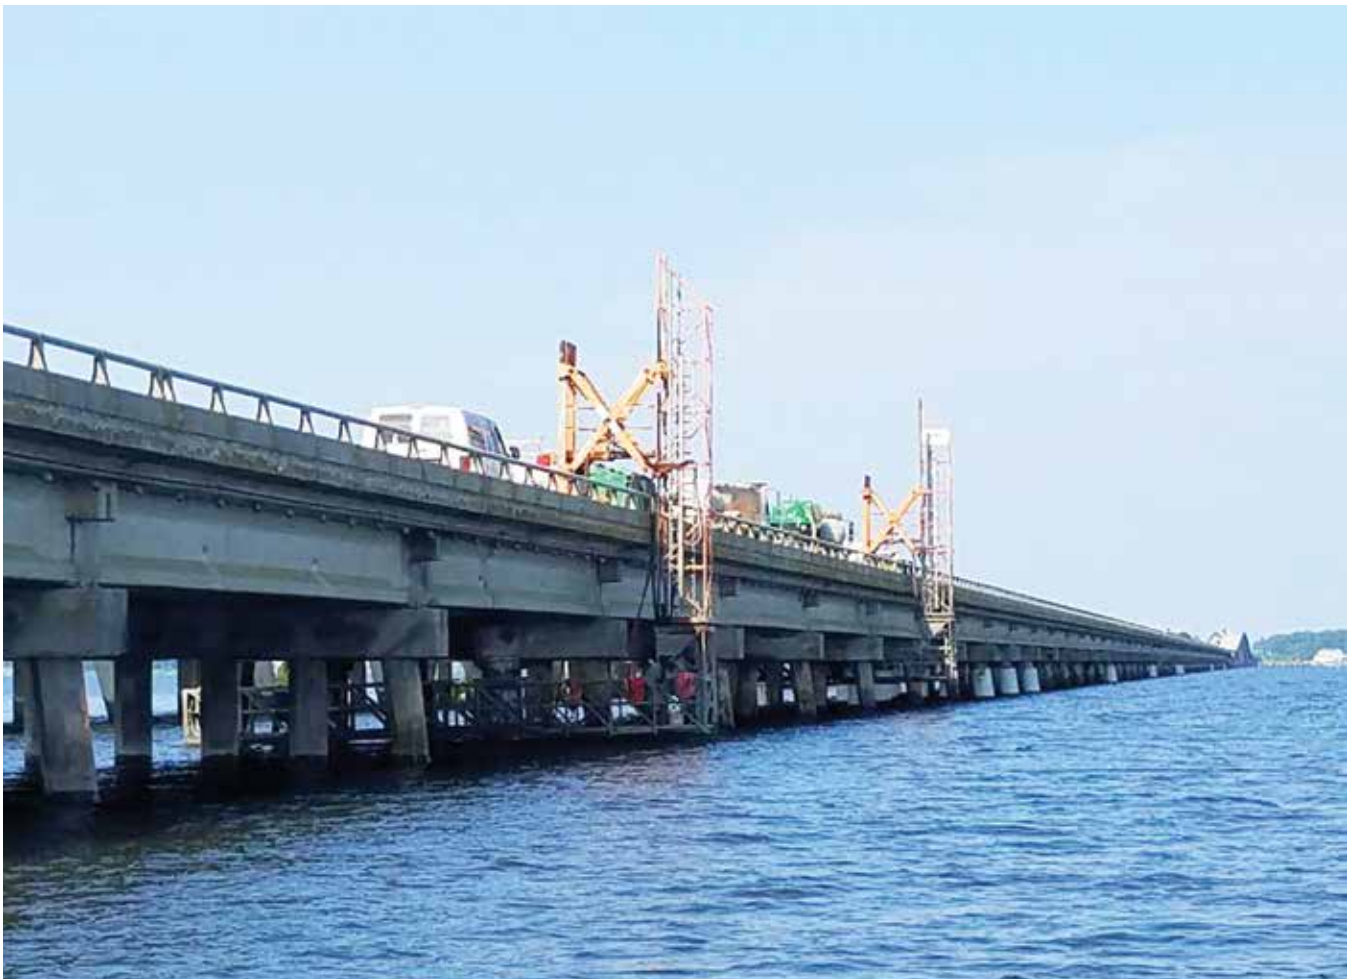
Fig. 7: Anderson Hydra-Platform Bridge Access Machines in use

Access to the underdeck, bent caps, and girders was achieved using a couple of Anderson Hydra-Platform

trailer-mounted under-bridge access machines and working from the water as well. Coordinating with other contractors to perform the work on top of the bridge required Coastal Gunite to work from the water; equipment was staged on two 10 x 20 ft (3 x 6 m) barges that were married together. Rough water conditions were common, limiting the use of the barges as stable work platforms, so a swing stage was suspended from the parapet walls of the bridge to provide a suitable work access to the bent caps. Multiple scaffold hangers were installed when bridge deck access was limited so that the scaffolding sets themselves could be moved around from the water level. This system allowed the contractors on site to work efficiently and decrease the total duration of the project and limit inconvenience to travelers.

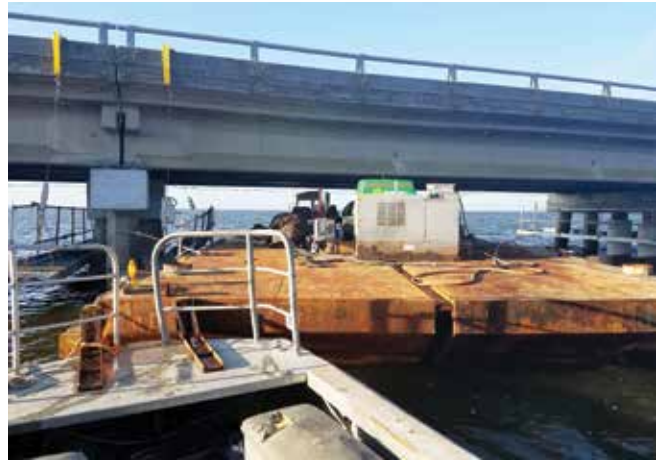
Fig. 8: Barge system for metalizing operations

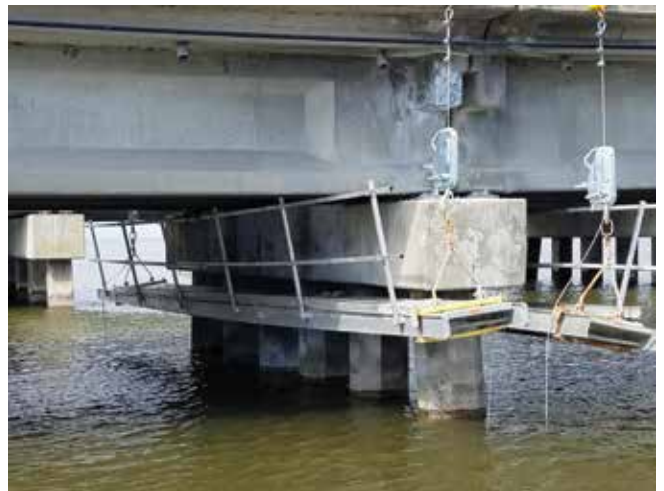
Fig. 9: Swing stage scaffolding

Memorial Bridge. Advanced warning systems allowed Coastal Gunite to properly secure and evacuate all personnel, equipment, and materials well in advance of the storm. Although Hurricane Florence had devastating impacts in North Carolina further south, the project was able to resume afterwards relatively unscathed. Hurricane Michael, which after crossing over land from the gulf coast, hit the project unexpectedly hard from the west resulting in far more equipment damage, cleanup, and delays. Scaffolding still staged under the bridge was especially hard hit despite it being secured before the storm.
