Déjà vu, West Aliquippa, PA

Shotcrete repairs to the Henry Mancini Bridge

By Ted W. Sofis

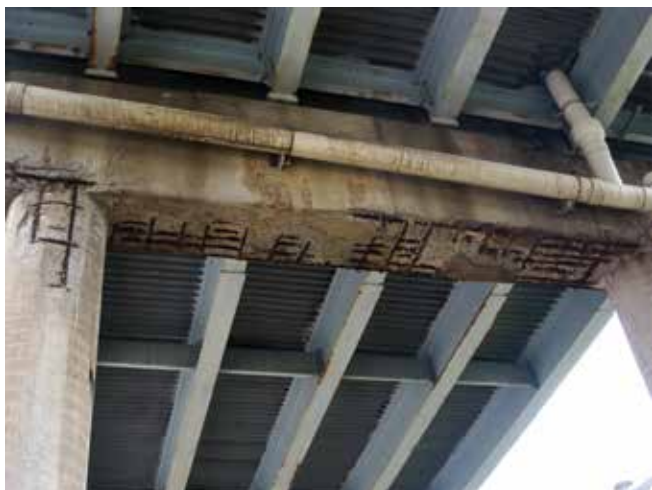
Crossing the bridge for the first time in many years certainly brought back memories. On arrival in West Aliquippa I drove through the streets and circled back under the bridge to look at the condition of the structure. Several of the piers showed exposed reinforcing bars and there was deterioration of the concrete on almost every pier. The reinforcing bars were too close to the surface in many locations. Wherever there were issues with downspouts, scuppers, or expansion dams, the concrete showed deterioration. In those locations, the drainage issues caused

Fig. 2: All but one of the bridge piers had deterioration where repairs were necessary

The following year with the scheduled rehabilitation of the bridge, we began the dry-mix shotcrete repairs on the bridge piers and abutments. For me it provided a bit of irony to work on a project where I first started gunning shotcrete over 40 years ago.

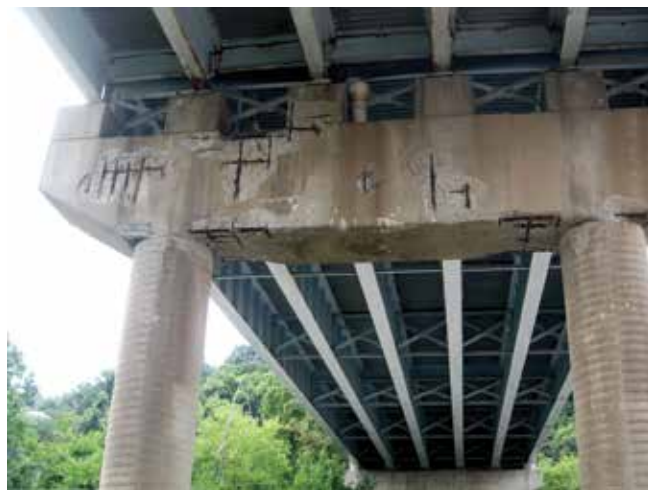
Fig. 3: When reinforcing bars close to the concrete surface corroded, the expansion of the rust spalled concrete off the rusted bars

the reinforcing steel to rust and spall the surface concrete off the bars.

With repairs of this type, it's important to properly prepare the surface. This means removing all the unsound concrete, exposing and chipping around the bar, sandblasting

the reinforcing steel, to remove the rust and scale, and coating the reinforcement prior to installing the mesh. The repair mortar used on the project was Quikrete's Shotcrete MS, a prepackaged microsilica-enhanced repair mortar with Cortec MCI added in as a corrosion inhibitor. The use of prepackaged repair mortars eliminates the need for on-site mixing and provides the installer an extra level of quality control that engineers and Department of Transportation material personnel prefer. Production panels were shot and cores taken and tested for confirming as-shot compressive strength. The installation was performed by an experienced shotcrete crew and shot with ACI-certified nozzlemen.

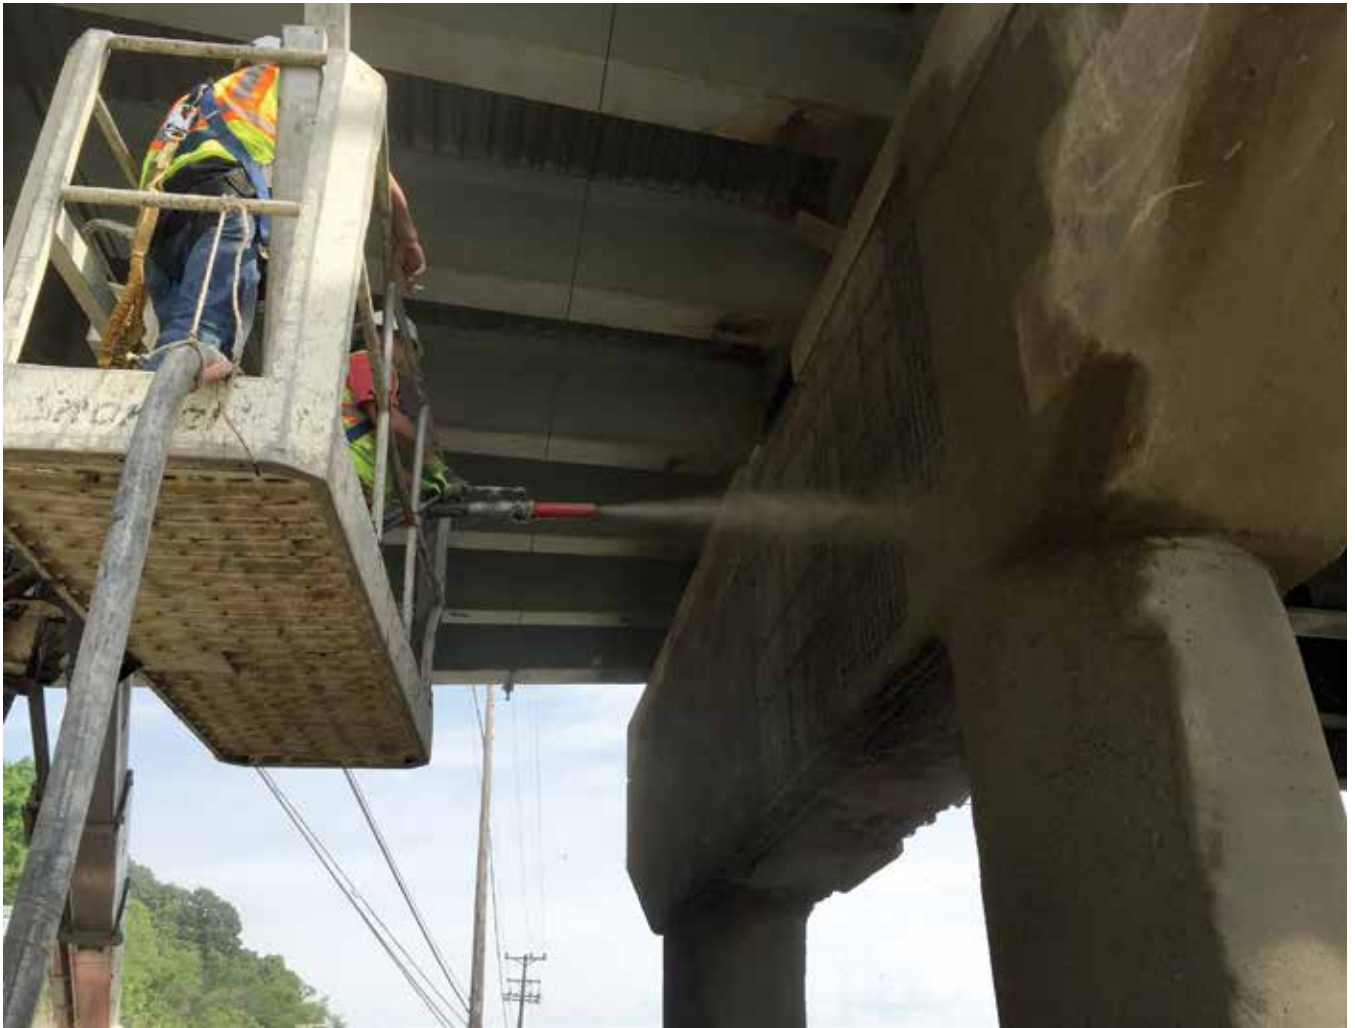
Fig. 4: Dry-process shotcrete placement on a bridge pier

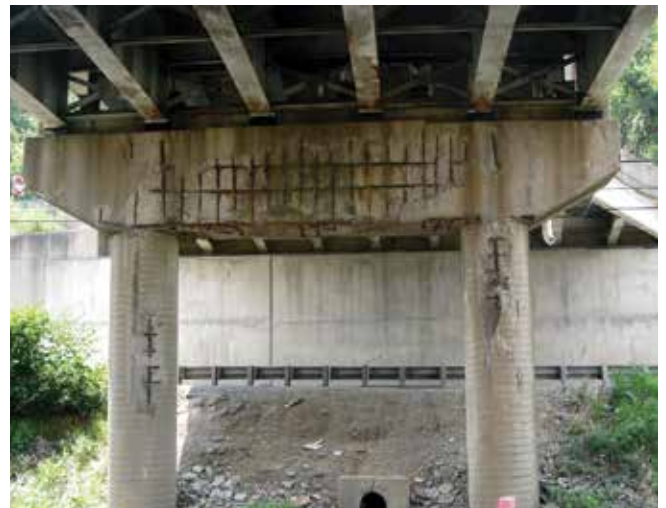
The general contractor, Swank Construction, began the project in Spring 2016. Because of structural concerns, the repair work was limited to one side of each pier. All the surface preparation, chipping, sandblasting, and the placement of anchors and mesh were completed and the shotcrete repair concrete was shot in place. The repaired areas were then cured for a period of time to achieve adequate strength before removal work could begin on the other side of the pier. There was concern that Pier 2 might need to be replaced. However, after extensive examination by the engineers, it was determined that shotcrete repairs were acceptable, but that only one-quarter of the pier could be done at a time. This meant that after all the other work was completed, the Pier 2 repair work had to be performed

Fig. 5: Because of concerns about the condition of this pier the repairs were performed in four phases

in four separate phases, allowing for adequate curing time in between each repair.

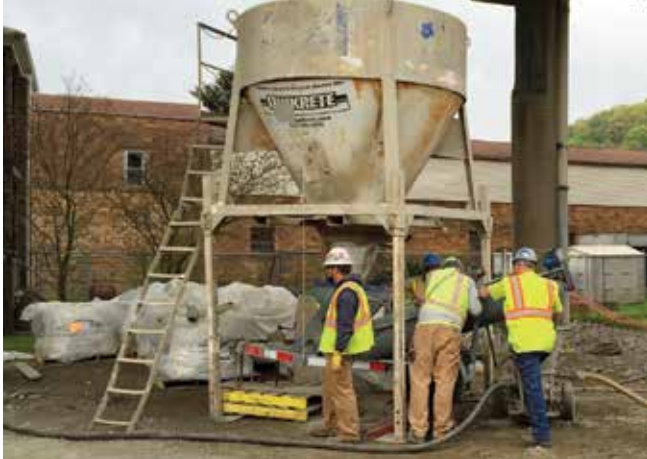
Fig. 6: Equipment setup for gunning prepackaged material

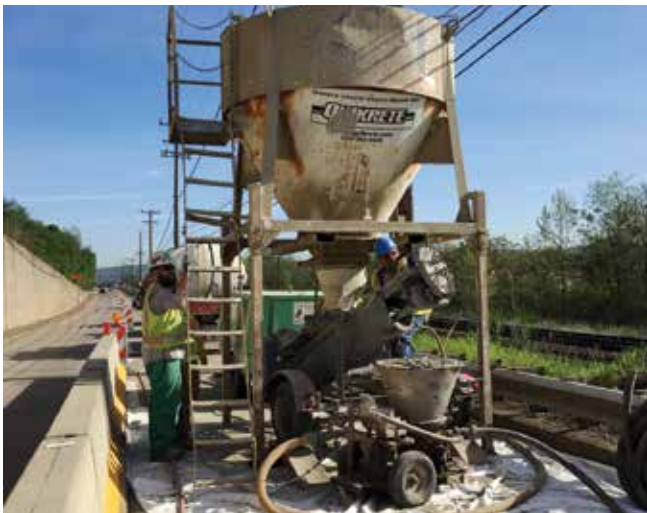
Fig. 7: Material hopper, predampener, and continuous-feed rotary gun setup for gunning prepackaged shotcrete repair mortar

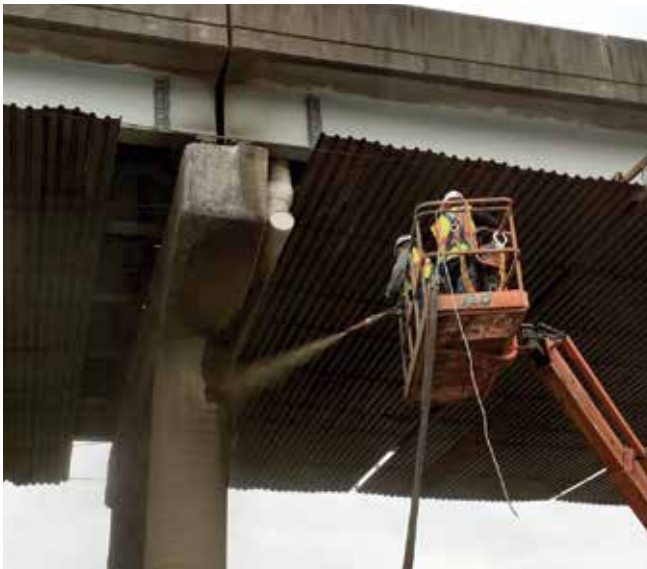
Fig. 8: Gunning of prepackaged material on bridge pier. We were required to repair one side of the piers at a time
