# Oroville Dam Emergency Recovery

By Mick Haggerty

Oroville Dam, built in 1957, is an earth-filled embankment dam located on the Feather River, east of the city of Oroville, CA, in the Sierra Nevada foothills east of the Sacramento Valley. At 779 ft (238 m) high, Oroville Dam is the tallest dam in the United States, 20 ft (7 m) taller than the Hoover Dam. The dam serves mainly for water supply, hydroelectricity generation, and flood control.

In February 2017, after an emergency discharge due to extensive rain events, Oroville Dam's main spillway chute and emergency spillway were damaged, prompting the evacuation of more than 180,000 people living downstream. The State of California, Department of Water Resources, enacted an emergency repair project shortly after the event.

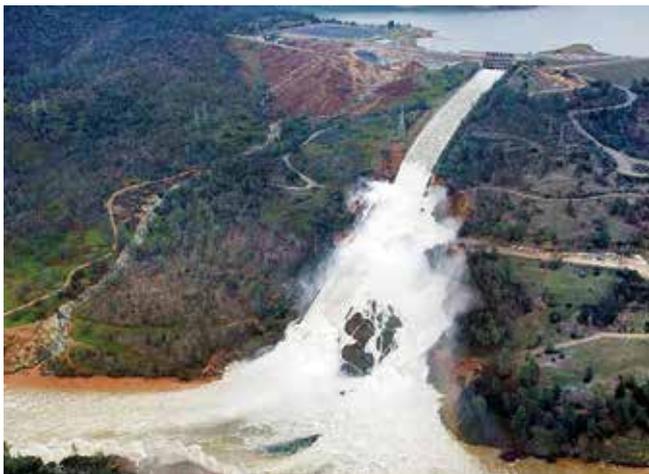
Fig. 1: February 2017 Oroville Dam main spillway is damaged

In Phase 1, roller-compacted concrete (RCC) was used to fill in the portions of the spillway that were washed out. A 1100 ft long, 200 ft deep (335 x 60 m) trench in the main spillway had been undercut and significantly damaged during the February 2017 emergency discharge. When it became clear that the volume of the repair would push the completion date beyond the Phase 1 deadline for the next rainy season and potential water discharge, shotcrete was chosen to accelerate the temporary spillway walls. With an aggressive schedule of extended, staggered shifts and weekend work, the spillway was completed in approximately 4 weeks.

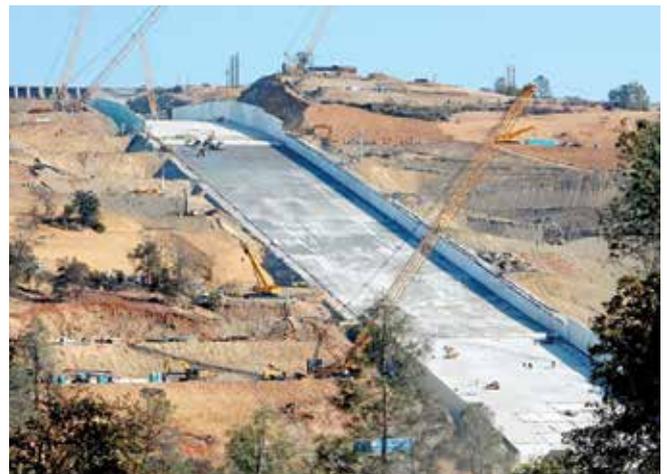
Fig. 2: Middle third of the 3000 ft (900 m) main spillway chute

The middle third portion of the 3000 ft (900 m) long spillway used 6 in. (150 mm) thick shotcrete for the spillway walls against the RCC berms on either side of the spillway. The 2500 ft (760 m) of walls were reinforced with welded wire mesh and epoxy anchors back into the RCC berm. The concrete mixture, furnished by Mathews Readymix, LLC, included 752 lb (341 kg) of cement and 3/8 in. (10 mm) pea gravel, with hot weather concrete provisions for ice and a set retarder. Slumps were 1 to 3 in. (25 to 75 mm). The walls were given a smooth trowel finish. Properly prepared construction joints were provided between placements.

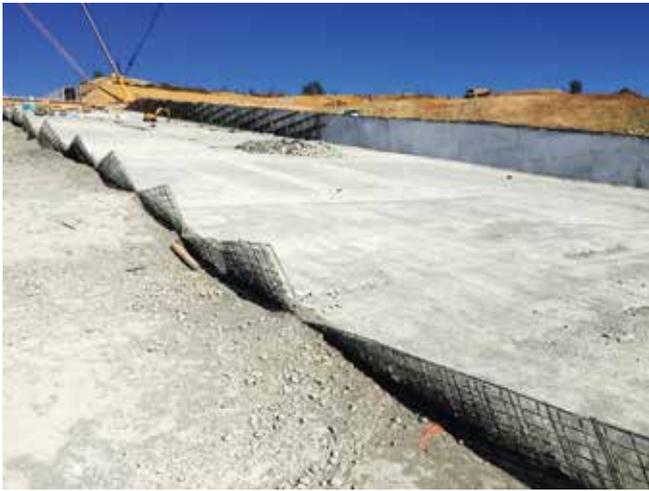
Fig. 3: RCC berm supporting main spillway walls

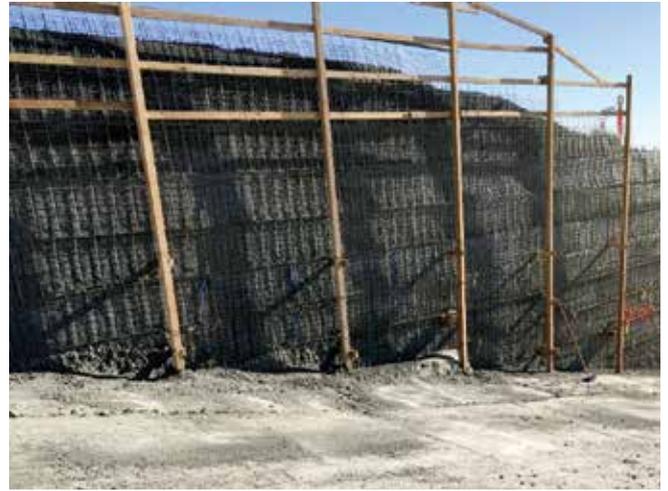
Fig. 5: Shotcrete substrate of RCC berm and WWF reinforcing

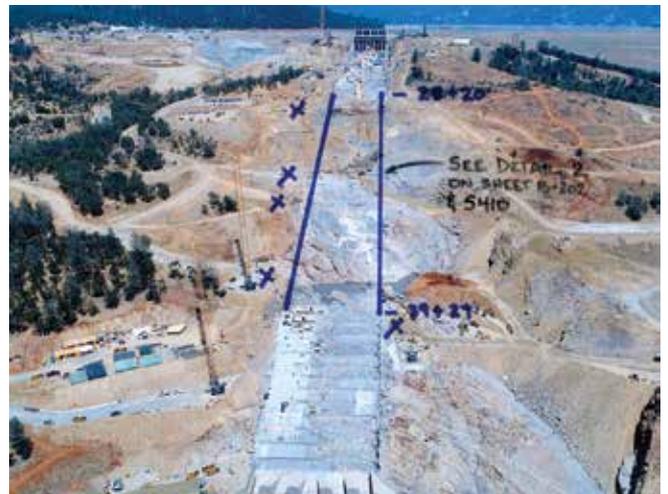
Fig. 6: Deep trench in middle third of main spillway chute, temporary shotcrete walls
