Repairs and Strengthening of Brick Arch Masonry Storm Water Drains for MCGM

ICRI 2019 Project Award Finalist – Project of the Year, Water Structure Category
Mumbai, Maharashtra, India

By Kasturi Projects PVT, LTD

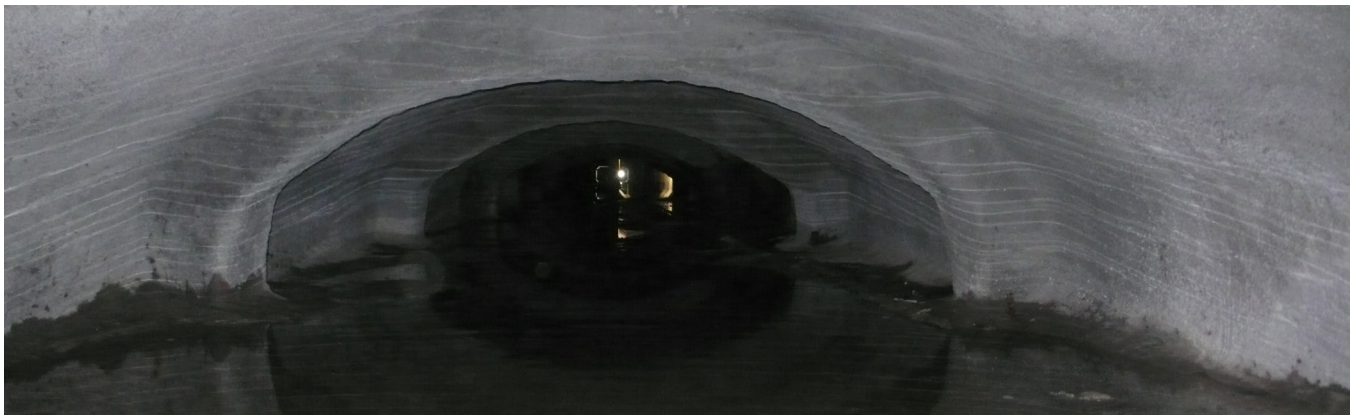
Fig. 1: Completed repair of the storm water drains in the City of Mumbai, India, that are over a century old and were constructed of brick arch masonry during the British Era

The storm water drains in the city of Mumbai, India, are over 100 years old and constructed with brick arch masonry during the British Era (Fig. 1). The storm water drains (SWD) were prone to frequent cave-ins. To prevent cave-ins, enhance their safety, and maintain the SWD system, the Municipal Corporation of Greater Mumbai (MCGM), under the Central Government of India “BRIMSTOWAD” Scheme, initiated a detailed survey and mapping of the SWD for the City of Mumbai.

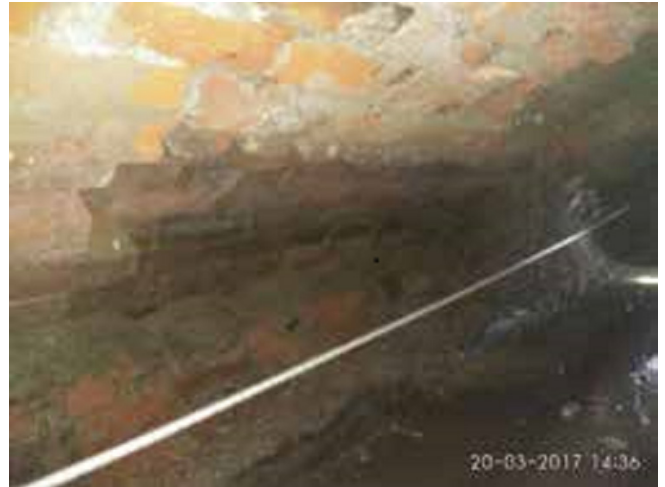
- Deterioration and spalling of lining and brickwork (Fig. 2), some due to scouring. There was also bond failure due to ingress of water, undermining the integrity of the lining through corrosive effluents;

Fig. 2: Delamination and spalling of brick lining

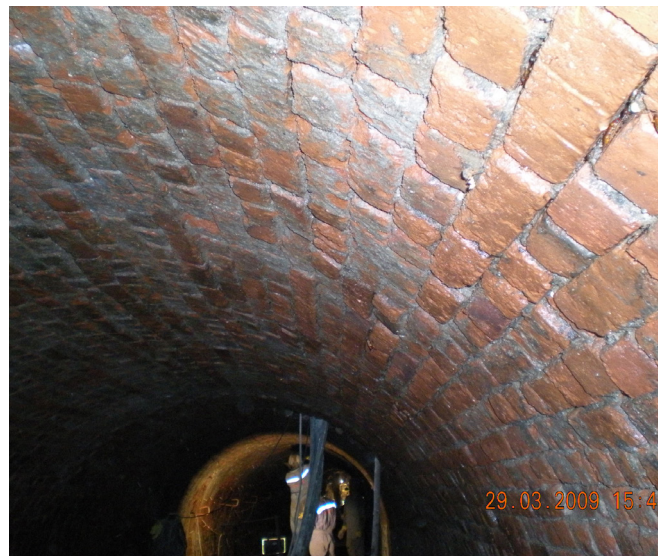
- Erosion of mortar joints (Fig. 3) impaired the structural strength of the drain, which if not rectified, would result in misplaced bricks;
- Excessive loading was generally the cause of longitudinal cracking. Circumferential cracking was infrequent;

Fig. 3: Erosion of mortar joints

- Repointing the mortar joints where eroded;
- Injecting a two component sealing rigid polyurethane resin to stop water ingress into the drains (Fig. 7);

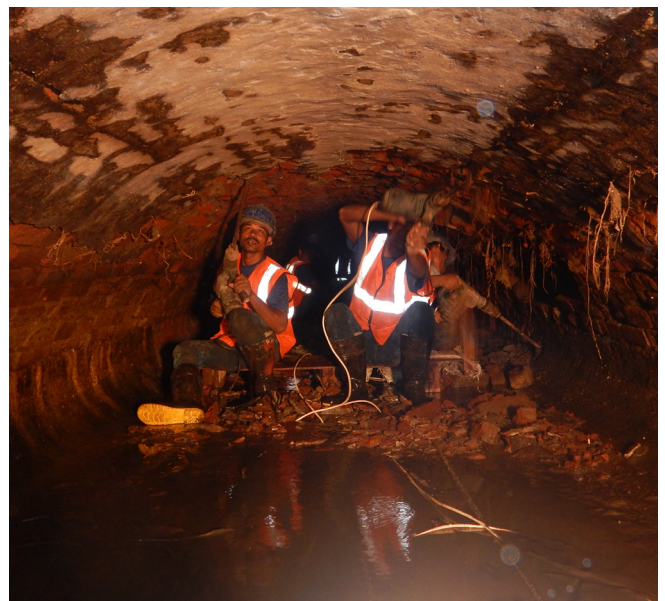
- At one location, roots of an appreciable size penetrated the brick arch construction (Fig. 4). In this case, local collapse of the brickwork was a real possibility in the short term; and

Fig. 4: Root penetration through masonry lining

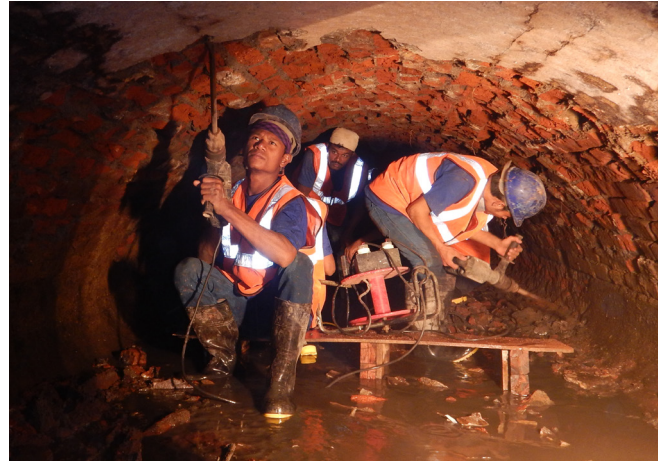
Fig. 5: Demolition of deteriorated brick lining with lightweight breaker

In most areas, the internal brick masonry lining was eroded. Where deterioration was evident, the old lining was manually removed with 11 lb (5 kg) breaking hammers (Fig. 5). Lightweight hammers were used to avoid disturbing the bricks and mortar lining. After removal of the lining, the debris generated was taken out of the drains manually. High-pressure (7250 psi [500 bars]) waterjet washing was used to clean the brick surface and remove loose, damaged mortar pointing (Fig. 6). Loose bricks, where removed, were replaced with new bricks.

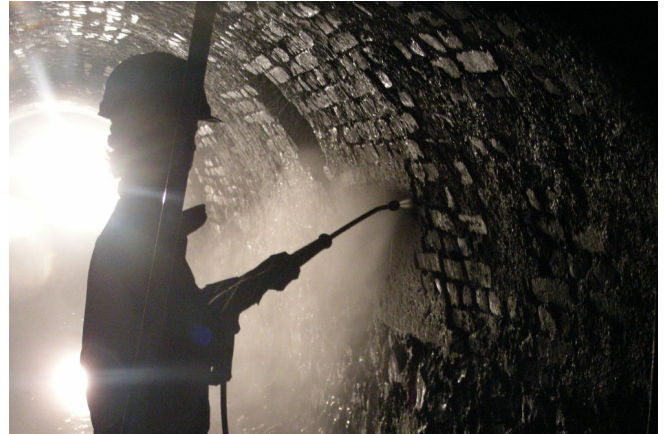
Fig. 6: High-pressure waterjet washing

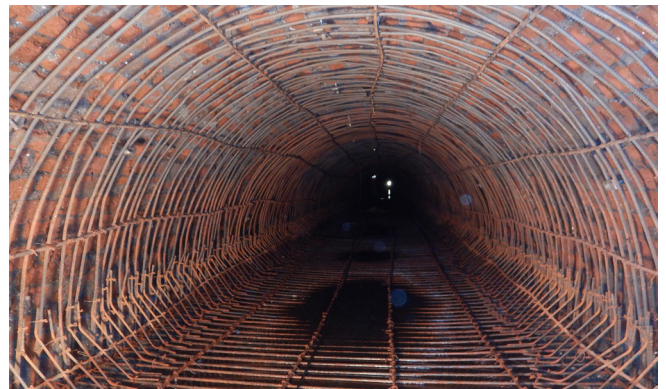
Fig. 8: Fixing steel reinforcement

- Installing reinforcement FE 500D per the structural drawings and anchoring to the brick arch masonry at sufficient interval with anchors and spacers (Fig. 8);

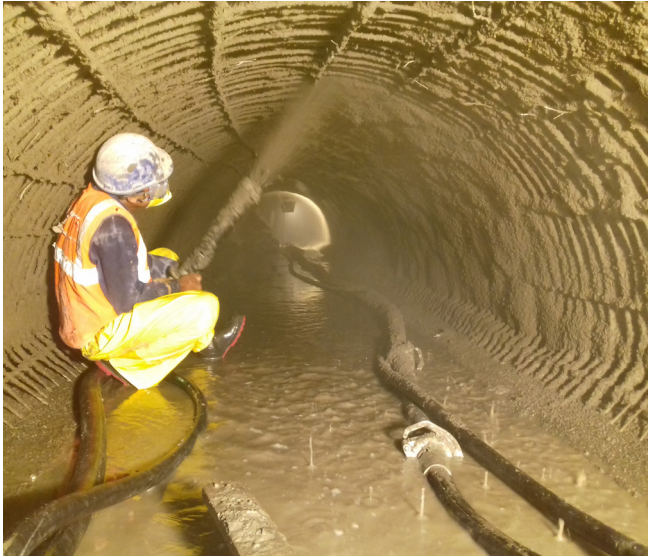
Fig. 9: Placing wet-mix shotcrete

- Wet mix shotcrete, M-30 Grade (30 MPa [4300 lb/in²]), was applied to the entire brick masonry internal surface at a thickness ranging from 5 in. (125 mm) to 9 in. (230 mm) per structural requirements (Fig. 9). The application was completed in one or two passes per site conditions;

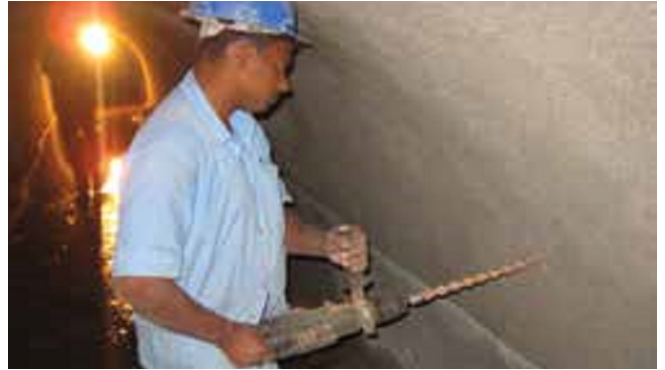
Fig. 10: Drilling holes into the brick masonry

- Drilling 1 in. (25 mm) diameter x 22 in. (550 mm) long holes into the brick masonry (Fig. 10), installing injection packers, and grouting using a non-shrink cementitious, anti-washout grout, to the point of rejection (Fig. 11). The goal was to fill the voids behind the buried drain structure and into the mortar joints to strengthen the pointing; and
- Spray applying a 0.25 in. (6 mm) thick two-component mineral-based mortar system to form a lining that is resistant to aggressive environments (Fig. 12). The ceramic-based mineral coating can withstand extreme pH (3-12), chloride and sulfate loading, biogenic sulfuric acid attack, and abrasion. In addition, the coating is breathable, preventing damage due to hydrolysis and osmosis.

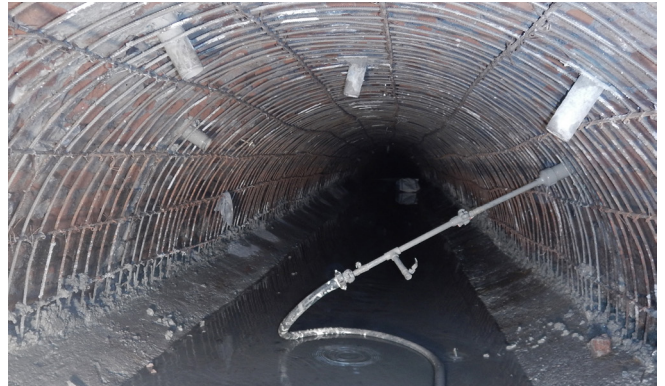
Fig. 11: Fixing injection packers and grouting using a non-shrink cementitious, anti-washout grout

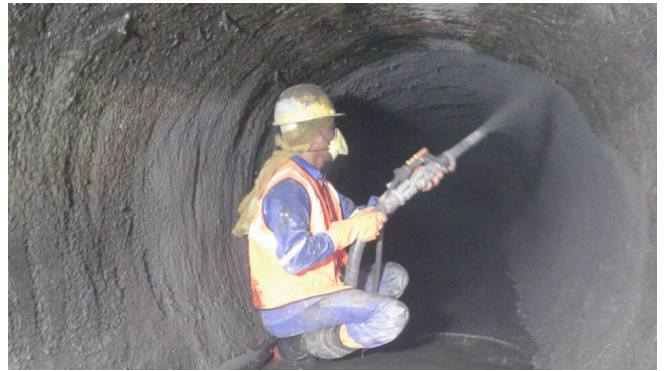
Fig. 12: Spraying two-component mineral-based mortar system to form a lining
