INFRASTRUCTURE CATEGORY WINNER

DAVIS BARRACKS CHILLER PLANT WALL

Thorcon Shotcrete and Shoring - Shotcrete Contractor

DAVIS BARRACKS CHILLER PLANT WALL - WEST POINT, NY

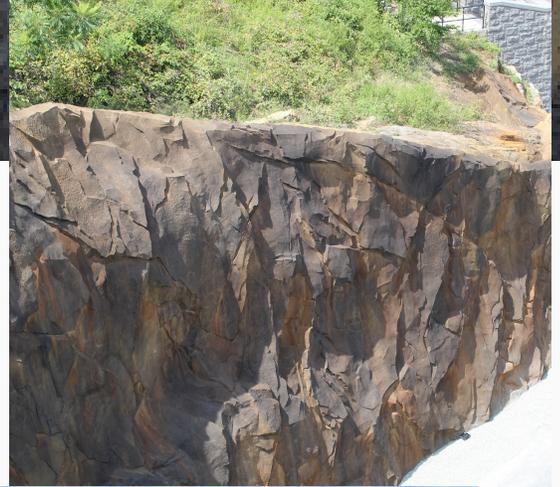
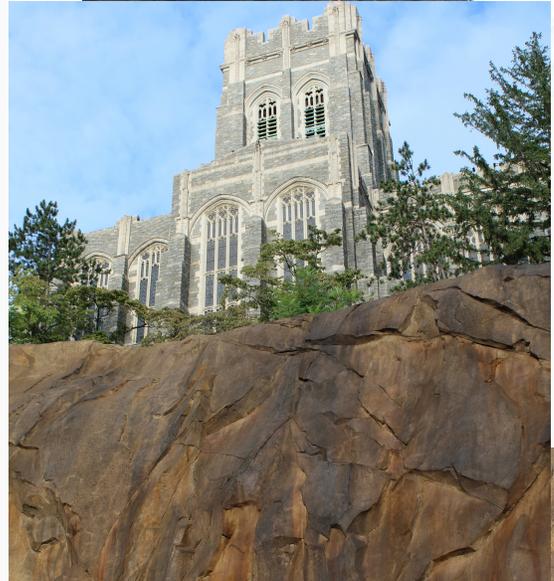
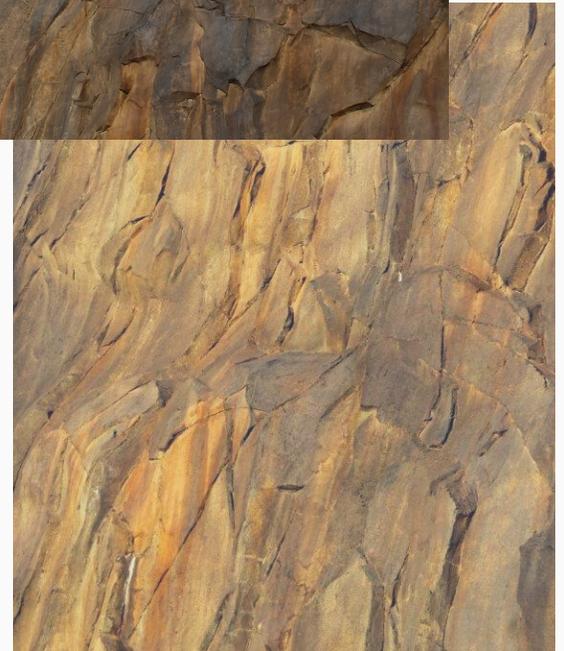
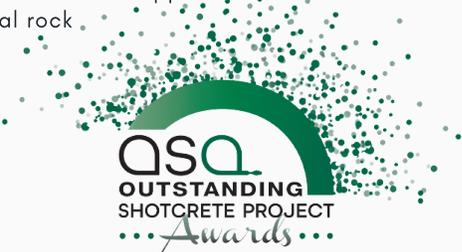
Drains were placed on the rock face to drain the seasonal groundwater that would seep through the rock. Rock bolts were used to help tie the new shotcrete wall to the existing rock. The shotcrete placement required careful attention to surface preparation, reinforcement placement and then shooting to get adequate thickness for the wall. Multiple manlifts were used by various members of the crew for ready access to the tall rock faces. Once placed the shotcrete artisans carved and colored the shotcrete surface. They carved in all the nooks and crannies to make the shotcrete look like a natural rock face with varying colors and faults. Using quality, high strength, durable shotcrete solved the problem of a deteriorating in situ rock, controlled moisture coming through the rock, and yielded a final appearance that meet or exceeded to look of the original rock.

Shotcrete placement was the primary component for the Davis Barracks Chiller Plant Wall. Sculpted shotcrete was selected by the designers to stabilize and manage environmental deterioration of the newly blasted wall face directly next to the newly constructed Davis Barracks while aesthetically looking like a natural rock face. Shotcrete was the optimal choice with the high aesthetic requirements and challenging site conditions. Shotcrete could efficiently achieve the appearance of natural rock despite the irregular wall face, wall heights up to 120 ft and with an overall 700 ft length. Additionally, there was limited access between wall face and barracks buildings with a little as 40 ft in some areas. These requirements and site characteristics made sculpted shotcrete the only viable solution.
