# Davis Barracks Sculpted Wall

## 2020 OUTSTANDING INFRASTRUCTURE PROJECT

**Davis Barracks Chiller Plant Wall**

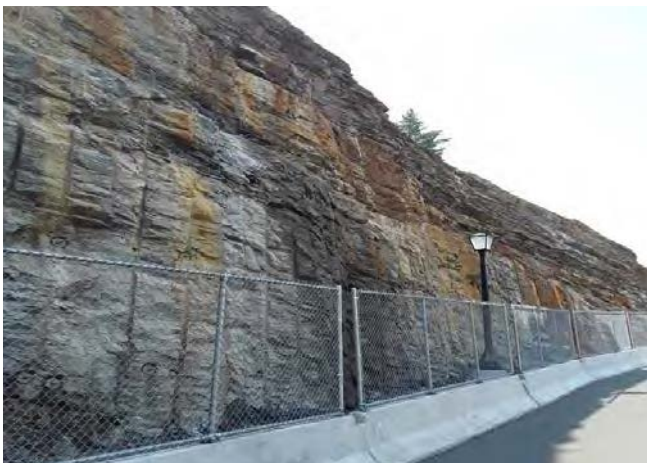
The wall behind the barracks, which was exposed to a combination of exposure to the sun, as well as freezing and thawing, caused the rock to become weathered and brittle. This created the need for our work, because without an engineered solution the exposure would continue to erode the mountain side. The US Army Corps of Engineers (USACE) were tasked to provide a solution for this extensive exposed rock wall face. An elaborate sculpted shotcrete system was the answer.

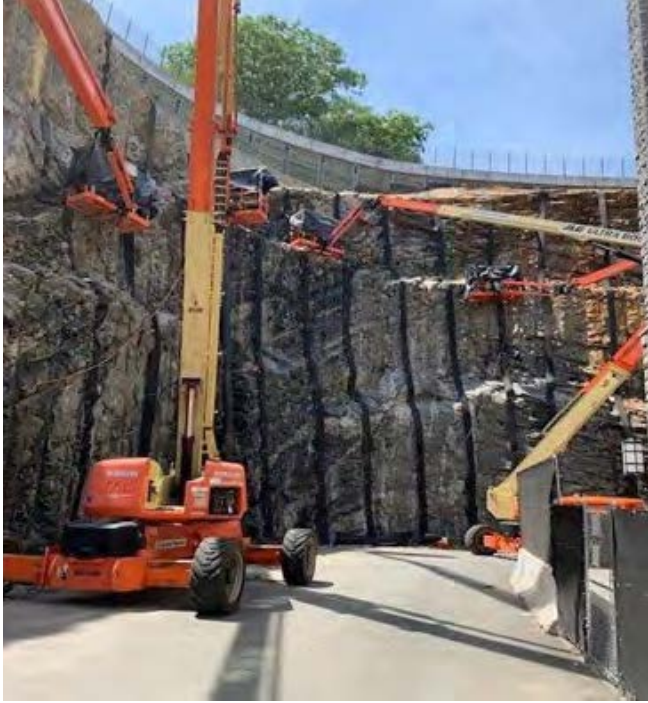
The wall was extremely large, approximately 825 ft (251 m) long, 100+ ft (30+ m) tall. The work was done with 125-ft

(38 m) articulating manlifts and personnel secured on ropes from topside for work operations. Specialized safety and training was required for this part of the project.

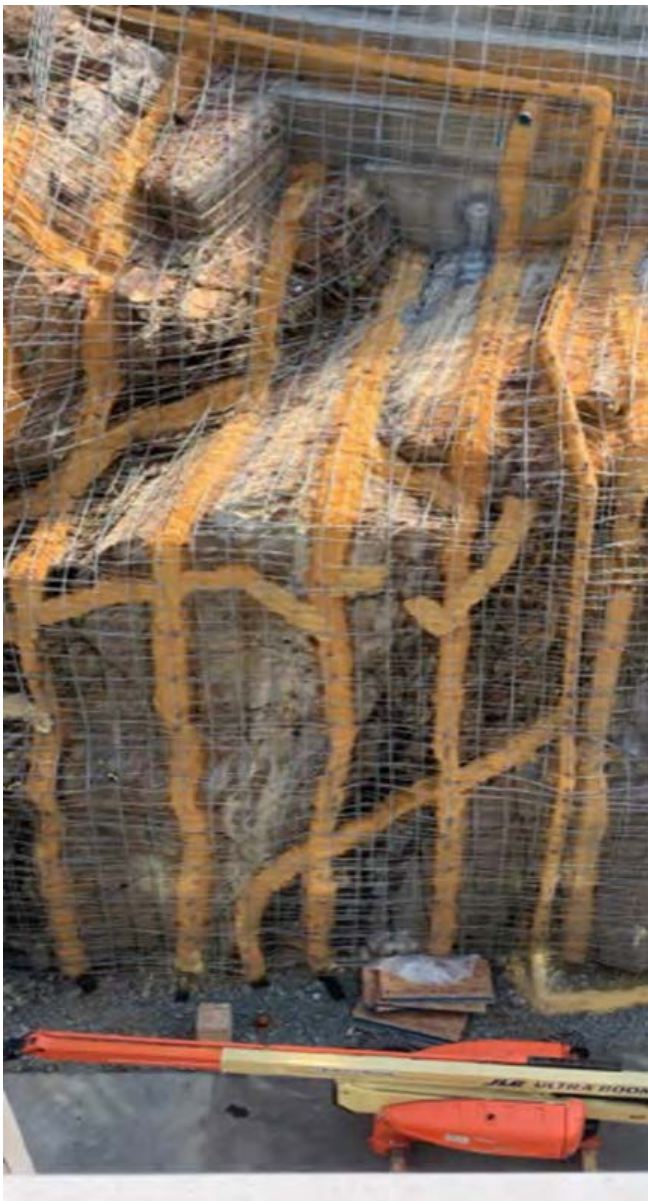
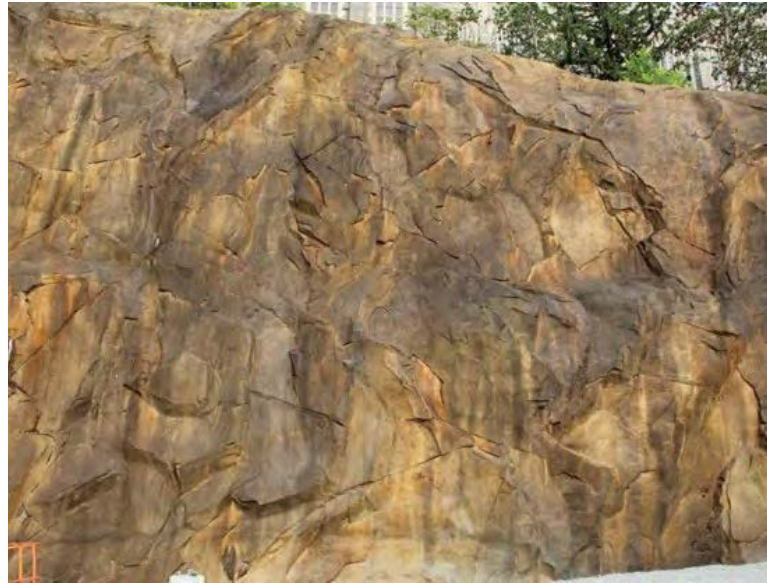
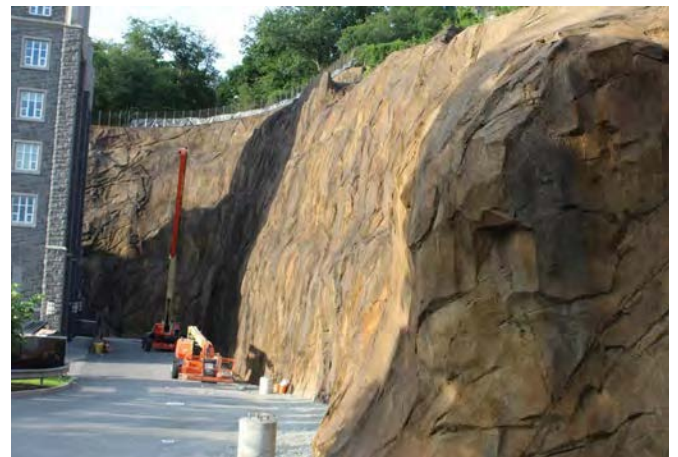
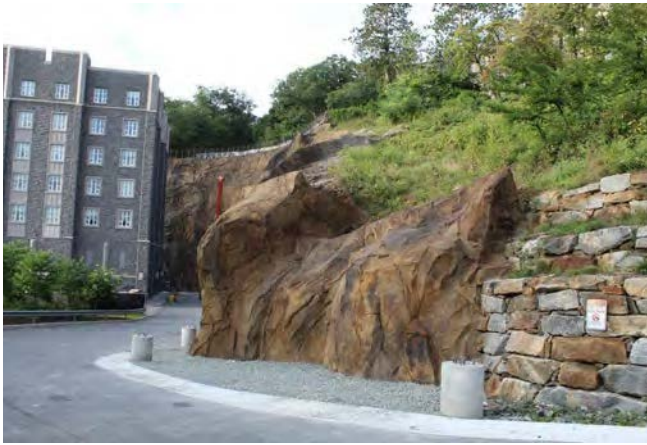
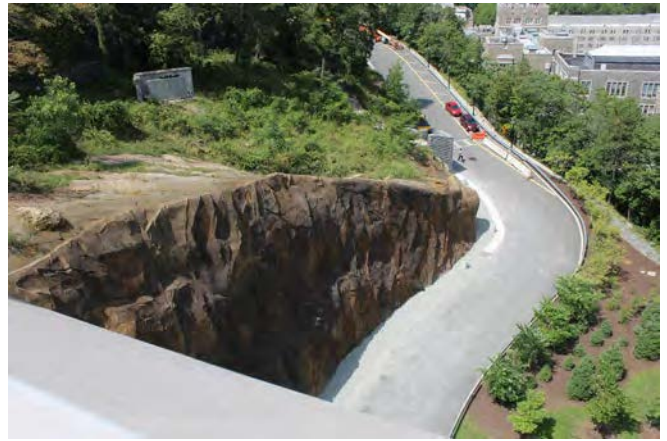
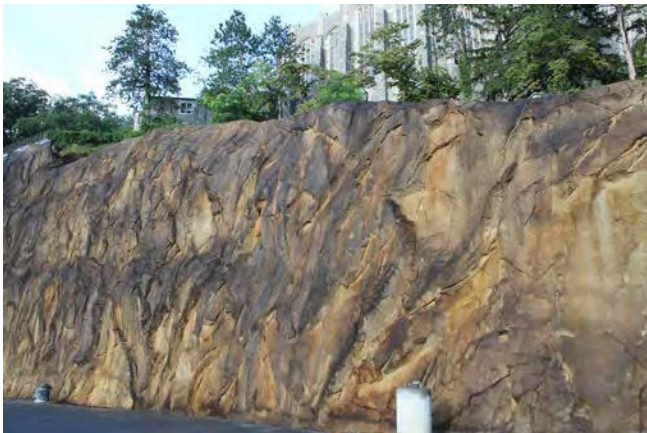
The specification called for a large amount of reinforcing bar to be attached to the wall. To achieve this Thorcon installed over 4000 L-shaped epoxy-set dowels every 4 ft (1.2 m) each way. While drilling into the granite, drill bits were burning up and becoming dull at an astonishing rate. Hilti Manufacturing Company recommended using specialized drill bits that helped eliminate these issues, allowing more productive installation of the dowels.

20 ft (6 m) mats using #4 (#13M) reinforcing bar spaced at a 12 in. by 12 in. (300 mm by 300 mm) spacing each way were formed on the ground. Then a large telehandler was used to raise the prefabricated reinforcing bar mats onto the wall. Because of the difficulty of bending the reinforcing bars around the ledges and curvature of the wall, personnel in manlifts were used to support the mat to the epoxied dowels. This was done twice in each location since a double layer of reinforcing was required by the design.

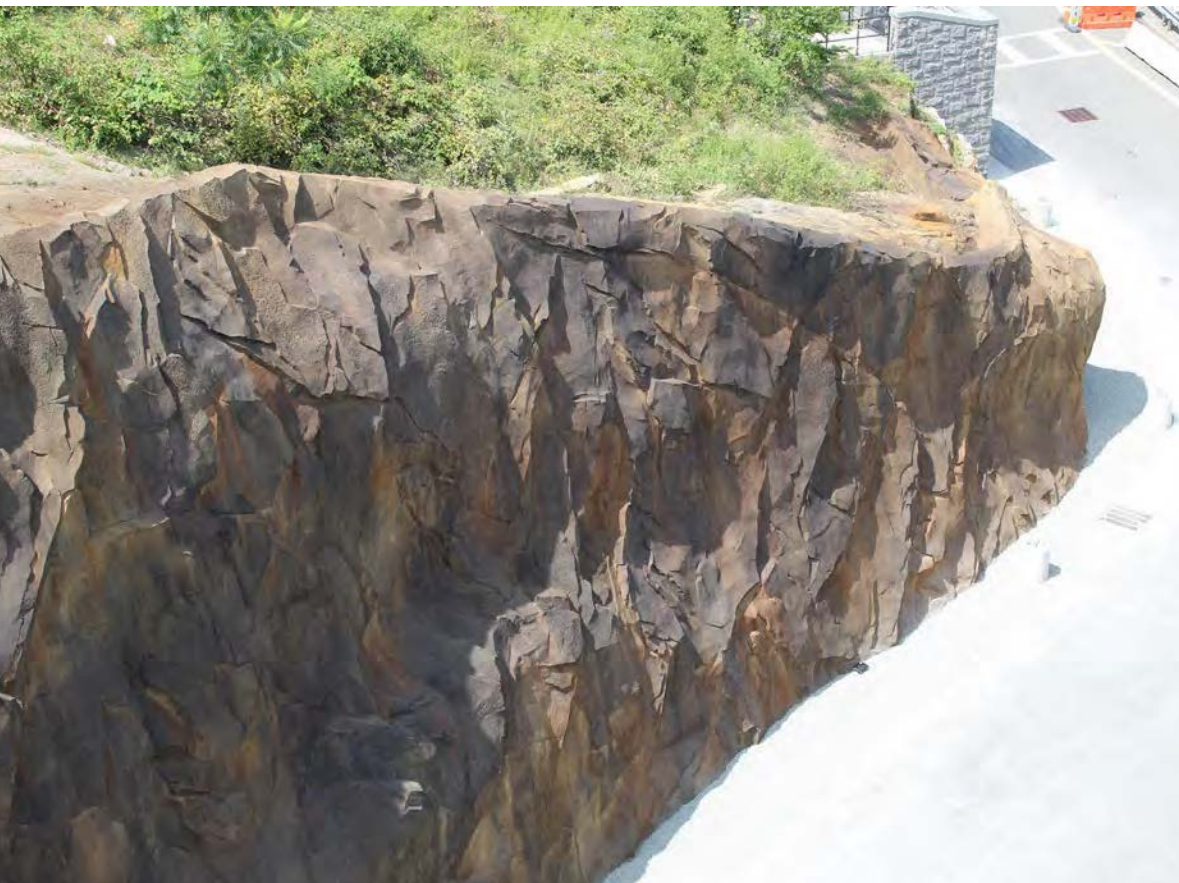
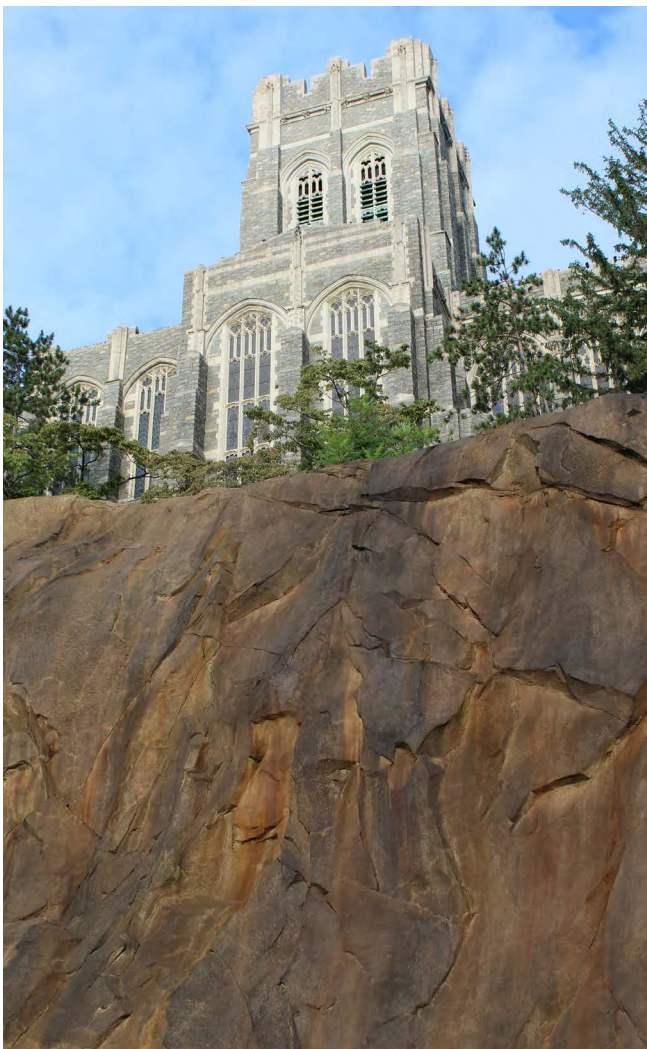
Two crews with concrete pumps placed shotcrete pneumatically in thicknesses from 12 to 16 in. (300 to 400 mm), shooting anywhere from 60 to 100 yd<sup>3</sup>

(46 to 80 m<sup>3</sup>) per day. When the last architectural layer was placed, six artists sculpted the wall by hand with trowels and other small miscellaneous carving tools using manlifts and ropes for ready access to the face of the wall. The intent of the sculpturing was to mimic the natural rockscapes of the surrounding New York region. Then, to make the sculpting look extremely natural, several different colors of acid-based mineral stain were applied to the wall surface completing the natural appearance sought by the designers.
