UMA Corrects Shotcrete Pool Settlement Issues with HDPR Injection

The engineer chose UMA's High-Density Polyurethane Resin (HDPR) Injection to remediate the voiding below the shotcrete surface of a pool that was experiencing settlement issues.

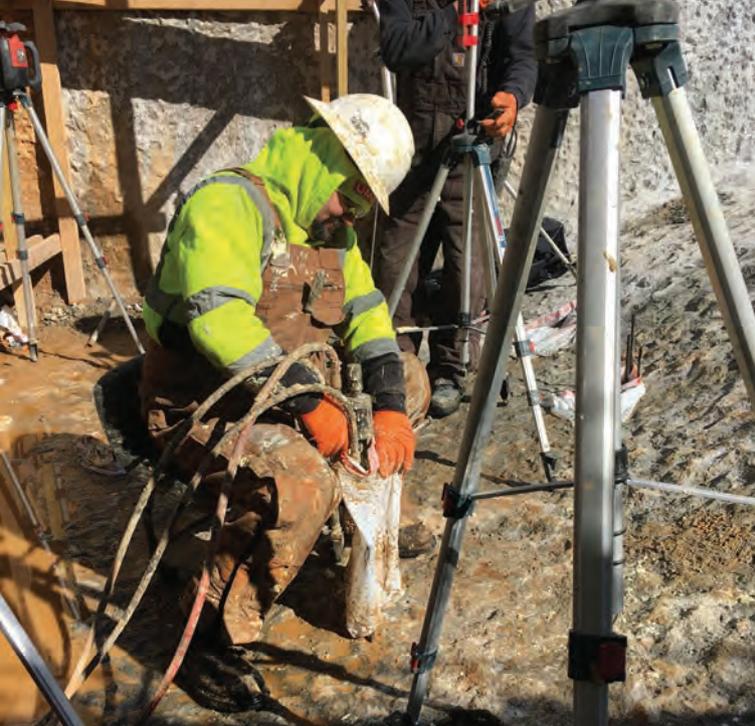
HDPR was injected by performing a series of Deep Injections (DIs) at increments of 3 ft below the bottom of the pool to a final depth of 9 ft.

UMA determined that injecting HDPR by performing Deep injections (DIs) was the best method to solve this problem. The plan was to perform a series of DIs at increments of 3 ft (0.9 m) below the bottom of the pool to a final depth of 9 ft. (2.7 m) The pool treatment area consisted of approximately 640 ft² (60 m²) with DIs placed on approximate 3 ft centers.

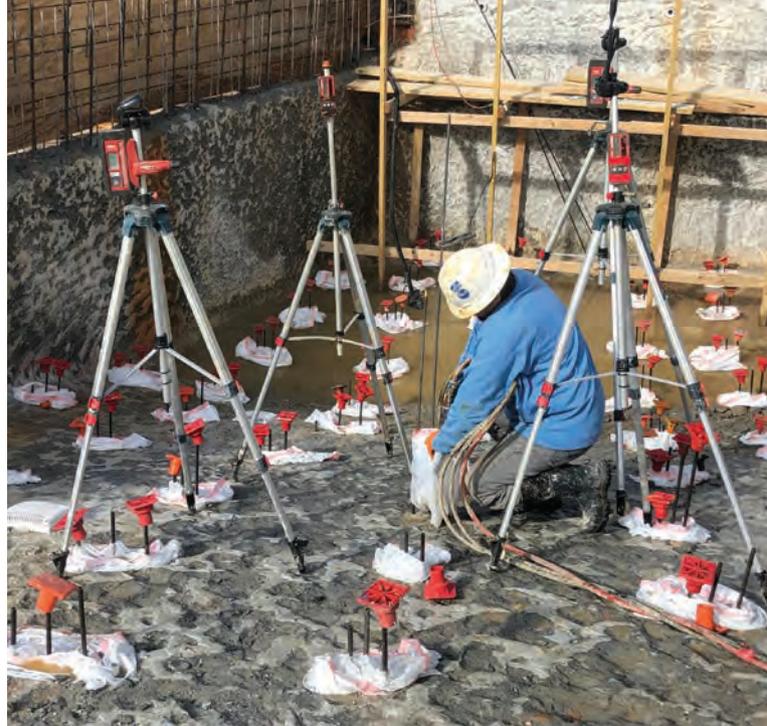
The settlement was easily corrected, and voids were filled without the need to rip out and replace the valuable shotcrete.

developer and was unknown to the homeowner or pool contractor. Due to the resilient nature of reinforced shotcrete construction, the settlement was easily corrected, and voids were filled without the need to rip out and replace the structural shotcrete.

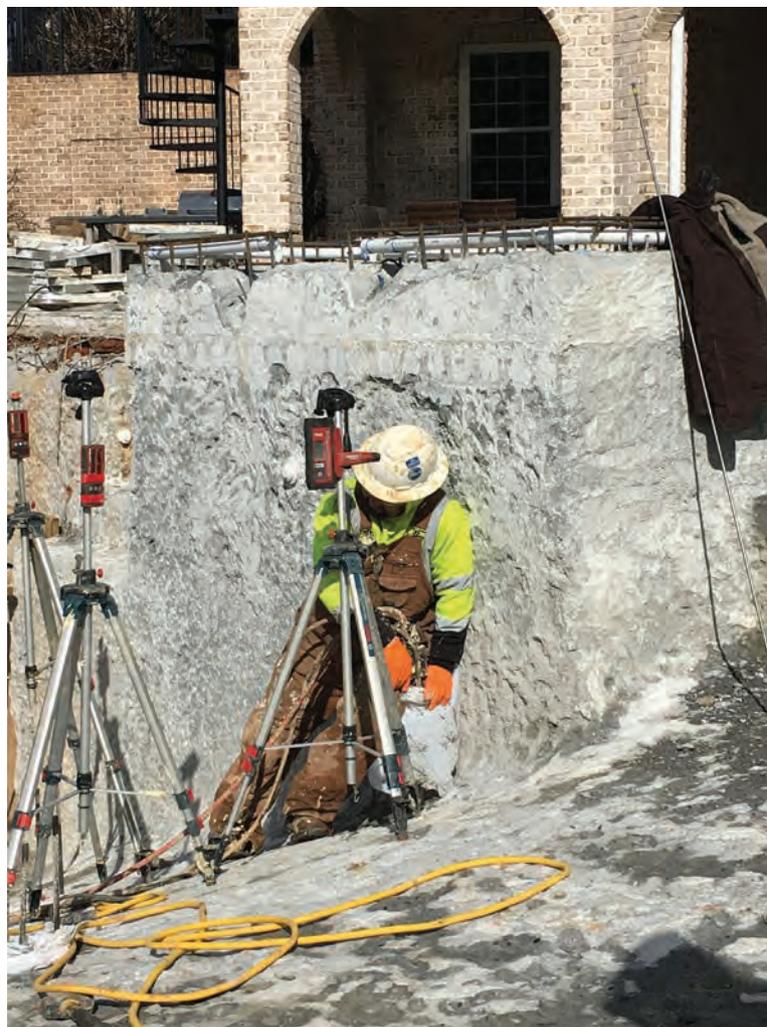
UMA deployed laser measuring devices capable of measuring tolerances within 1/16 of an inch to ensure that no lifting or shotcrete damage occurred.

Extreme caution had to be exercised, because if the structure was lifted, even the slightest cracking in the shotcrete surface could cause more damage. UMA deployed laser measuring devices capable of measuring tolerances within 1/16 in. (1.6 mm). In addition to monitoring elevations, avoiding further damage, and alleviating pore pressure increases from excess water, crews had to methodically inject material by periodically "jumping" back and forth between the shallow and deep ends. This made the process slower than working in a single area because equipment had to be constantly moved and re-calibrated. Despite the additional time required, the work was done effectively and damage-free. The client's pool technician repaired the surface of the pool following UMA's injections.
