2023 Outstanding Repair & Rehabilitation Project

O'Hare Plaza West Drive and Executive Garage Restoration

By Joshua Freedland

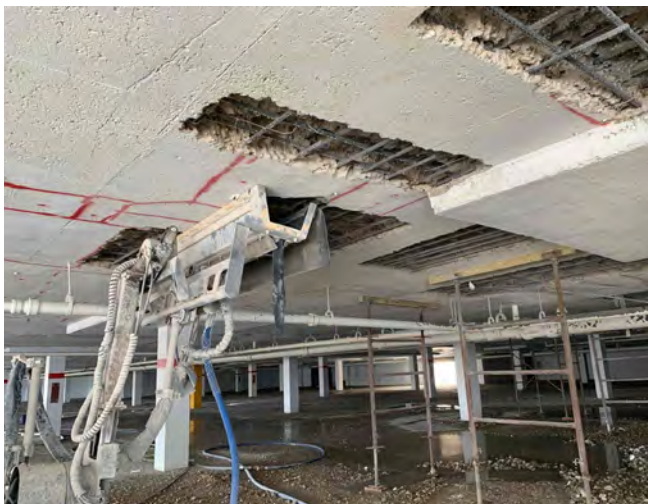
After 50 years of enduring Chicago's often unpredictable and extreme weather, the garage was showing signs of deterioration. Its façade and structural integrity eroded over time. Exposure to deicing salts and freeze-thaw cycling led to cracks and spalls of the concrete as well as corrosion of the embedded steel reinforcing.

Fig. 2: Extensive deterioration inside the parking structure.

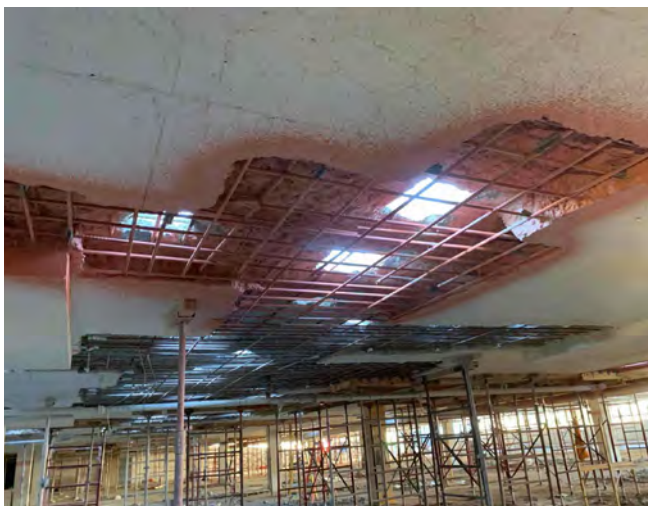
Fig. 3: Extensive deterioration inside the parking structure showing sunlight through the ceiling.

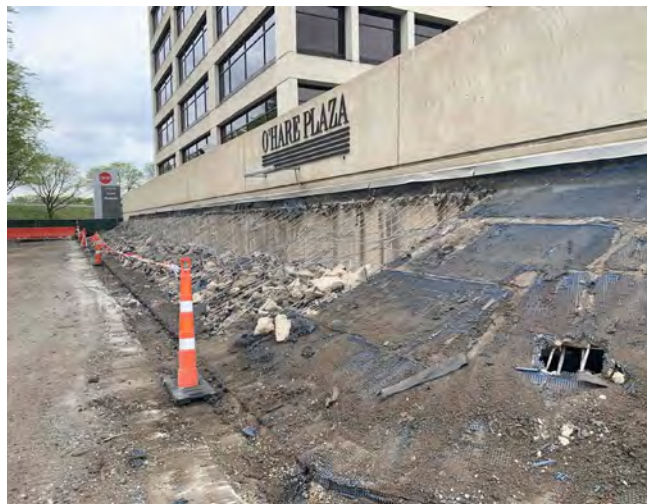
Fig. 4: Demolition of exterior slab.

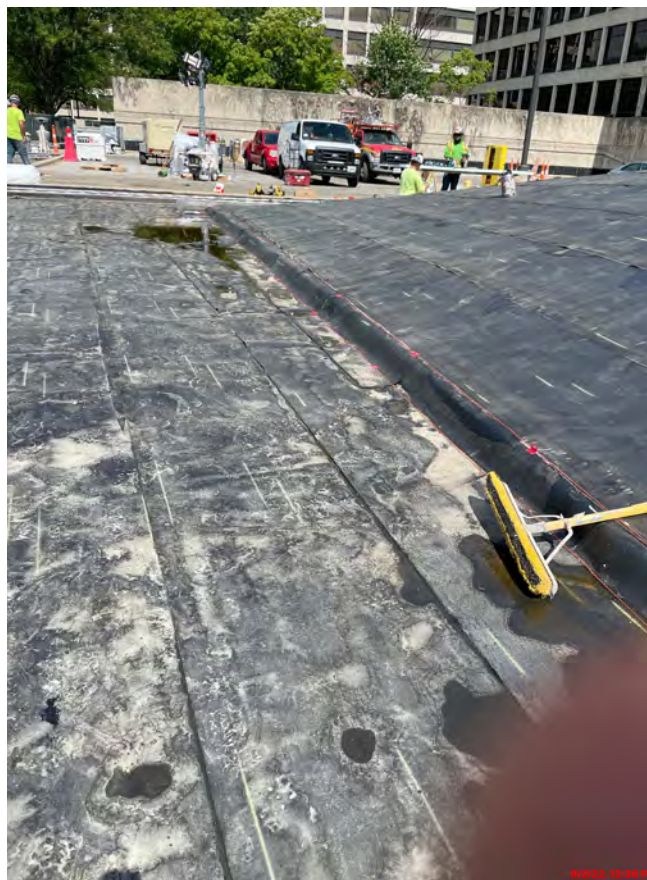
Fig. 5: Waterproofing membrane on exposed roof slab.

Phase 1 (South Drive Renovation Project) included improvements to the concrete structural slab, beams, and columns. These repairs included partial, underside and full-depth repairs using shotcrete. A new paver system was installed including a waterproofing and a snow-melt system and drains. New concrete curbs and sidewalks were installed, as well as new handrails for staircases. A new skylight was added to provide natural light below grade, while new lighted bollards were installed for site protection. Finally, new electrical, including lighting, was installed throughout the area.

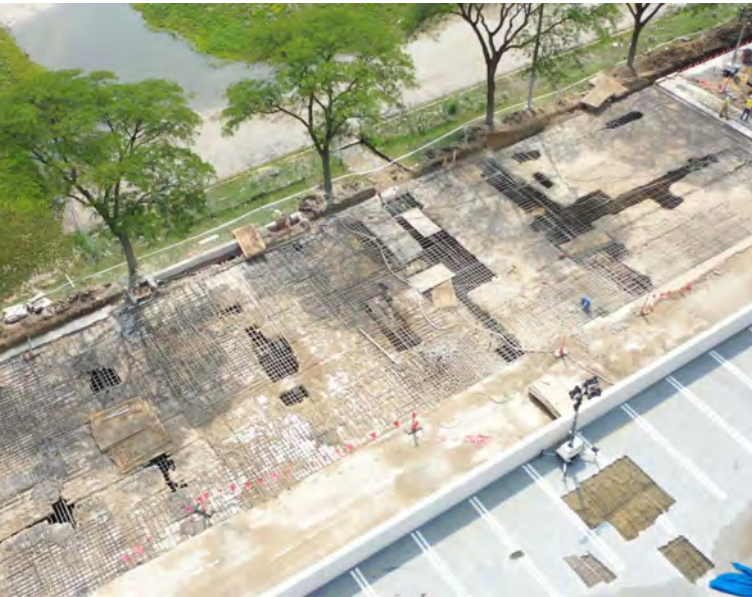
Fig. 6: Overview of roof slab with full depth repair areas apparent.

Phase 3 (Executive West Drive Restoration) included repairs to the concrete structural slab, beams and columns. These repairs included partial, underside, and full depth shotcrete. Phase 3 alone included 11,000 ft² (1000 m²) of

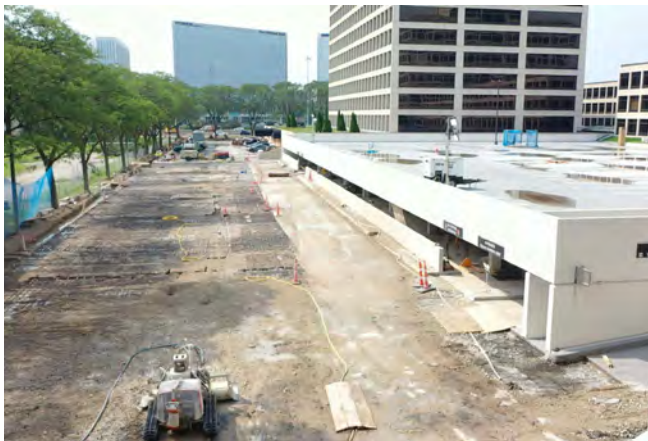
Fig. 7: Ground view of removed roof.

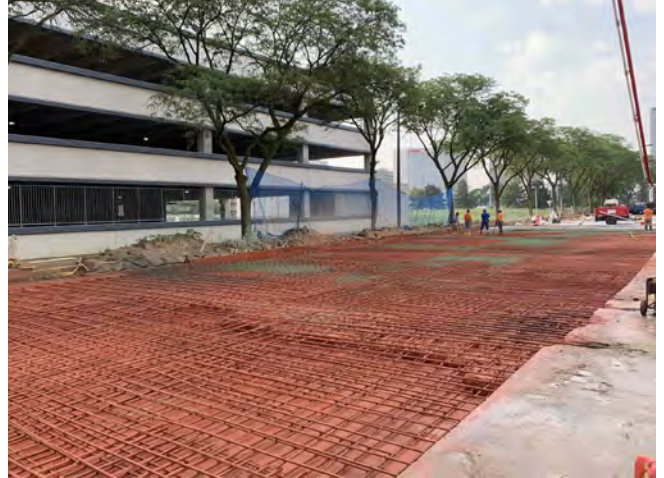
Fig. 8: Replacement roof slab ready to cast.

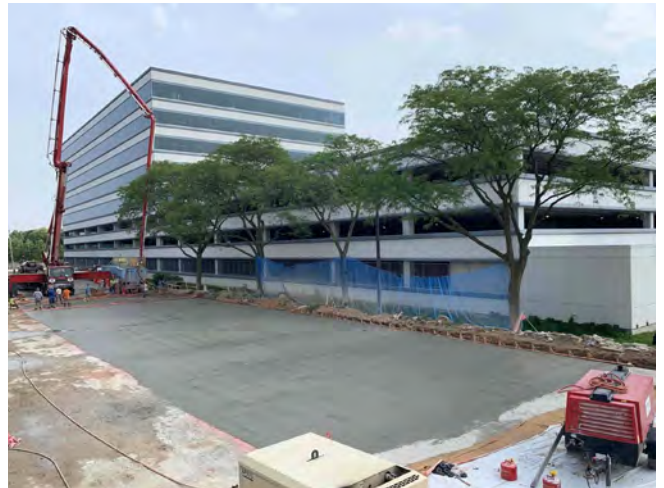
Fig. 9: Replacement roof slab.

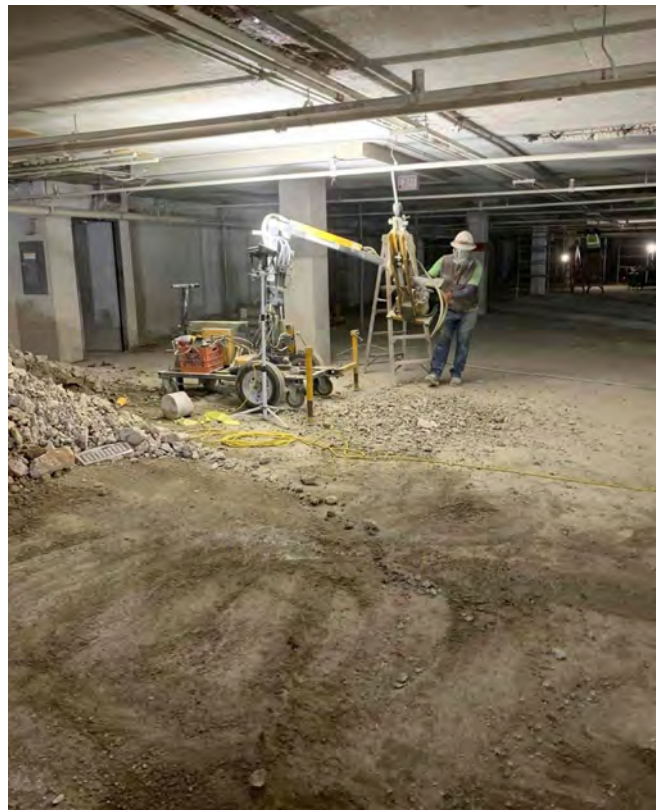
Fig. 10: Mechanically assisted chipping hammer for overhead demolition.

To accommodate the aggressive schedule and to minimize disruption to the building's tenants, BACR worked two shifts to complete the demolition work overnight. Advancements in technology and equipment enabled BACR to focus on sustainability and efficiency. The team used PAM OVE robots for vertical and overhead concrete demolition at locations identified by WGI. The robots reduced the overall load carried and provided increased safety (Fig. 10).

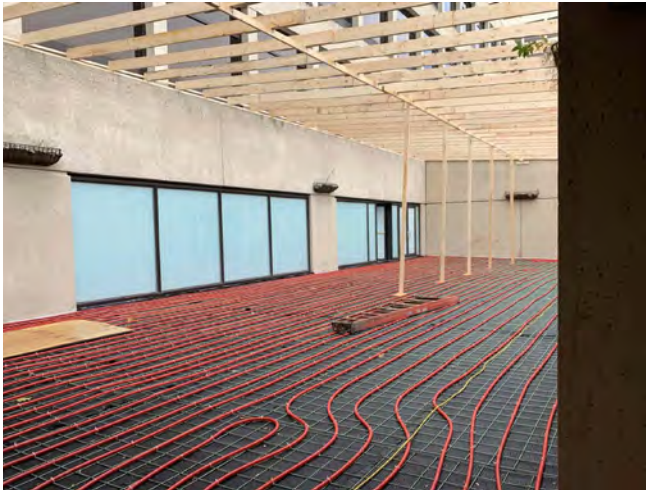
Fig. 11: Concrete slab with heating piping for melting ice and snow.

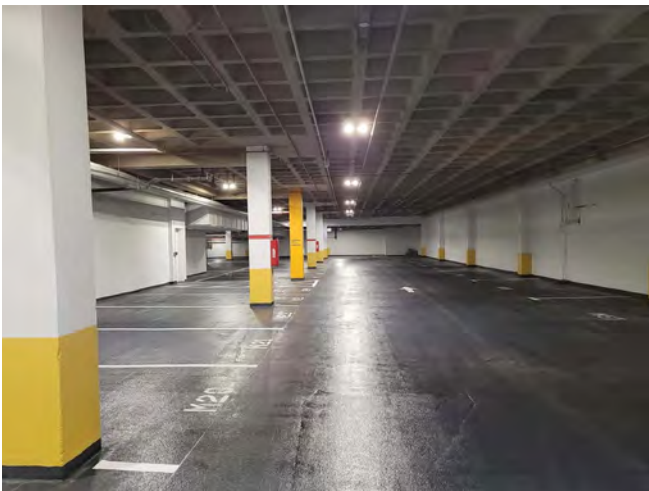
Fig. 12: New top-side coating on repaired slabs.

underside repairs. A new deck coating was installed in addition to a new paver system, including a waterproofing system and drains. Similar to the repairs in Phase 2, new concrete curbs and sidewalks were also installed, and the basement level of the garage was repainted.

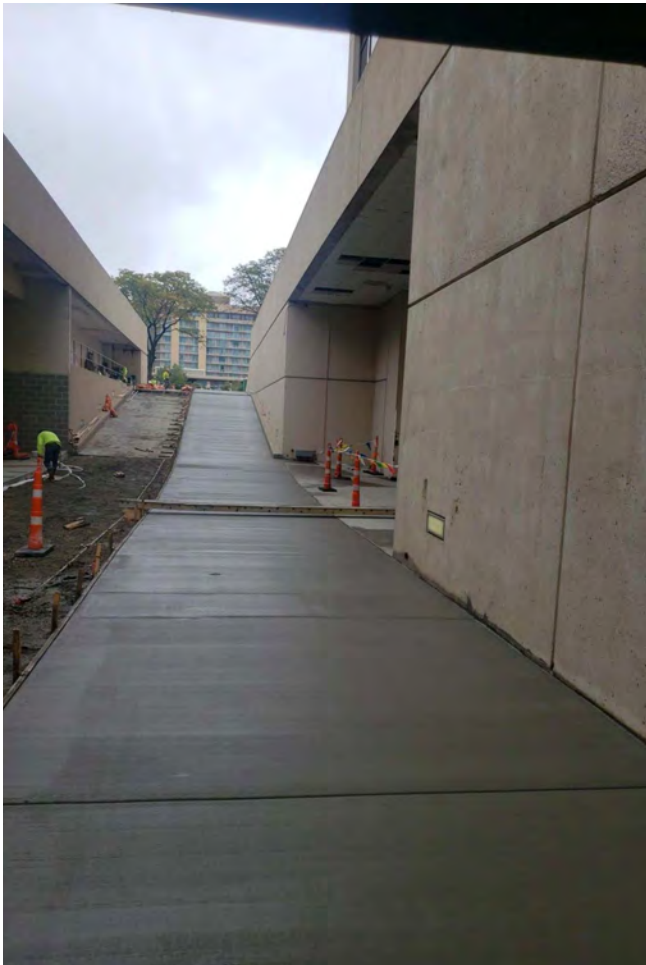
Fig. 13: Repaved pedestrian walkway.

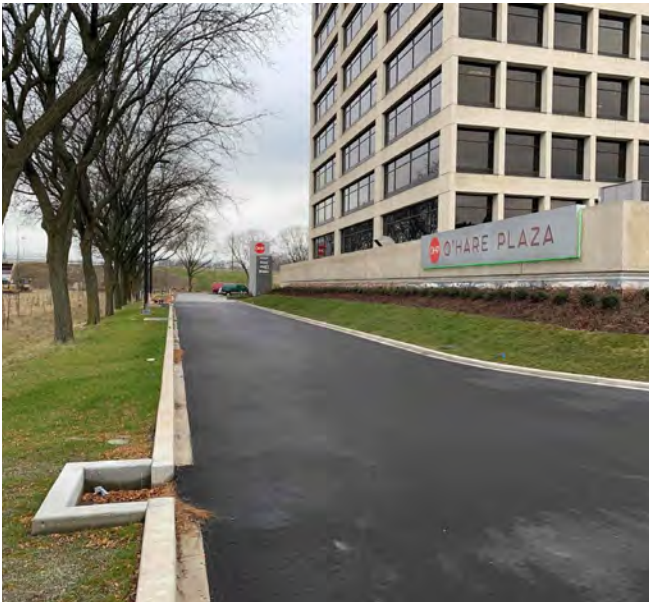
Fig. 14: Repaved and re-landscaped driveway approach to O'Hare Plaza parking garage.
