2022 Honorable Mention

# Taking Tuscarora into another Century

Pennsylvania Turnpike's Tuscarora Tunnels are undergoing a \$110m rehabilitation, aimed to deliver the 'wow' factor to its users. Kristina Smith reports.

**Pennsylvania Turnpike Commission –  
Tuscarora Tunnel Rehabilitation**

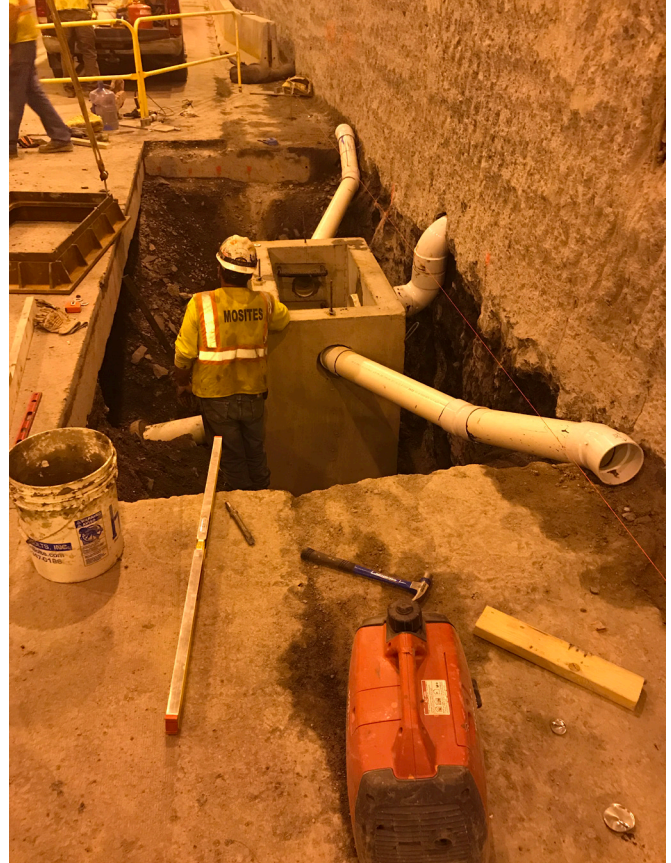
*Fig. 2: Drainage installation - The new 'umbrella' waterproofing in the eastbound tunnel will be directed into the existing system beneath the tunnel.*

"Rather than trying to fight the water, we are creating an umbrella system here," explains Martin. "Water will run down the back of the PVC membrane into the existing drainage system." (Fig. 2)

"At the construction joints, the design calls for three drainage relief holes to be drilled with a 1 ft wide (300 mm) J-drain – a dimpled plastic sheeting – placed over the joint to convey water down to the side wall drains at the base of the tunnel walls. The relief holes will also be packed with filter material to prevent large solids flowing into the system," adds Martin.

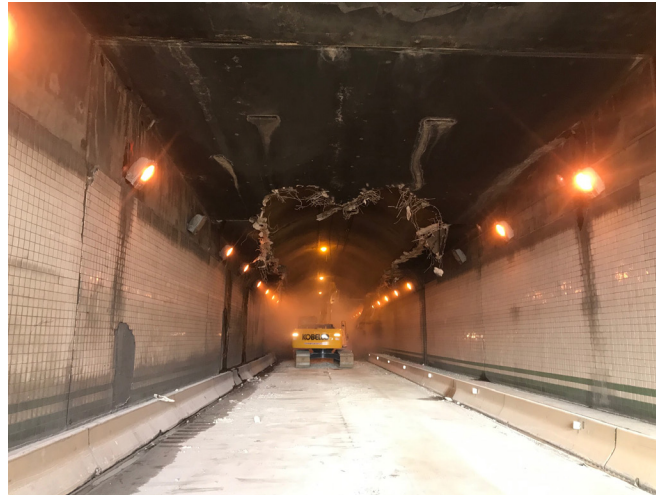
*Fig. 3a: Work underway in Eastbound - Mosites has removed the ceiling and the barriers at either side of the tunnel. Each weekend, the tunnel must be reopened to traffic.*

Work started in the eastbound tunnel in February 2020 with the removal of the cracked ceiling. Mosites then moved on to demolishing the barriers that run along either side of the tunnel, followed by additions to the drainage at the base of each wall. (Fig. 3a and Fig. 3b)

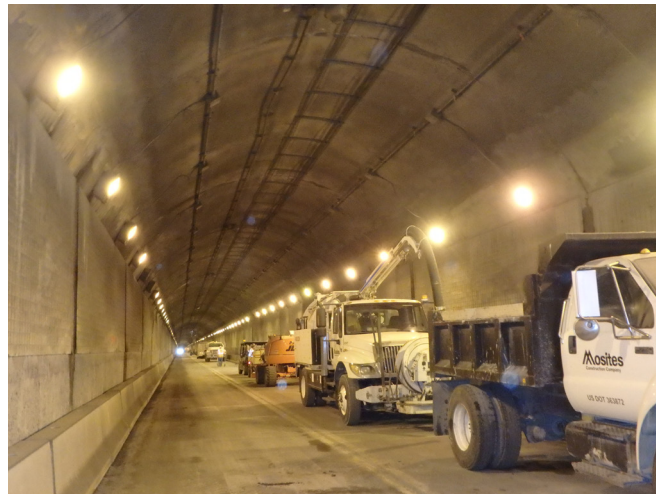
*Fig. 3b: Ceiling removed in Eastbound - The concrete in the older, eastbound tunnel was not air-entrained so the cracking of the ceiling was far more extensive; here we see the tunnel with its ceiling removed.*

"As a consequence of the action of freeze-thaw in the older, eastbound tunnel, the tunnel's extensively cracked ceiling has been totally removed. The ceiling in the westbound tunnel will remain in place. It is still sound and will prevent water from dripping onto traffic if more leakages appear in the arch above it in the future," says Martin.

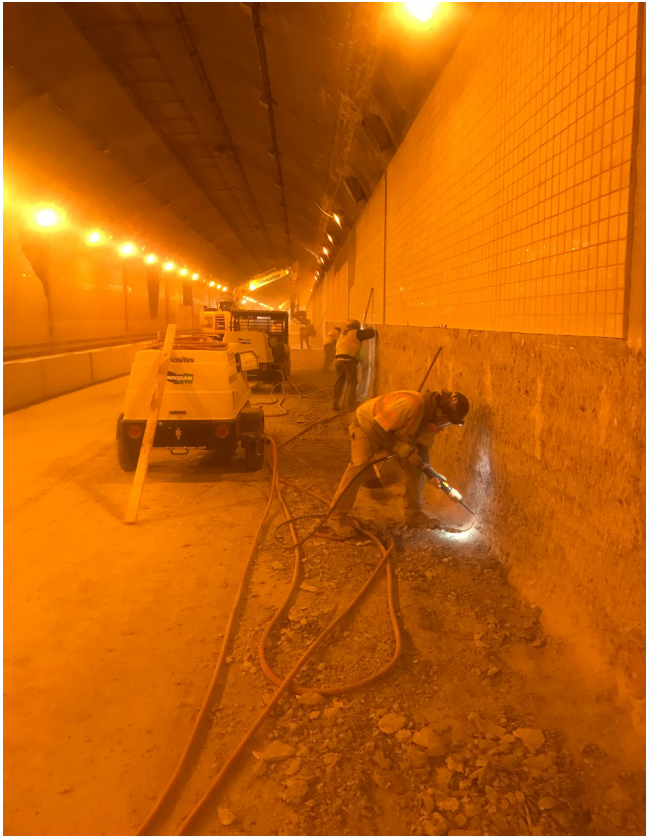
*Fig. 4: Demolition 1 - The barriers at the side of the eastbound tunnel were removed so that the new waterproofing system could be installed.*

The crack and spalling repair will be a precise business. “The Turnpike and their consultants have done a good job in mapping out where these repairs are. The tunnels are broken down into construction joints every 30 ft or 50 ft (15 m) (depending on the tunnel), which are all numbered so you can get a feel for where you are, how many repairs there are, and what kind of repair,” says Jeannerette. “It does require a lot of coordination between us and the inspection crews so that everybody is on the same page.” (Fig. 4)

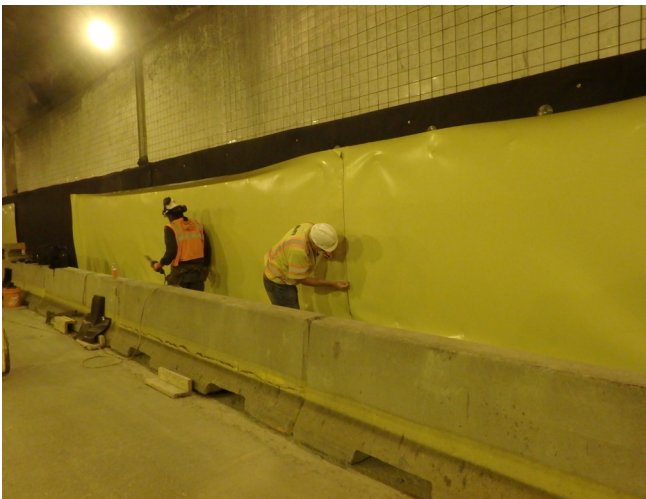
*Fig. 5: PVC membrane installation - Specialist contractor Schneider-Moran is installing the first sections of waterproofing in the eastbound tunnel on the lower sections of tunnel wall.*

“It’s a very involved process. It will have to be just like clockwork every week for a year straight,” says Jeannerette. “That will be the biggest challenge.” (Fig. 5)
