# Use of Synthetic Fiber-Reinforced Dry-Mix Shotcrete for the Rehabilitation of a Wharf in Northeast Quebec, Canada

by Pierre Lacombe, Martin Gendreau, and Yann Ropars

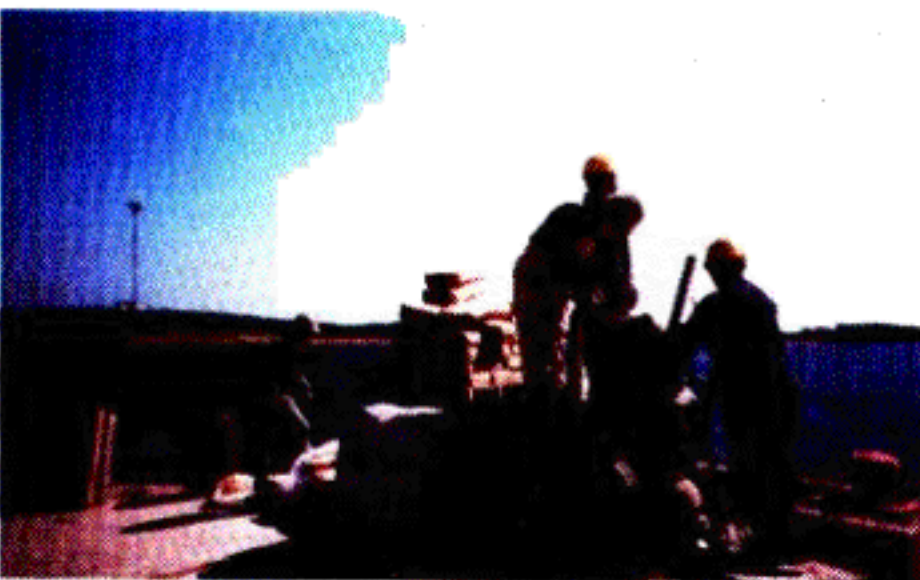
Figure 8. Equipment and materials stored on the Wharf.

Because the repair area was located inside the tidal zone, several constraints had to be considered, such as immersion of the shotcrete into salty waters a short period after shotcreting operations, and very brief working periods due to the tide cycles. Due to the restricted access to the repair area, all the equipment and materials needed were installed on the Wharf (Figure 8).
