Structural rehab in Portugal...

The Setenave Dry Docks Rehabilitation

by Ivan Ramalho de Almeida, Thomaz José Ripper Barbosa Cordeiro, and José Paulo Veríssimo Maia Costa

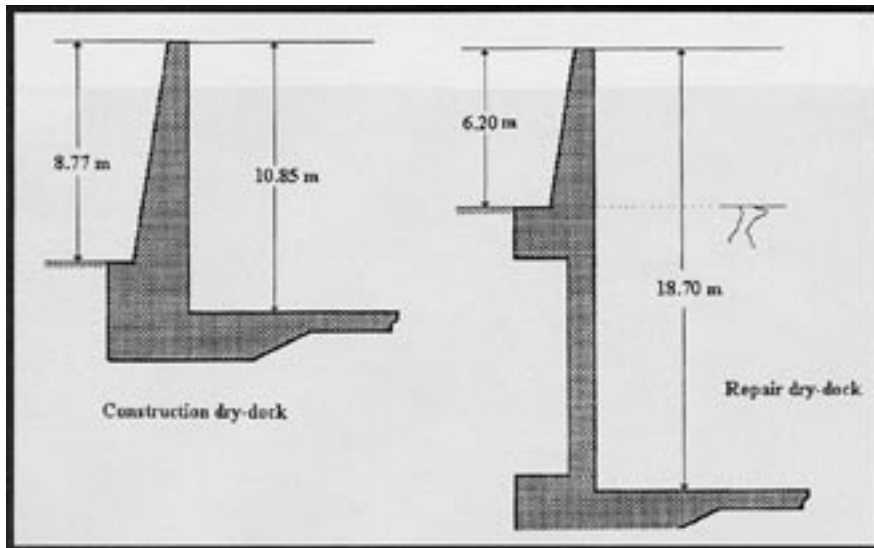
Fig. 2: Cross sections of the concrete walls

The reinforced concrete walls of the dry docks — constructed as semi-buried tanks, about 75 x 900 m (250 x 3000 ft) in plan — are nearly 1 km (0.6 mi) long, about 11 m (36 ft) high in the part designed for ship construction, and 22 m (72 ft) high in the ship repair area. The bottom of those areas lies at about 2.0 and 12.5 m (6.6 and 41.0 ft), respectively, below sea level (Fig. 2).
