Bad Benchmarks

Workmanship Issues in Swimming Pool Dry-Mix Construction

by Ron Lacher

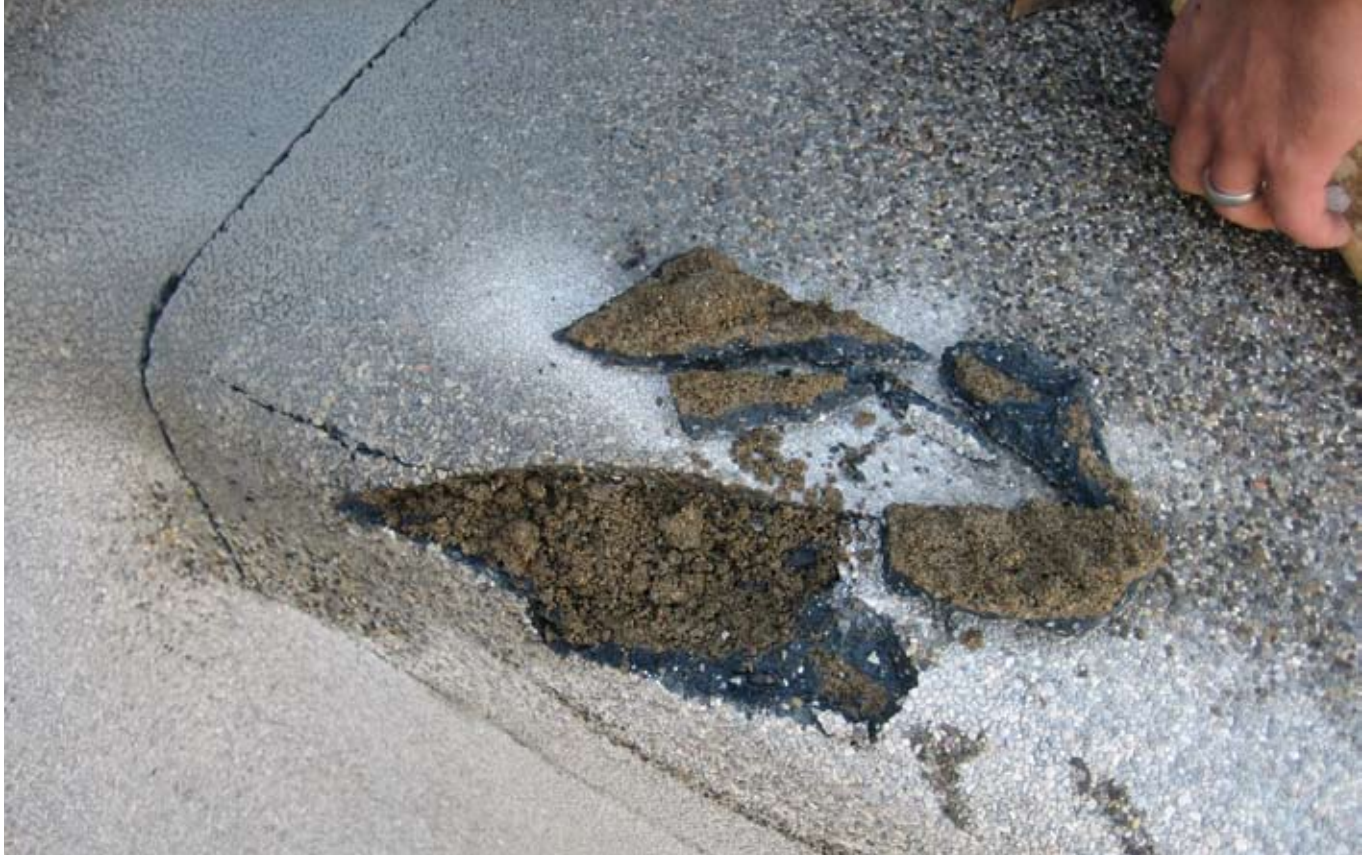
Yes, there are cases when cracking extends from some sort of plaster delamination, but that is the case in only a minor percentage of the cases I've examined. Far more commonly, the problem extends from unreliable shotcrete *beneath* the plaster. Time and time again, chipping away the plaster layer reveals a shotcrete substructure that literally crumbles at the touch—even though this material should be able to resist damage of a solid blow by a hammer.

Further investigation reveals the plain truth that the shotcrete under the cracked steps and benches has nowhere near the required 3000 psi (20 MPa) compressive strength at 28 days for frost-free zones and minimum 4000 psi (28 MPa) compressive strength for frost-exposure zones, and that eventual failure was inevitable.

Saw-cutting the damaged area of this spa bench made it possible to flick off a piece of the plaster and discover the disaster lurking beneath the hard shell. It's rare even in cases of step or bench failure to find shotcrete so sandy that you can plunge a finger into it with ease
