*Gunite Protection for
Steel Structures*

Full Reprint of Bulletin No. 4, 1924
Issued by the University of Toronto

Gunite Protection for Steel Structures

Experiments at Leaside, Ont., with Two 42-ft. Steel Plate Girders Covered with Gunite to Ascertain Cause of Superficial Cracks on Bridges at Hamilton — Conclusions Favor Employment of Guniting Process

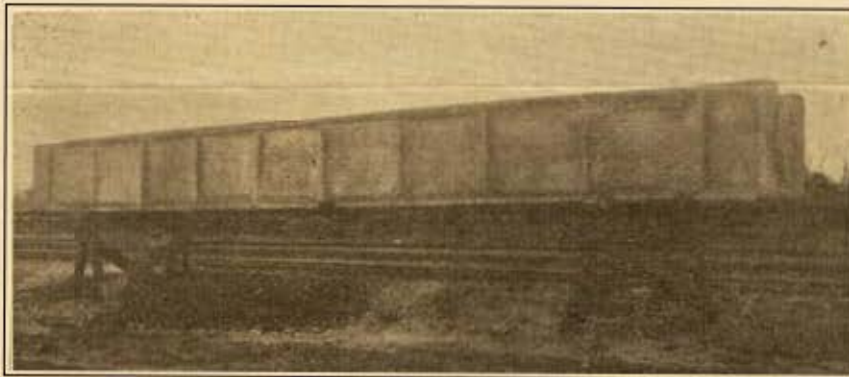
FIG. 1.—LEASIDE GIRDBERS PRIOR TO APPLICATION OF GUNITE

were drilled and three horizontal lines of ½ in. round rod attached to either face in order to keep the reinforcement away from the plate. To these rods the fabric was wired. In each girder there were eleven panels. The north girder was covered with expanded metal commercially designated as 1½-14-20. The north side of the south girder was covered also with expanded metal of larger mesh design-

ated 3-14-10. The south side of this girder, with the exception of one panel, was covered with Groening square wire mesh. Three series of tests, A, B and C, were planned according to the following schedule.

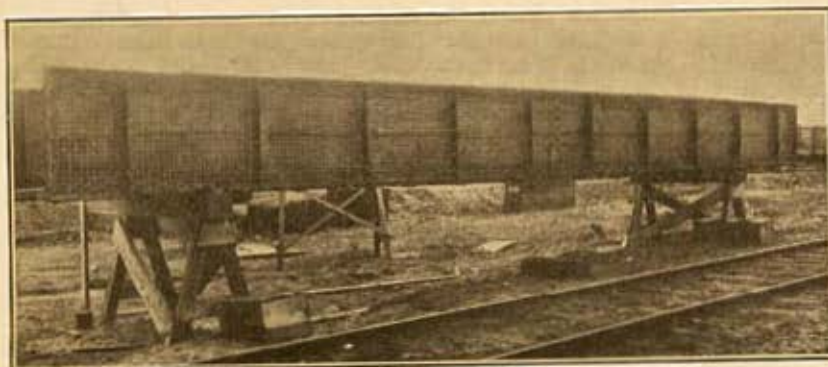
FIG. 2.—LEASIDE GIRDERS AFTER APPLICATION OF GUNITE

on the edges by having light steel T's riveted to them were provided. These were coated in the field and afterwards transferred to the testing laboratory for observation. They are known as series "D."
