Ruskin Dam Spillway Shotcrete Assessed

Study shows that the dam's long service life can be extended by almost 50%

By Lihe (John) Zhang, Mazin Ezzet, Natalya Shanahan, Dudley R. (Rusty) Morgan, and A.P. Sukumar

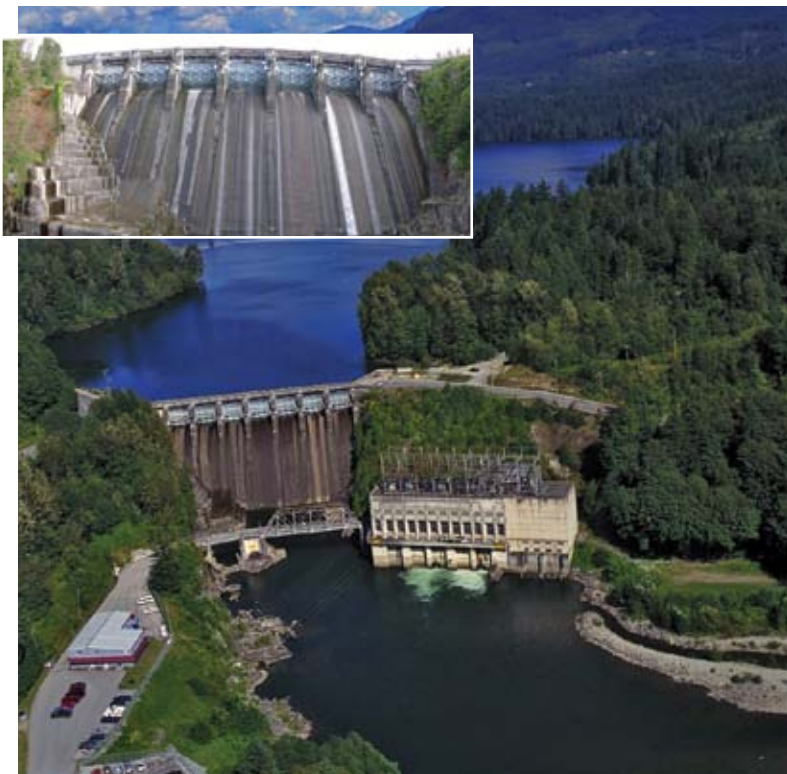
Ruskin Dam was built long before the development of air entrainment to protect concrete from frost. As a consequence, the concrete in the spillway suffered some frost damage, as well as erosion/abrasion from water and water-borne debris. Some initial repairs were made on the spillway surface in 1954 using shotcrete. But deterioration continued in the concrete spillway and adjacent stepped structure at the right (looking downstream) abutment.

Fig. 1: Ruskin Dam and 105 MW generating station. The spillway (inset) has undergone two renovations in its 80-year life

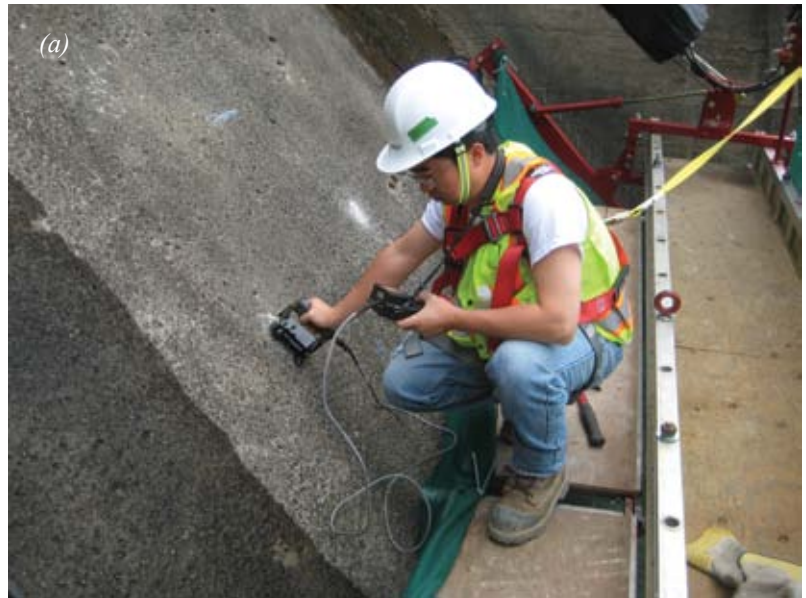
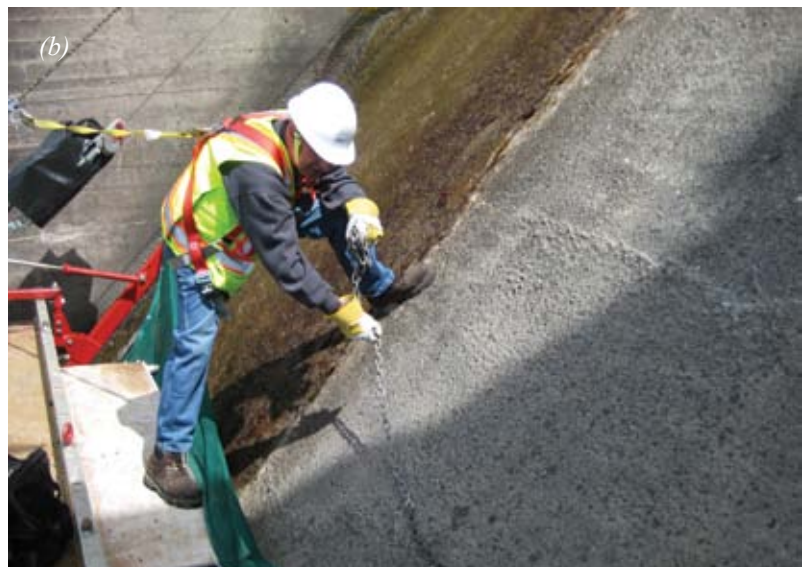
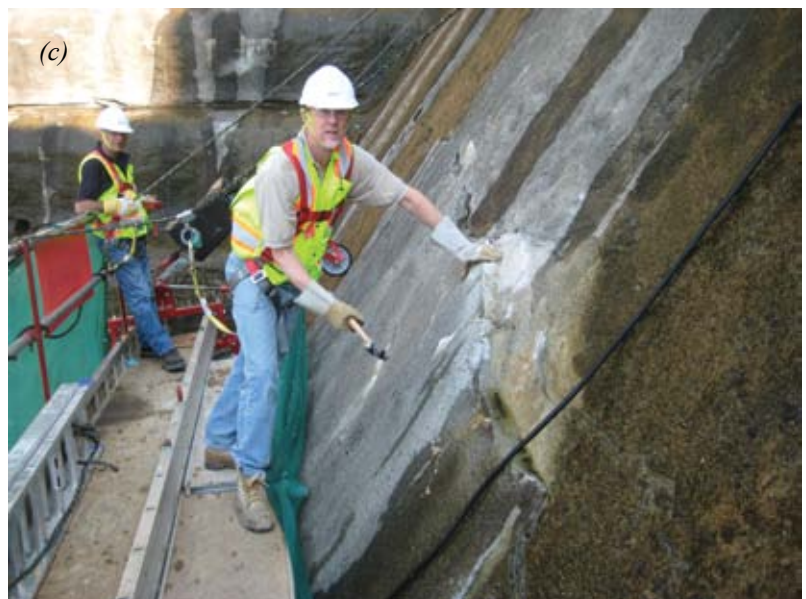
- Visual examination and photographic documentation of obvious defects, including cracking, erosion, and signs of construction joint delamination; and
 - Nondestructive testing (NDT) using impact echo (IE) (Fig. 3(a)), coupled with sounding for delamination using chain drag (Fig. 3(b)) and appropriately weighted hammers (Fig. 3(c)).
- While chain drag and hammer testing was conducted for the entire shotcrete surface, IE

Fig. 3: Nondestructive testing: (a) IE; (b) sounding using a chain drag; and (c) sounding using a hammer

testing was conducted at a grid of 2 m (6.6 ft) in accessible areas with no water flow. The shotcrete surface at IE test locations was ground smooth within and beyond the zone between the impactor and transducer.
