Shotcrete Rehabilitation of the Noblestown Road Bridge

By Ted W. Sofis

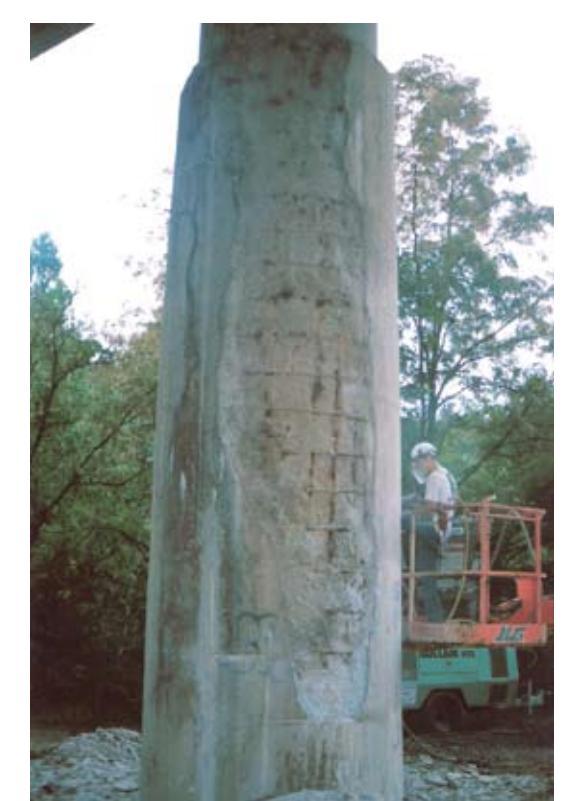
he Noblestown Road Bridge is located in Allegheny County just outside of Pittsburgh, PA, in Pennsylvania Department of Transportation's (Penn DOT) District 11. The Noblestown Road Bridge piers were badly deteriorated for a structure of its age and the deterioration in many places looked as if the concrete had eroded away like a mud embankment.

A badly deteriorated bridge pier

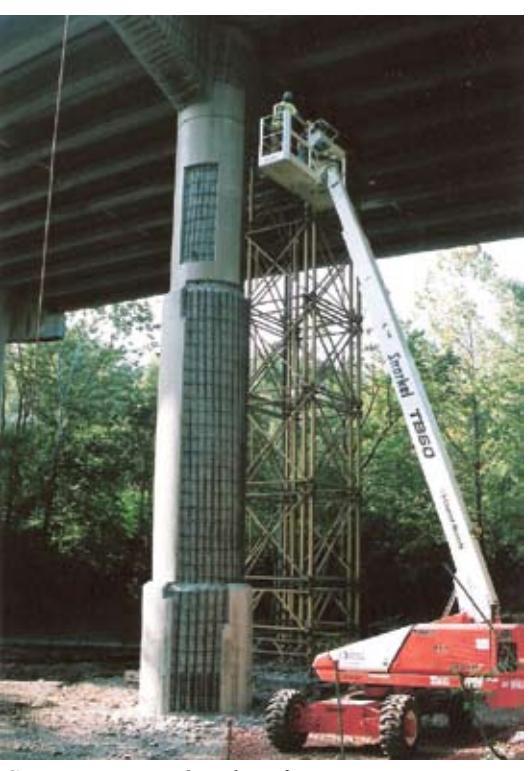
Concrete removal and surface preparation prior to the shotcrete placement

In concrete rehabilitation, certain things remain constant. To get a good repair, all unsound or deteriorated concrete needs to be removed because the shotcrete is only as good as the material to which it adheres. Whenever possible, it is important to get behind the outer layer of reinforcing bars. This secures the shotcrete to the surface better than any anchors or dowels. In past years this was often ignored and many repairs were treated as merely cosmetic surface treatments that had little structural value. On installations over the years where the extra time was taken to get behind the reinforcing bars, however, much better results have been achieved.

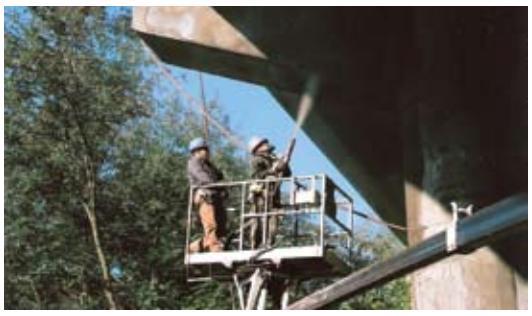
Overhead dry-mix shotcrete application to a pier hammerhead

The method of repair chosen was the dry-mix shotcrete process. This choice was made for several reasons. With the dry-mix process, both the overhead and vertical areas could be shot to the full depth of the repair without using any accelerators. A full-depth monolithic repair is preferable to shooting in layers because it eliminates laminations that can sometimes prove to be points of failure. Also, with scattered repair areas, work could stop and start more easily without concern about wet material in the hoses, as is the case with the wet-mix shotcrete process. The dry-mix process allows the nozzleman to make the adjustments in water content at the nozzle and allows the material to be placed with a much lower water content. So the material being installed is essentially a zero-slump pneumaticallyplaced concrete. As the shotcrete contractor, Sofis Company was responsible for saw-cutting the perimeter of the repair areas, tearing out the deteriorated concrete, sand-blasting the reinforcing bars, adding new reinforcing bars where needed, installing the mesh, drilling and installing epoxy anchor bars, and placing shotcrete to restore the concrete piers to their original contours.

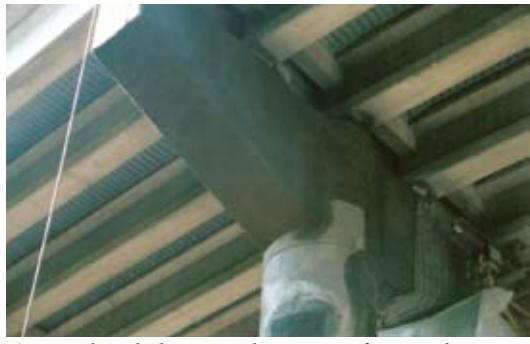
A completed shotcreted section of a pier hammerhead

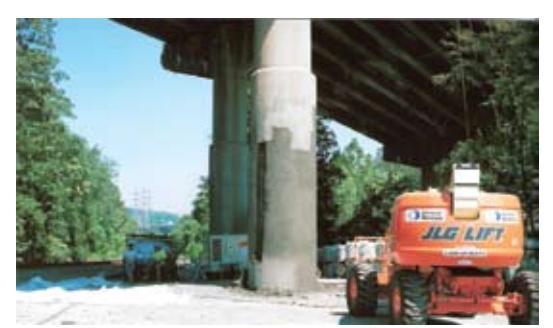
A shotcreted section of a bridge pier

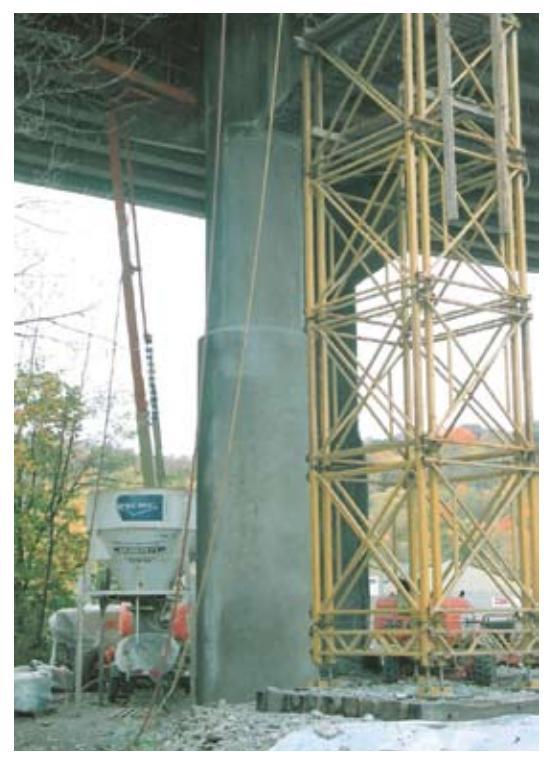
A completed shotcrete repair of a pier

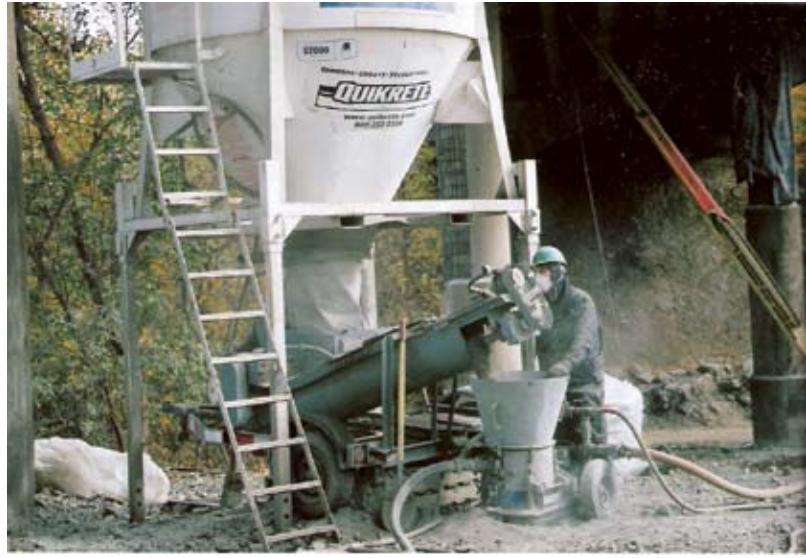
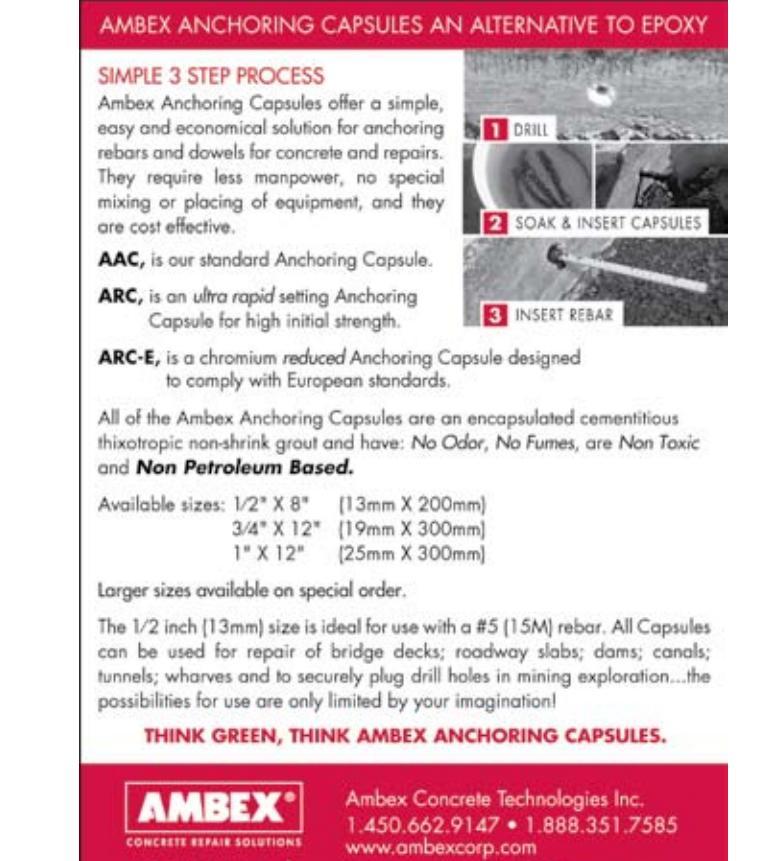
A material hopper with the material being predampened and fed into a

rotary gunite machine during shotcrete placement

The material chosen for the repair was Quikrete Shotcrete MS with a Cortec migrating corrosion inhibiter added. By using Shotcrete MS, a premixed material, the need for on-site mixing was eliminated, which provided better quality control for the shotcrete mixture. Premixed materials are blended in a more controlled environment and the ratios are uniform and certified by the manufacturer. The cement and aggregates are kiln dried and the material can be predampened on site to achieve the optimal moisture content. Often with on-site mixing, ratios can vary and sand may be too wet, which can create production problems, plugged hoses, and a slug feed that causes surging. On this project, the premixed material was predampened with an auger-type predamper and the Shotcrete MS was shot with a rotary Ridley C-10 gunite machine manufactured by Airplaco. Both the auger-type predamper and the rotary gunite machine are continuous feed devices, so as the premixed material is predampened, it is immediately conveyed into the gun and through the hose. The moist material is not allowed to sit and is only dampened moments before being fed into the gunite machine and discharged. Therefore, there is no concern with truck time as with ready mixed concrete or with the moist sand reacting with the cement in large holding hoppers in some of the older batch-type mixing rigs.
