# SAFETY SHOOTER

## Guilty through Association Wall Forms and Rebar Safety Tip

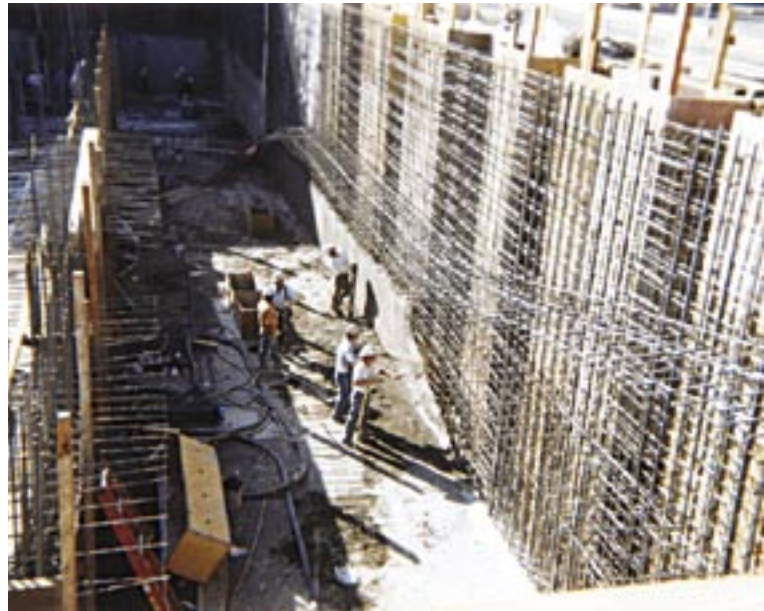
a crack developing between the 2-in. foam spacer and the existing building. It was also noticed that tractor work was continuing on the project. Suspecting the worst, the foreman directed everyone out of the basement and the tractor work stopped. Ten minutes later, 100 ft of the wall fell... all in one piece! Luckily, nobody was injured or trapped!

It turned out that the glue did not adequately hold the foam in place, and the dowels at the footing bent. The vibration from the tractor work shook the building, allowing movement of the foam and rebar. If the wall would have set for another 60 min. before the vibration, it likely would not have fallen for a lifetime.

I hope this true story helps to highlight some safety issues you may find at the job site that may be out of your control. Forms must be checked for stability, both backward and forward. Why forward? The rebar cage needs to be tied to something, usually to the back form. When the shotcrete wall is being built up, the placed shotcrete wants to sag forward, bringing the rebar with it. If the rebar moved, most likely, the form also moved. This is a very severe problem as noted in the job mentioned previously, in addition to having a wall built out of line. Remember, SAFETY FIRST! Check all forms and rebar for stability before shotcrete placement.
