# Bordeaux Prison: Rehabilitation and Repair of the Perimeter Walls

By Kevin Robertson and Pierre Brassard

## 2016 OUTSTANDING INFRASTRUCTURE PROJECT

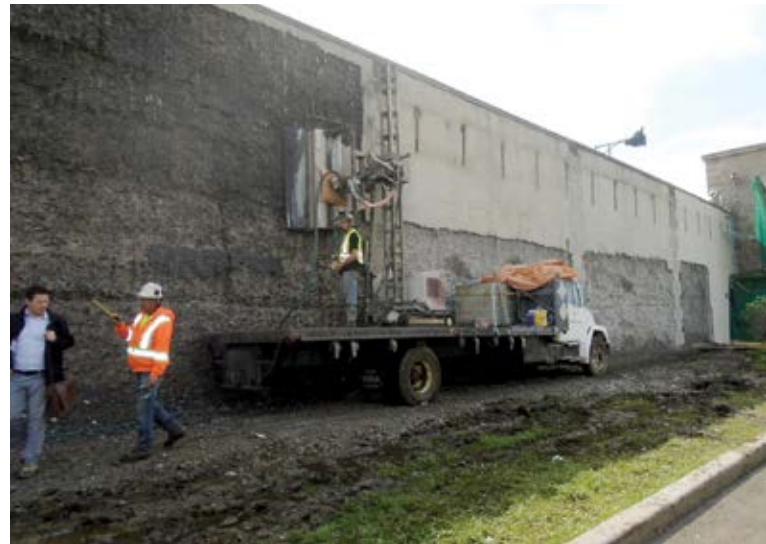
Fig. 1: Hydrodemolition machine setup

The shotcrete portion of the work required removal and replacement of deteriorated concrete on both inside and outside of the perimeter walls. The original scope called for the removal of 32,000 ft<sup>2</sup> (3000 m<sup>2</sup>) of concrete at an average depth of 4 in. (100 mm). Hydrodemolition was used to remove the deteriorated concrete and prepare the concrete surface. This removal method was chosen because it would provide an ideal surface for the shotcrete material to bond to and minimized microcracking that often accompanied the use of conventional mechanical chipping equipment. The original concrete mixture was produced using very large aggregates 1 to 1.5 in. (25 to 38 mm) in diameter. Special attention to the removal was critical to make sure that any large stone that was exposed would stay intact and not loosen because that could potentially create a bonding issue.

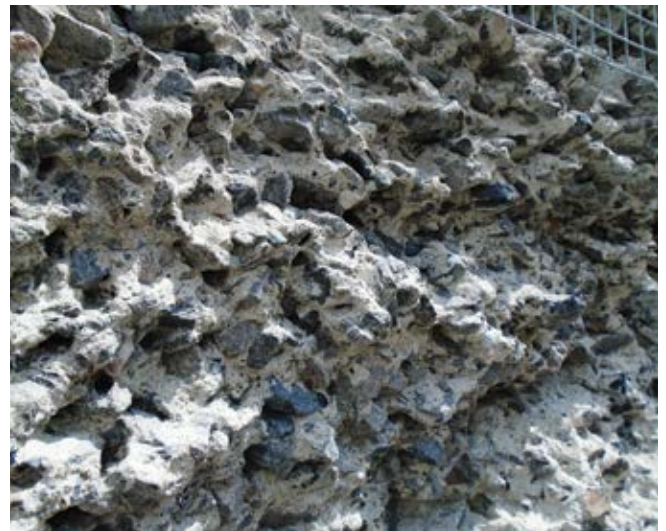
Fig. 2: Close-up of hydrodemolition concrete ready for shotcrete

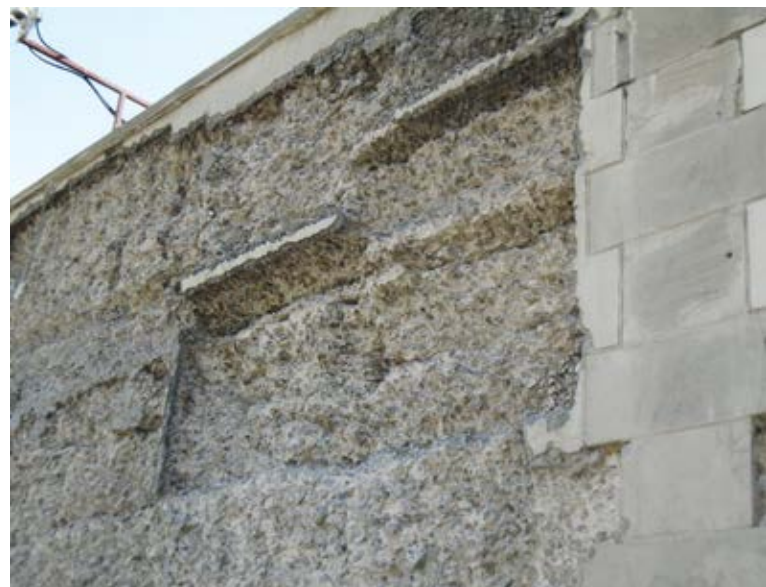
Fig. 3: Repairs ranging from 2.5 to 18 in. (64 to 450 mm)

During the demolition phase, it was revealed that the depth of deterioration was far greater than expected. In some cases, the outside of the perimeter wall had sections that required up to 18 in. (450 mm) of concrete removal. Apparently, the hydrodemolition equipment penetrated much deeper into the poor-quality concrete than originally expected. Thus, a special depth gauge was eventually used to maintain the proper depth of concrete removal. The specification also called for the installation of a 4 x 4 x W2.9 x W2.9 (102 x 102 x MW18.7 x MW18.7) galvanized wire mesh mounted every 20 in. (500 mm) center-to-center.

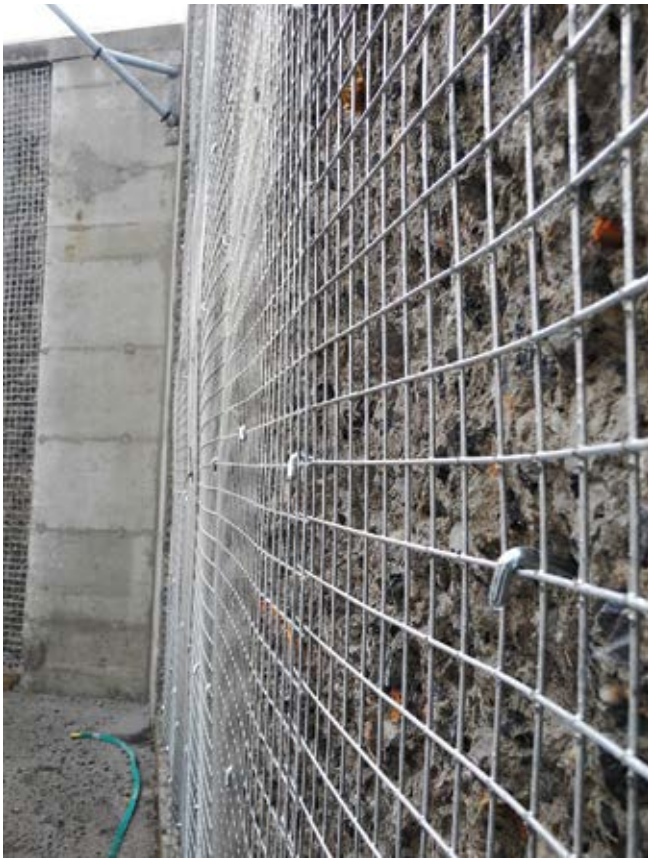
Fig. 4: Mesh installed using gunite hooks

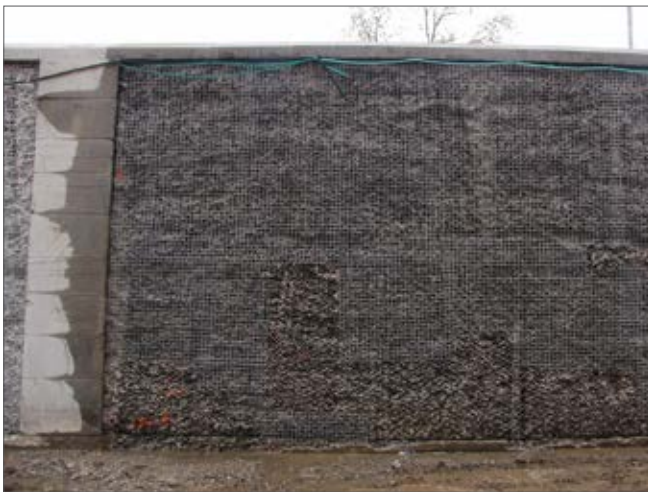
Fig. 5: Soaker hose creating a saturated surface-dry surface on area to be repaired

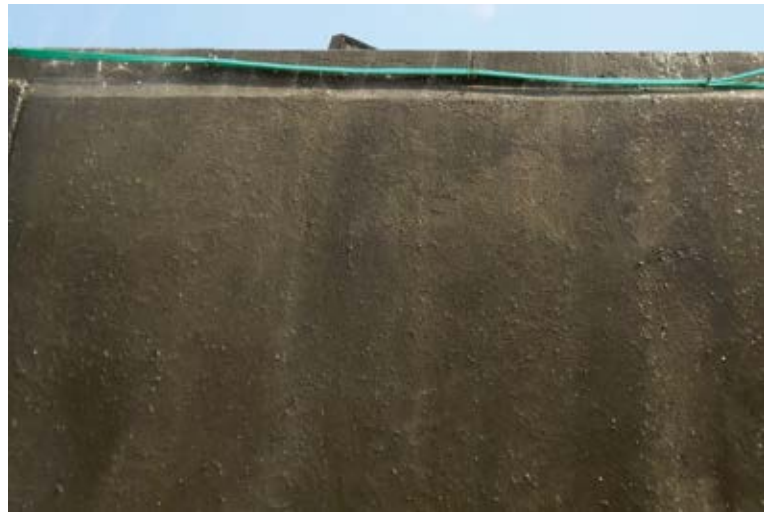
Fig. 6: Soaker hose used to cure the dry-mix shotcrete

In each section of wall, a vertical expansion joint was placed to full depth at approximately 15 ft (4.5 m) spacing and a horizontal joint was placed 7.2 ft (2.2 m) up from the ground to help control any potential drying shrinkage that may occur from shooting these large concrete sections. A 7-day wet cure was specified to further reduce the potential for shrinkage cracking. Perforated water dripper hoses were installed at the top of the wall and turned on once the shotcrete reached final set. The specification originally called for burlap to hang down from the top of the wall, but this was

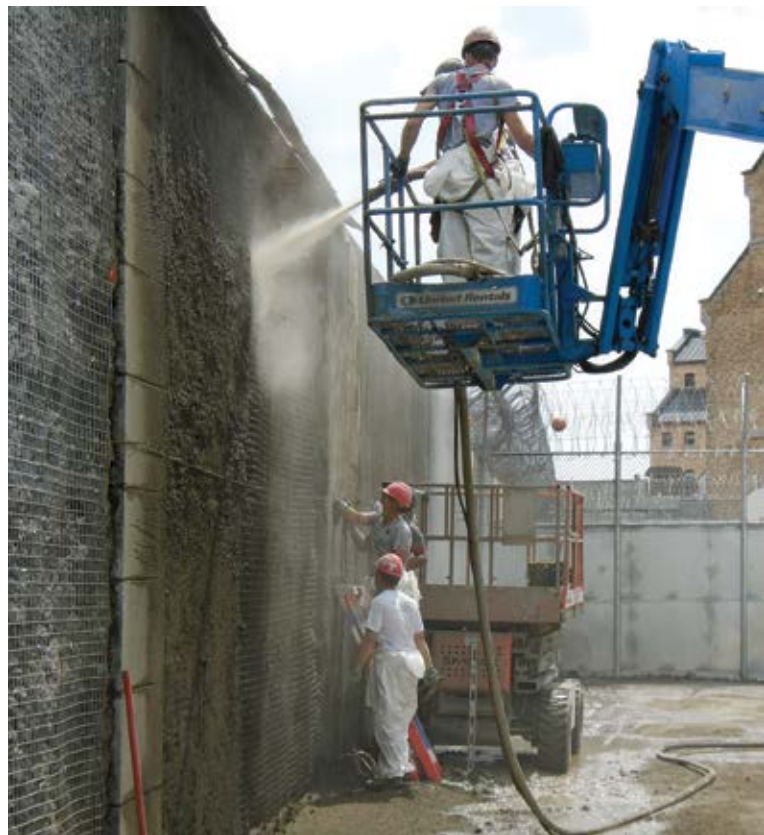
Fig. 7: Shotcrete application and finishers

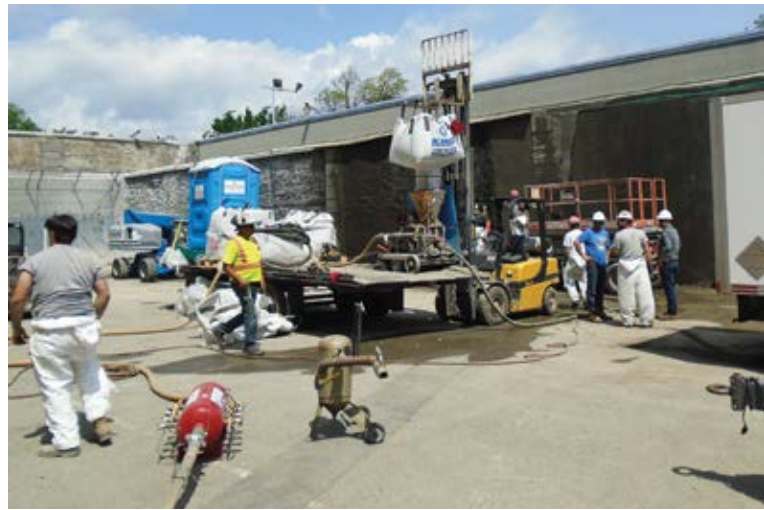
Fig. 8: Dry-mix shotcrete equipment setup on trailer
