# Portage Bridge 2010 Structure Rehabilitation

## 2011 Outstanding Infrastructure Project

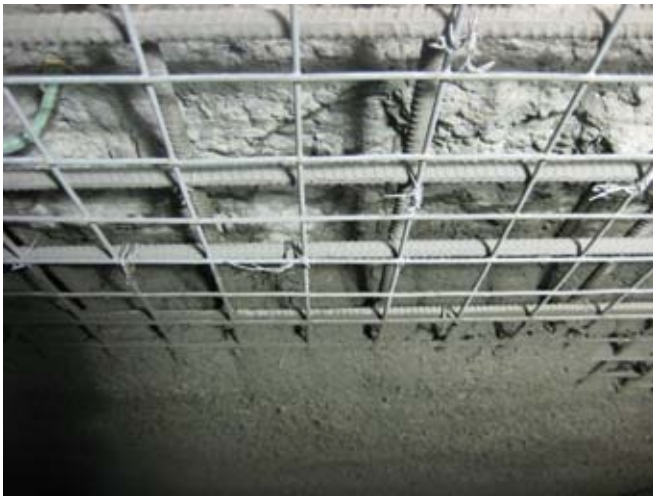
*Shotcrete encapsulating the reinforcing bar*

The repair process started with the removal of any unsound concrete using pneumatic hammers. A minimum of 1 in. (25 mm) of space was left behind the reinforcement steel to ensure full encapsulation and provide sufficient mechanical

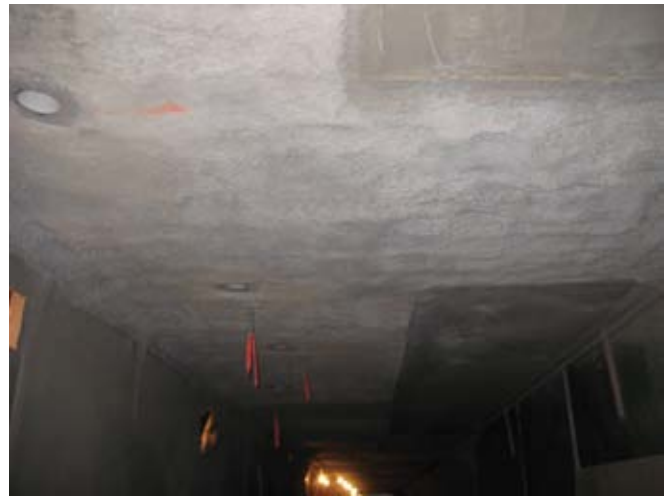
*Core testing for bond and compressive strength was taken from these locations*

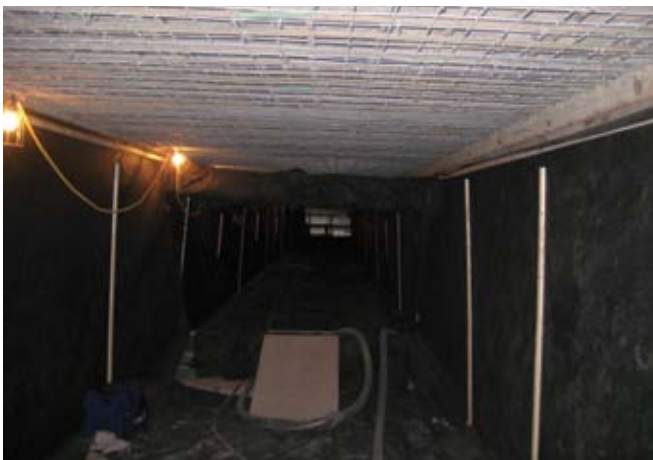
*Underside of deck ready for shotcrete placement*

bond. The perimeters of all repair areas were saw cut to eliminate any feather edges.

The area to be repaired totaled approximately 9730 ft<sup>2</sup> (904 m<sup>2</sup>) and, with an average thickness of 4.75 in. (120 mm), required approximately 410 bags weighing 2200 lb (1000 kg) each of preblended shotcrete mixture. Steel reinforcing anchors were placed at 24 in. (600 mm) center-to-center each way. Any significantly deteriorated reinforcing steel was removed and replaced. A mat of 4 x 4 W2.9/2.9 (102 x 102 MW18.7/18.7) galvanized wire mesh was installed before any shotcrete was applied.

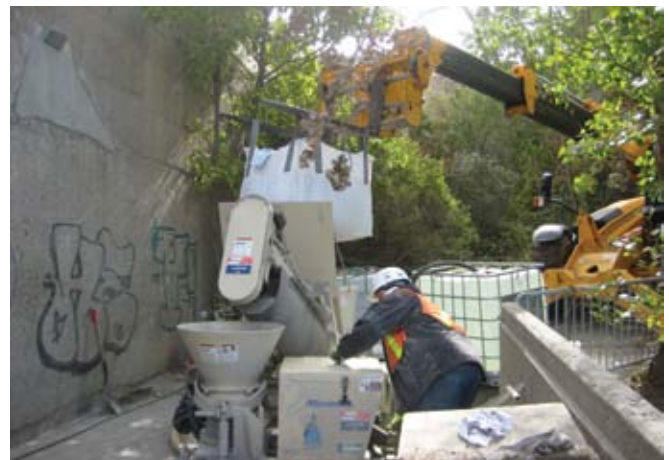
*Equipment setup. Bulk bags were used*

An offroad telescoping boom forklift was used to lift the bags over the hopper of the shotcrete machine and provide a continuous feed of material to the nozzleman, who had only 6 ft (1.8 m) of head room when shooting. The nozzleman designed a small movable chair that could be rolled into position, providing a distance of 3 to 5 ft (0.9 to 1.5 m) from the end of the nozzle to the concrete surface. A standard gun finish was accepted because the area under the bridge was not accessible to foot or vehicular traffic.

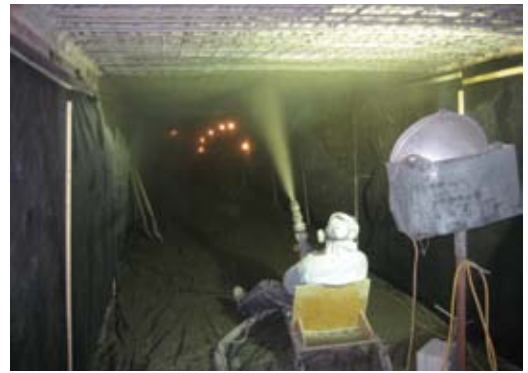
*Nozzleman in cramped quarters*
