# Outstanding Shotcrete Project Award Winner

## 2005 Outstanding Pool & Spa Project:

# Vanishing Edge Pool

by Bill Drakeley

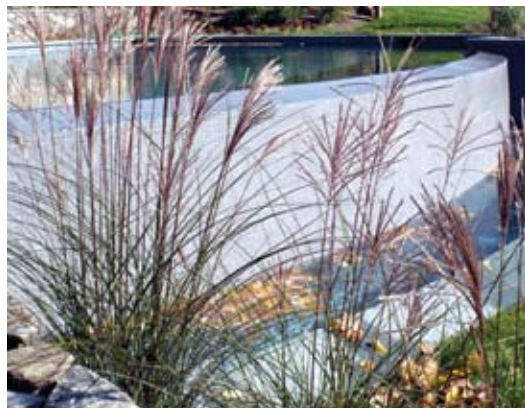
*Attention to detail in the areas not visible when enjoying the waterscape are just as important. The lower pool or surge trough is completed in the same materials as the main pool*

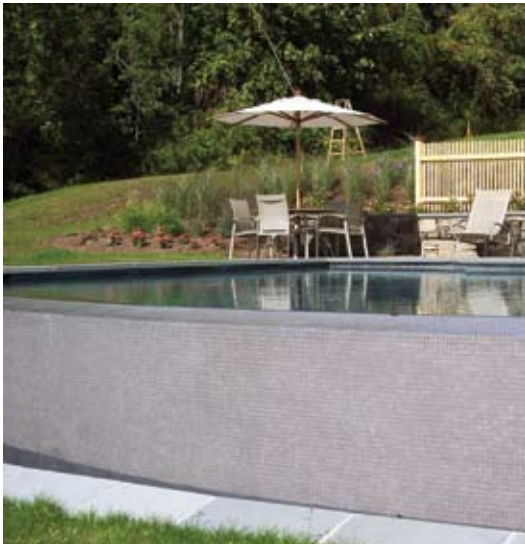
*A view of the edge wall shows the finish materials in place. Tolerance for the edge wall upon completion of the tile is  $\pm 1/32$  in. (1.5 mm). The flow of water over the edge is minimal if executed properly*

The shotcrete installation was approximately 80 yd<sup>3</sup> (61 m<sup>3</sup>). The shotcrete was a cement-rich mixture, 800 lb/yd<sup>3</sup> (475 kg/m<sup>3</sup>) cement with 3/8 in. (9.5 mm) stone and 10% air entrainment with a 3 to 4 in. (75 to 100 mm) slump. Special attention to detail was required for the edge wall. Drakeley Pools currently has the only three certified nozzlemen in Connecticut trained in this type of construction process. Our nozzlemen shooting the walls knew that the edge tolerance for the spillway wall had to be  $\pm 1/8$  in. ( $\pm 0.8$  mm) at time of placement. Correct water flow and the

whole success of water in transit were contingent on proper placement. Expected tolerance of  $1/32$  in. (1.5 mm) is the standard set by the tile installers.

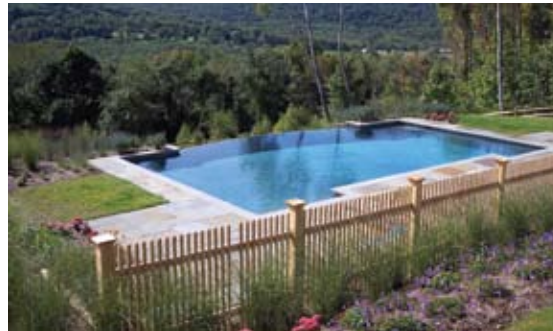
*A westerly view of the pool area shows the drastic slope of the building site. In the shadows of the edge wall is a foot ledge that continues the length of the pool*

The shotcrete process enabled us to bring the project from concept to reality. The shotcrete segment of the edge pool was the structure itself. Installation of the shotcrete entailed all aspects of high-end pool construction. The hillside on which the pool was installed had a slope in excess of 30 degrees. This type of site does require additional support encompassing the forming, steel, and shotcrete schedules.
