## The Star Pass Lazy River Project

by Warren Bezanson

# Pool & Spa Corner

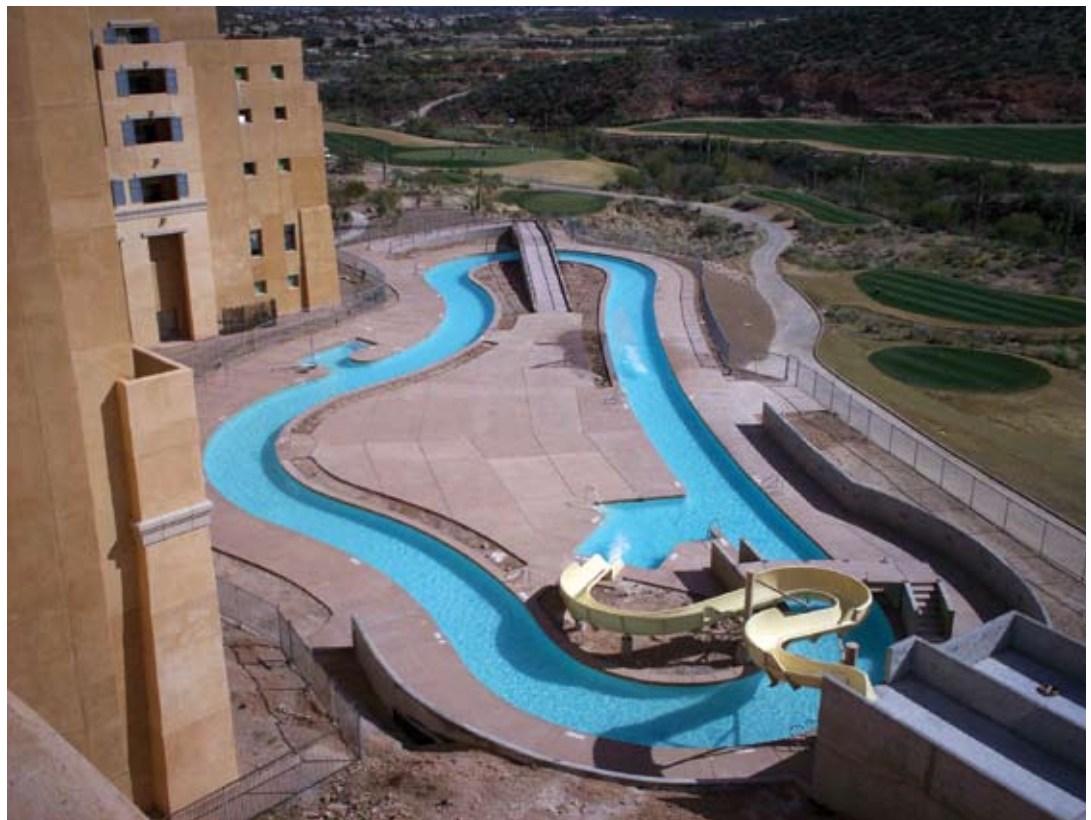
*The lazy river close to completion*

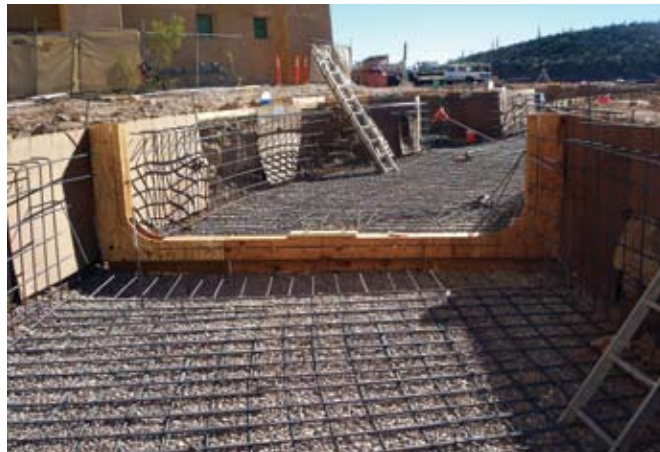
*Forms are constructed in sections for ease of removal and set prior to completing steel placement. Installing waterstop and 1/2 in. (13 mm) stainless steel rods will finish the form preparation. This photo shows a side view of the shotcrete placement*

Forming the joint required a form constructed from 3/4 in. (19 mm) plywood with a slot to position the waterstop and penetrations to accommodate the stainless steel dowels. Each section required 1 day for a four-member shotcrete crew to place approximately 40 yd<sup>3</sup> (31 m<sup>3</sup>) of 4000 psi (28 MPa) shotcrete. After the forms were removed, the steel reinforcement was placed in the adjacent sections and one of the two sets of forms

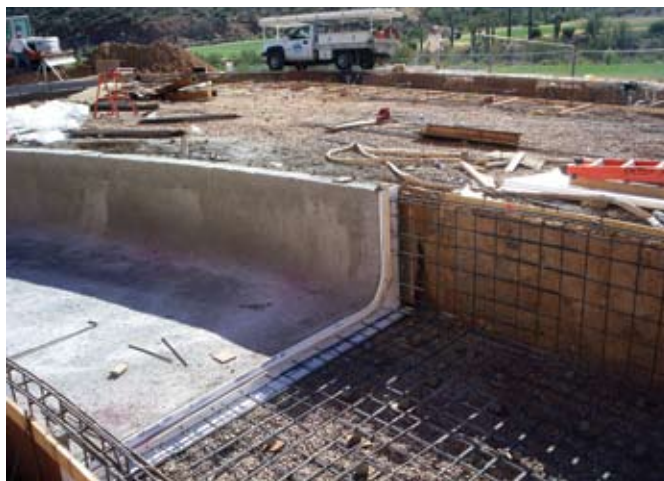
*A finished shotcrete joint section with 5/8 in. (16 mm) foam separation installed, ready for next shoot*

The expansion joint detail consisted of a butt joint at the bond beam and walls with a lap joint at the floor. The floor lap was reinforced with No. 5 reinforcing bar added to the typical No. 4 on 8 in. (203 mm) centers for the basic grid. Three foot long (0.91 m) smooth stainless steel bars were placed on 1 ft (0.30 m) centers spanning the joint to control lateral movement. Tile borders along both sides of the joint provided a terminus for the marcite plaster finish while an imbedded 9 in. (229 mm) polyvinyl chloride waterstop with caulking provided a waterproof seal.

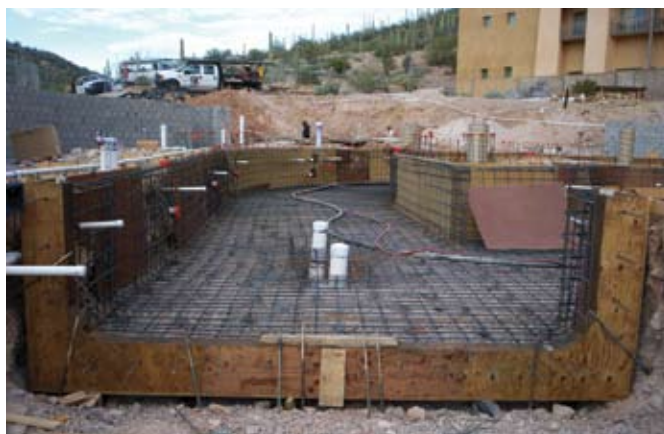
*A section ready for shotcrete with form joint in place. Peg board installed behind steel to save shotcrete material from filling voids in poorly consolidated soil in excavated walls, later backfilled with pea gravel*

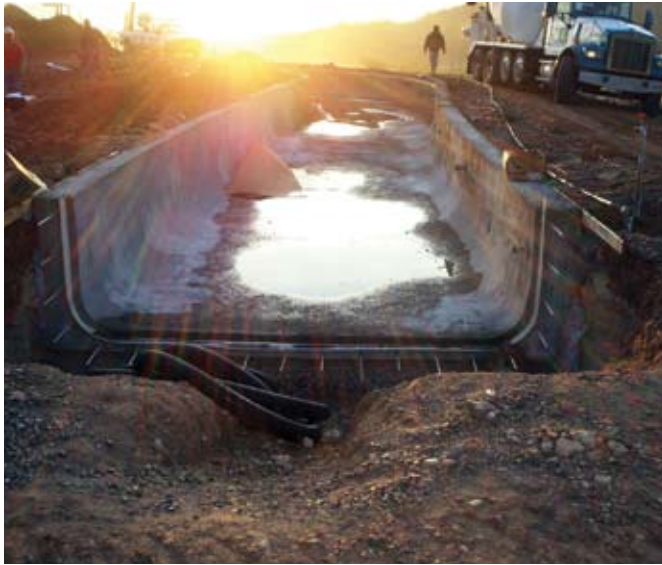
*Shotcrete section adjacent to the unexcavated final section*

Time and accessibility were constraints on the project. Access to the site was along a golf course cart route with limited or no staging. A critical path schedule was determined to build the lazy river in phases around other contractors doing infrastructure work. Sections of the lazy river were defined by the expansion joints and were constructed from excavation through shotcrete installation at various intervals of the project duration. The last section was left unexcavated for access until the majority of the concrete deck on the project was placed.

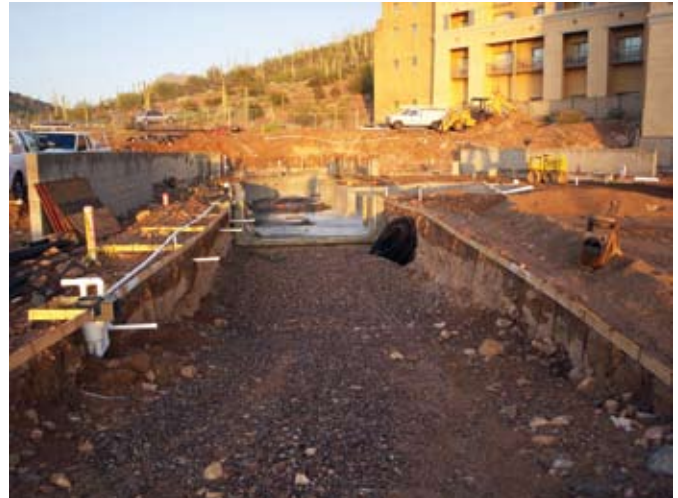
*Partial excavation of the last section left for access to island. Here is an example where the joint detail was formed incorrectly, where the integrity of shooting the subsequent lap beneath the floor cannot easily be validated*
