# Pre-Stressed, Post-Tensioned Ring Girder Resists Horizontal Component at Base of **Thin-Shell Concrete Dome Constructed by Gunite Method**

REQUIREMENTS OF the owner for an auditorium-type church, economically built, determined the design of the edifice under construction at Brooklyn Ave. and Bailey St. in Los Angeles for White Memorial Seventh-Day Adventist Church. The church will seat 2000 people, one-third of them in a balcony; an adjoining chapel will seat 250. The two buildings will be connected by a classroom wing.

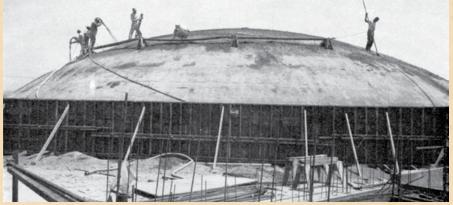
Guniting operation under way on the dome of White Memorial Seventh-Day Adventist Church. Height of dome above the floor is 70 ft; the diameter is 107 ft

Good control of curvature and proper screeding to get a uniform finish were essentials in concreting the dome shell to design requirements. At first the gunite contractor considered doing the work in vertical panels, like the segments of an orange, but decided he would have better control with horizontal joints and shot the job in a series of four annular rings on four seccessive days.

In shooting the job, the contractor used two units working from opposite sides of the dome. He also doubled up on the number of finishers employed, using twice as many as is customary in order to keep the slope uniform.

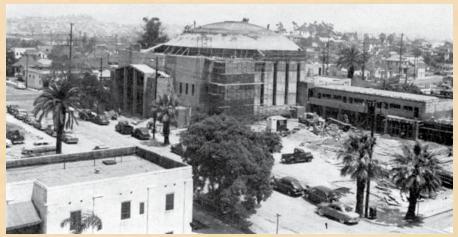
Overall view of White Memorial church and classroom wing which connects it to chapel (not in picture). Dome ranks in size with some of the largest in the West
