Pool & Recreational Shotcrete Corner

Perimeter-Overflow Negative-Edge Pool with Beach-Entry Spa

By Mason Guarino

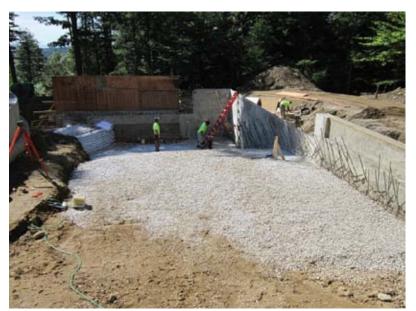
Fig. 1: Stone underlayment along with the reinforcing bars penetrating out of the first phase of construction so the second-phase pool section could be tied in correctly

The difficult part was creating the drawings detailing how to best build the pool to last in the harsh Maine climate with everything functioning correctly. Freezing winter temperatures required a significant foundation constructed with dry-mix shotcrete and clean, crushed stone. The complexity of the pool required it to be constructed in specific phases; the first phase included the negative-edge portion, followed in the second phase by the remainder of the pool (Fig. 1 to 3). The negativeedge feature, including the spillway wall and trough, needed to be constructed first to create a deep footing that would reach below the frost line. In the first mobilization, the trough area was excavated to the required depth and then overexcavated on the pool side to allow us room to construct forms. For the future, well-draining fill material was required under the pool. After excavation, extensive plumbing was installed, followed by form erection and placing of the pool shell reinforcing steel, and then shotcreted with dry-mix shotcrete. Some of the reinforcing steel in the trough wall extended out from the wall to allow for subsequent tie-in with the pool floor.

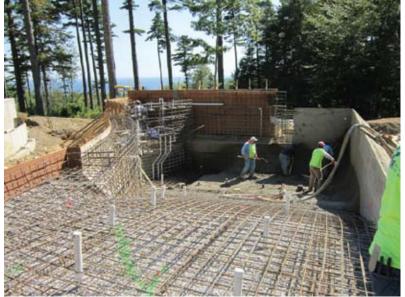
Fig. 2: Elaborate reinforcing required by the pool design as we start the second phase of shotcrete

The complexity of the pool structure created sections located from well below the frost line to right at and above the frost line. This required extensive structural design, resulting in a lot of reinforcement. The reinforcing steel consisted of two layers of No. 4 (No. 13M) reinforcing bar in the entire pool. The horizontal reinforcement spacing was 8 in. (203 mm) on center and vertical spacing was 6 in. (152 mm) on center. During shooting, a blowpipe was used extensively to keep the outer layer of reinforcing bar clean and prevent any rebound from building up on the bar surface, where it would reduce the quality of the in-place concrete. Overall, with the multiple phases, the shotcrete portion of the job was completed in 5 days.

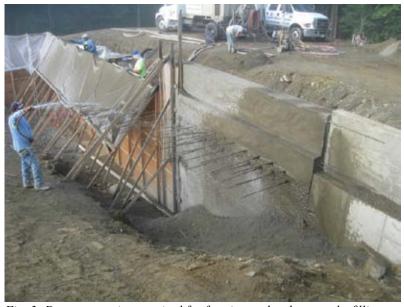
Fig. 3: Deep excavation required for forming and, subsequently, filling with free-draining stone to prevent frost heave. Also seen is the dowel reinforcing bar that was tied into the pool floor in the second phase

Next came the pool itself. After the trough and spillway wall were completed, the pool floor area was backfilled with free-draining crushed stone that would prevent any water buildup and potential heaving due to the freezing winter temperatures. Everything within 4 ft (1.2 m) of potential exposure to freezing air temperatures was filled with crushed stone or dry-mix shotcrete, as frost heave does not just affect horizontal sections of the pool but could also impact vertical sections that line the spillway. The pool had a shotcrete perimeter gutter that would later provide the overflow and deck-level water capability. Two pockets on either side of the beachentry area were constructed to hold natural rocks from the surrounding property to help the pool blend into the landscape. After initial curing and once the pool shotcrete reached the required strength, the boulders were installed. Shotcrete was placed around the boulders to secure them in place (Fig. 4).

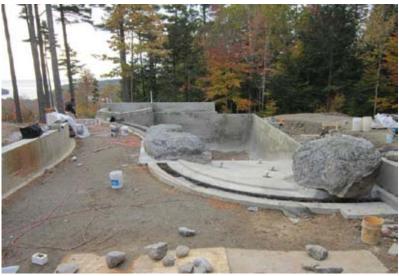
Fig. 4: Completed shotcrete with large rocks placed

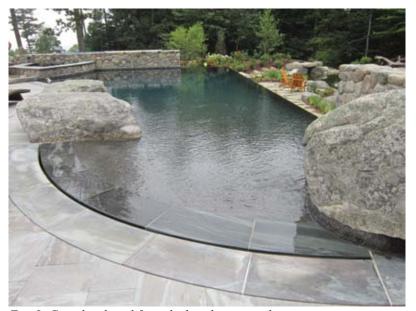
Fig. 5: Completed pool from the beach-entry end

The overall job took about 9 months to complete (Fig. 5 and 6). A lot of the construction was done in the winter under a tent that the general contractor erected over the swimming pool. This allowed the pool construction to be completed more quickly. All shotcrete work took place before the winter weather became an issue. The final product lived up to all of the expectations the homeowners were looking for and then some. This pool is definitely one of South Shore Gunite Pools & Spas' most intricate residential pools to date.

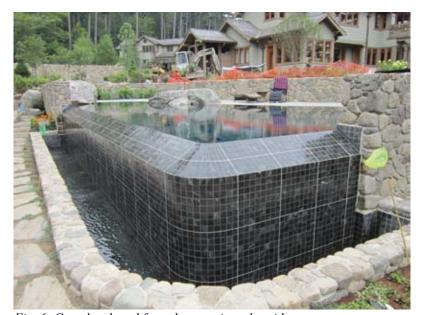
Fig. 6: Completed pool from the negative-edge side
