Restoring a Civil War Monument

By Ted Sofis

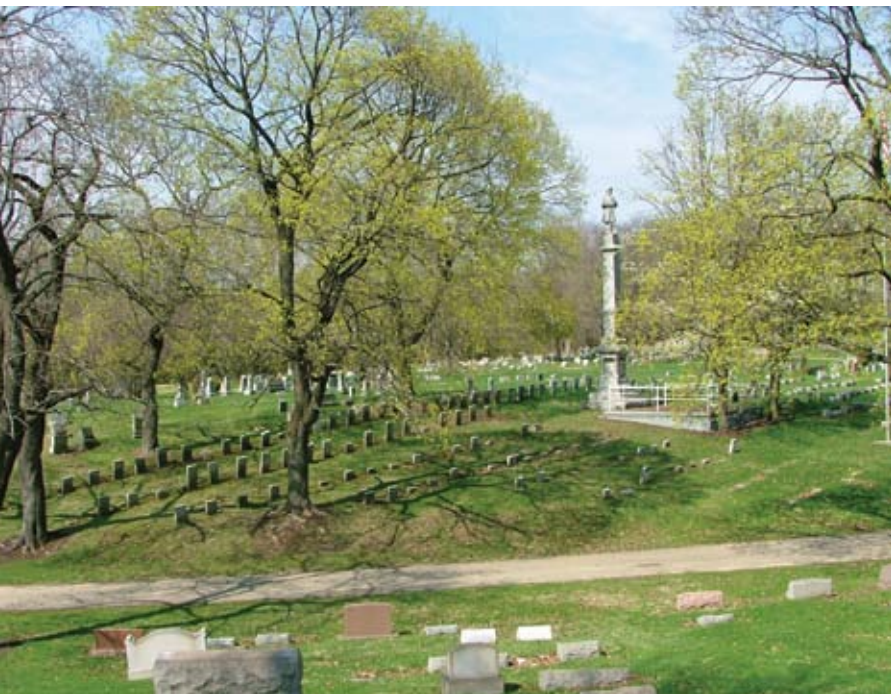
Fig. 1: The Civil War monument at Chartiers Cemetery in Carnegie, PA, with the Civil War veteran headstones in the foreground

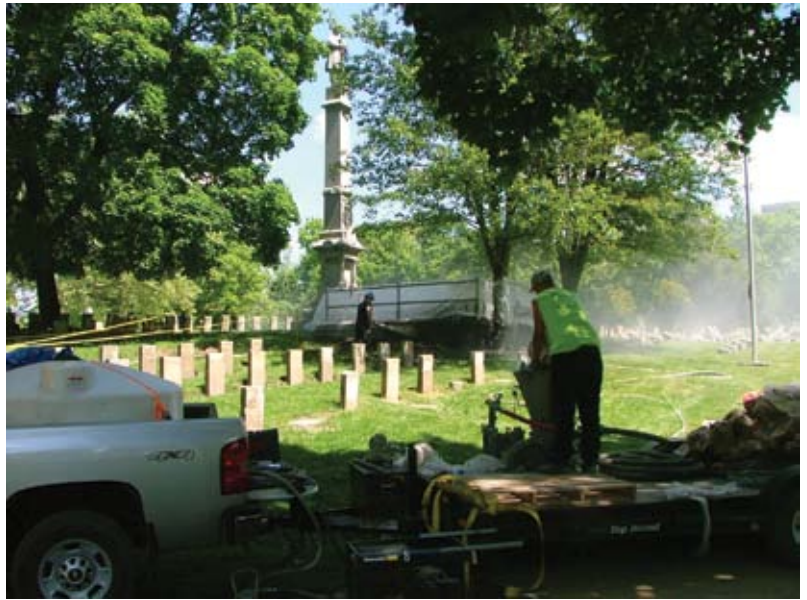
Fig. 3: Overview of the site with the dry-mix rig in the foreground

With the excavation work already behind us, the adjacent tree trunks and monument's railings were then covered with plastic to shield the granite monument from shotcrete over-spray. Then, the deteriorated concrete was removed. Removing all deteriorated concrete to expose a solid concrete substrate is essential to produce a durable shotcrete repair. After the surface preparation work was completed, galvanized 3 x 3 in. No. 11 gauge (76 x 76 MW5.6/5.6) mesh was installed and anchored in place with J-hook expansion bolts. A prepackaged microsilica-enhanced repair mortar, Shotcrete MS manufactured by Quikrete, was used for the repairs and gunned in place using the dry process. The areas where deteriorated concrete had been removed were filled. Shotcrete, approximately 3 in. (76 mm) thick, was gunned over the entire podium wall area to create a uniform final appearance (Fig. 3 and 4). From start to finish, everything was easily completed in 1 day—a very

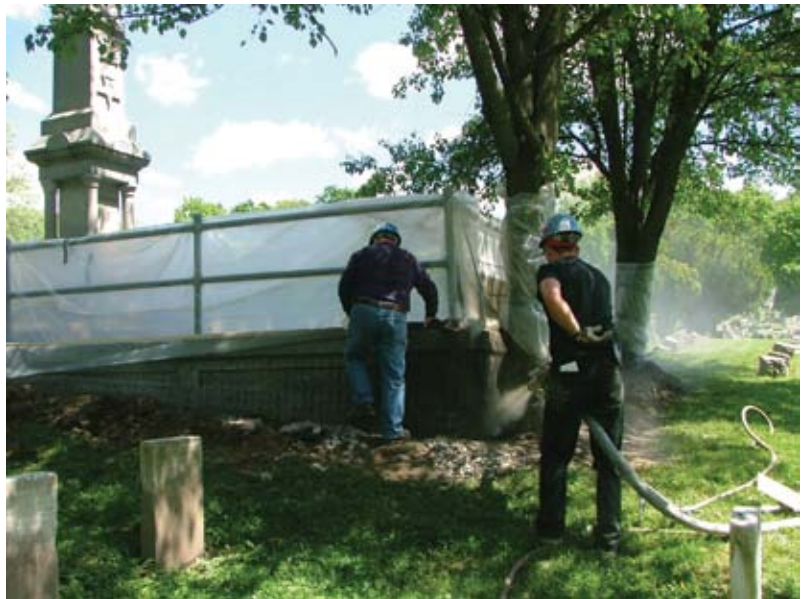
Fig. 4: After the deteriorated concrete was chipped out, the surface was prepared and meshed and the shotcrete was gunned in place

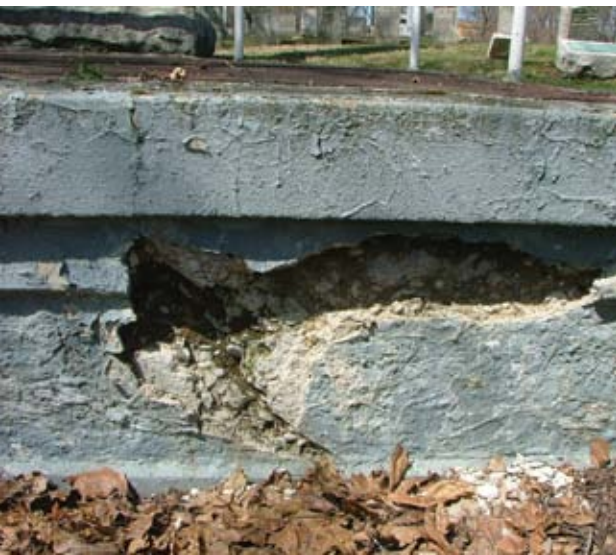
Fig. 2: The foundation wall of the Civil War monument's review stand at the Chartiers Cemetery was badly deteriorated

For this project at Chartiers Cemetery in Carnegie, PA, Neaman and Hoesch began raising money to reset many of the old veterans' headstones that had sunken into the ground. Many of the original headstone memorials were supplied by the county of Allegheny for the burial of indigent Civil War veterans. Some of the headstones happened to be placed over the old wooden coffins. Over time, as the coffins deteriorated, the headstones would sink into the ground, often tilting one way or the other. The donations received are used to remove and reset the sunken headstones on a concrete base, so they don't sink again. The stones are cleaned, soil is brought in to level the graves, flowers are planted, and memorial services are conducted. Neaman and Hoesch selflessly dedicate their time and efforts to this historic restoration work. On Memorial Day weekend every year, their Civil War reenactment group performs a ceremony at the Chartiers Cemetery. During one of these occasions, the poor condition of the monument's reviewing podium became apparent to them. With Memorial Day approaching, Martin contacted me and put the ball in motion (Fig. 2)

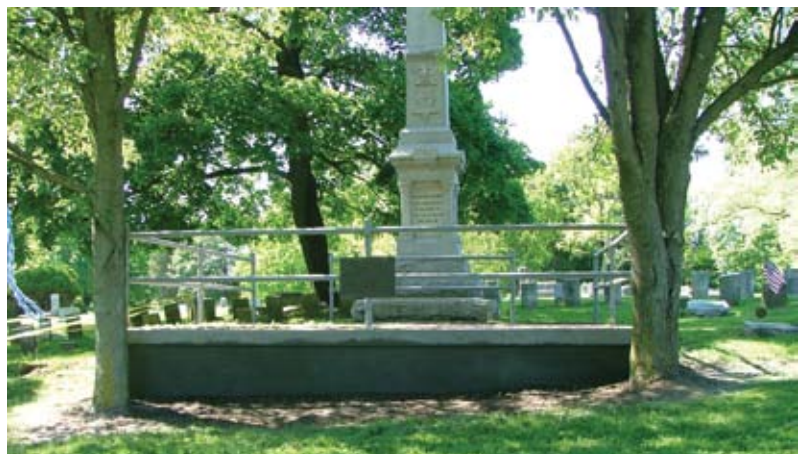
Fig. 5: Completed shotcrete placement on the monument review stand

short time for concrete restoration work. The dry-process shotcrete used in installation allowed the nozzleman greater flexibility and control to make subtle adjustments in his/her spray pattern and provided an extremely efficient method for repairing concrete structures (Fig. 5 and 6).

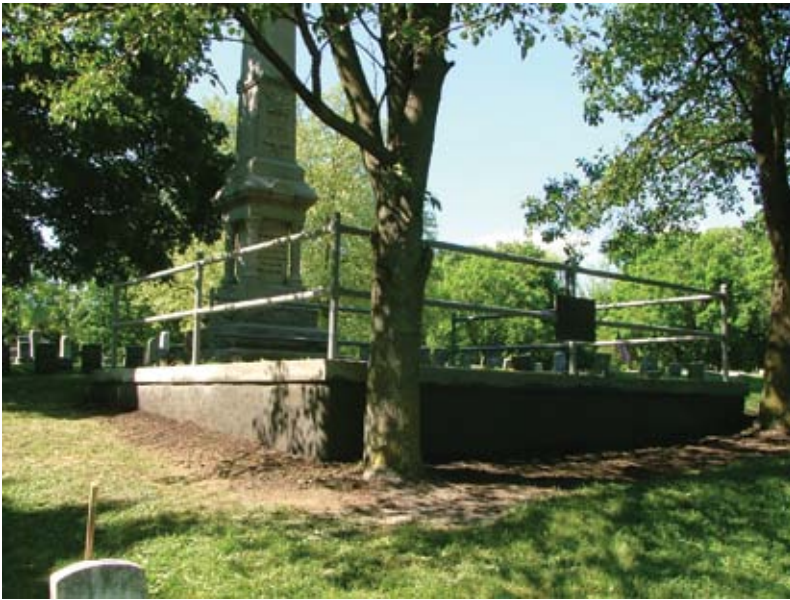
Fig. 6: A side view of the Civil War monument after the completion of the shotcrete work

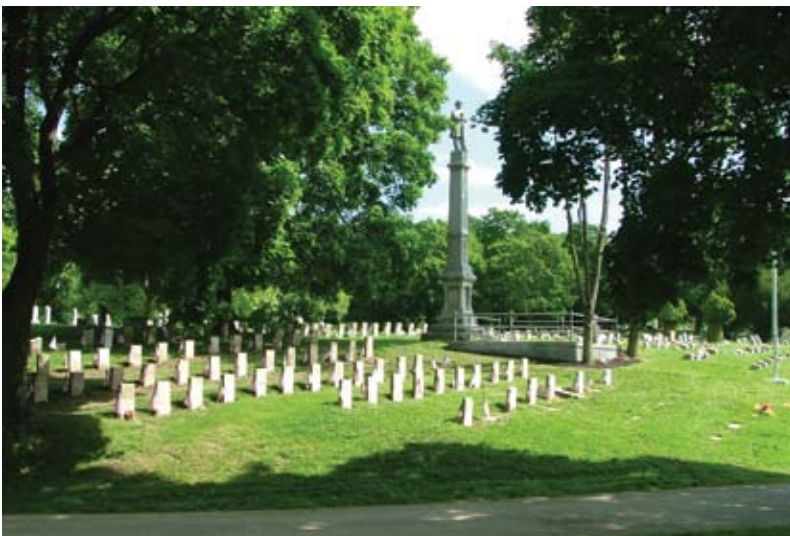
Fig. 8: Chartiers Monument completed
