2011 Honorable Mention

Blaine Hill Viaduct Bridge— Route 40 Ohio Department of Transportation 248-10

By Jason Pinney

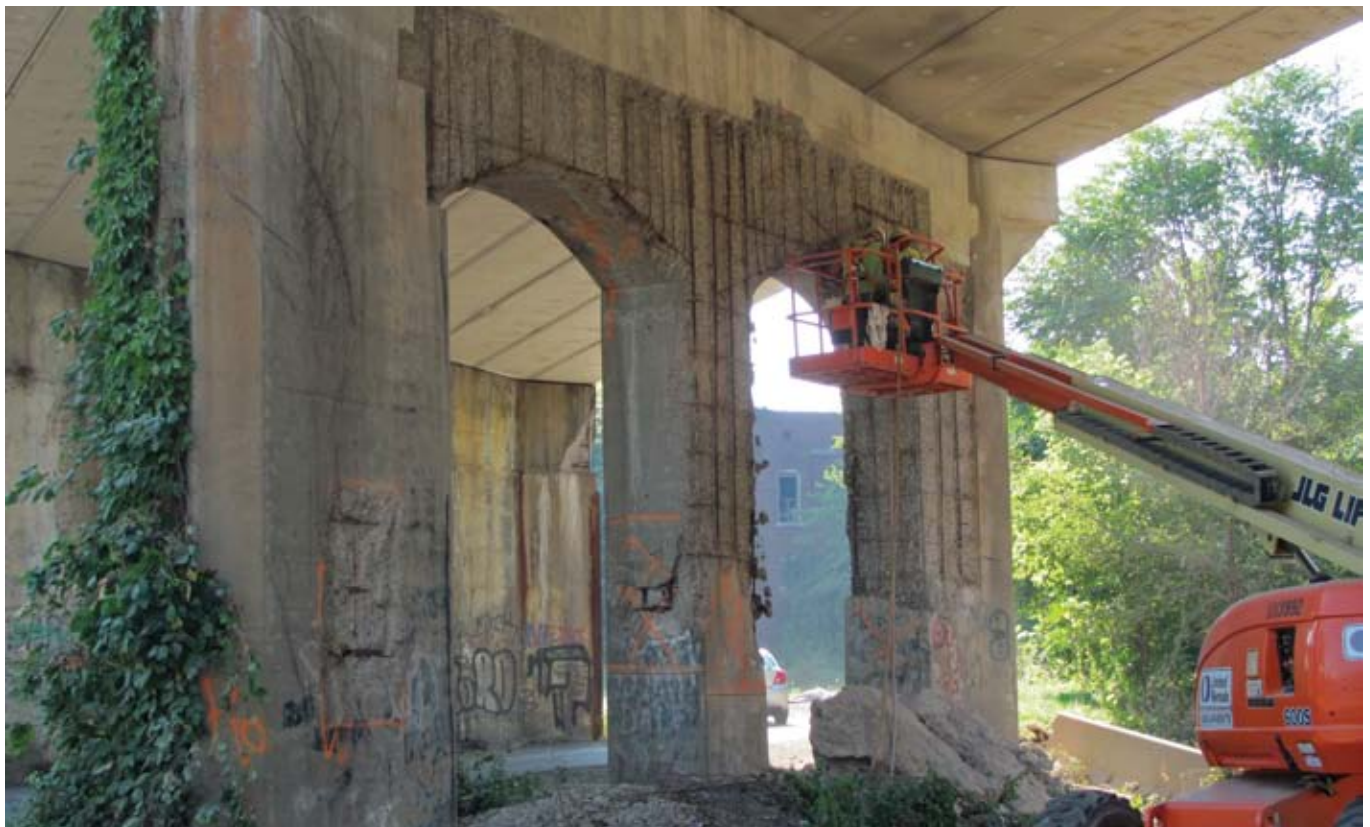
Fig. 1: Deteriorated concrete being removed during demolition

As the demolition process began, deteriorated and unsound concrete was saw cut and removed using 15 lb (6.8 kg) chipping hammers. Existing exposed reinforcing steel was sandblasted to bare steel. This removed all corrosion from the reinforcing steel. Where existing reinforcement was deficient, it was replaced with either reinforcement steel or wire mesh, depending on the size, shape, and condition of the patch area. Before shotcreting started, approximately 5300 embedded sacrificial galvanic anodes (Galvashield® XP2 anodes) were installed on the reinforcing steel.

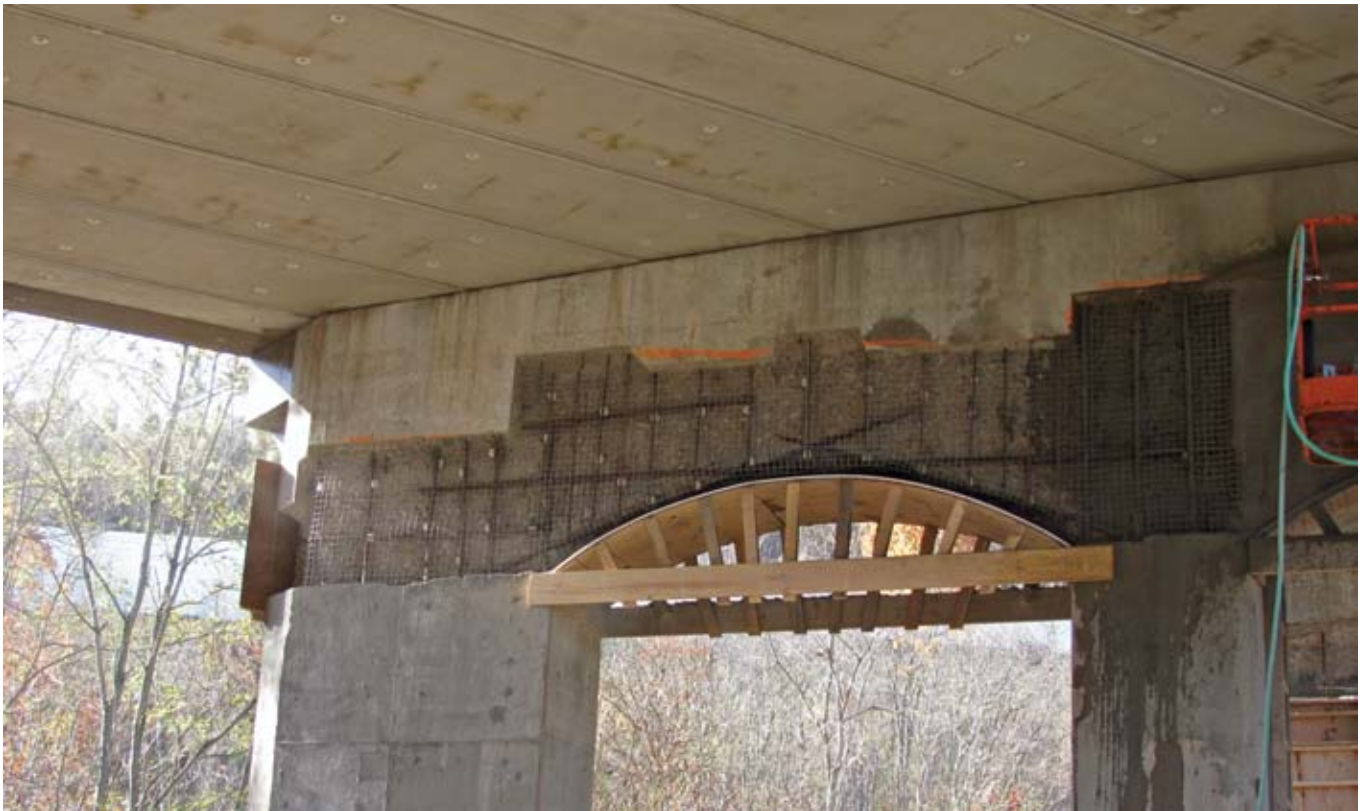
Fig. 2: Wire mesh and anodes installed prior to material installation

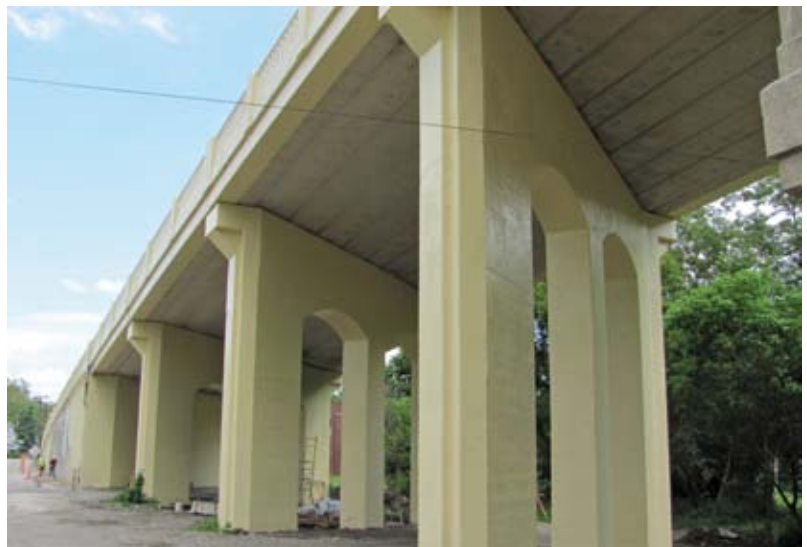
Fig. 3: Rehabilitated columns with tintable epoxy urethane sealer

sealer was applied to the entire concrete structure for added durability, protection, and overall aesthetics. In addition to the substructure rehabilitation, the bridge deck received a microsilica concrete overlay.

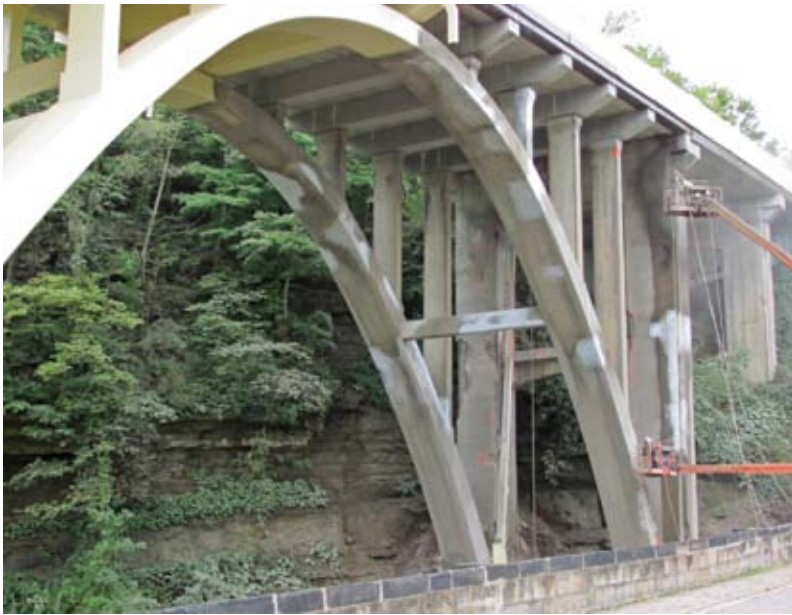
Fig. 4: Open spandrel arch and spandrel column rehabilitation

tation. Prior to the placement of the material, patch areas were saturated-surface-dry (SSD) to ensure proper bonding and hydration of the applied shotcrete. Areas patched on the structure included wing walls, piers, spandrel columns, arches, and abutments. Patches were “gunned” at varying depths from 2 to 6 in. (50 to 150 mm) in depth and a hand-trowel finish was used on the material. The patches were then sprayed with a white-to-clear ODOT-approved curing compound. The curing compound helped to ensure proper hydration and minimized shrinkage cracking. Ultimately, a final tinted epoxy urethane

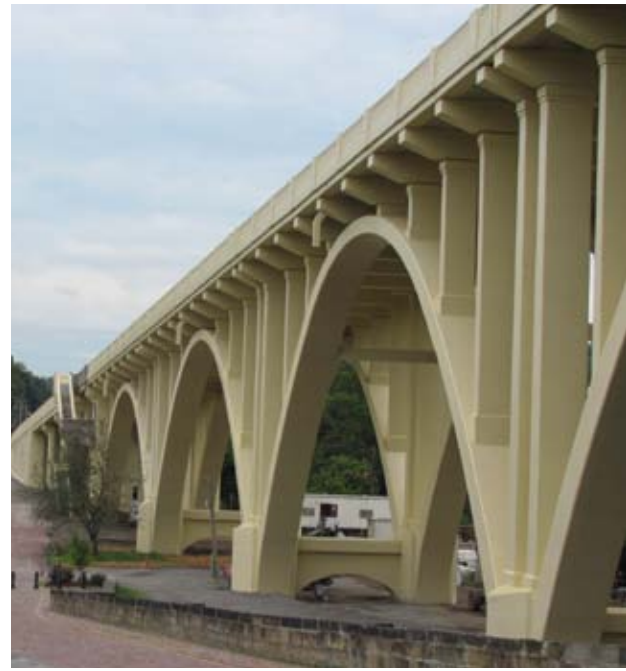
Fig. 5: Rehabilitation of Blaine Hill Viaduct Bridge near completion
