Article reprinted from the Fall 2006 issue of Shotcrete magazine

2005 Outstanding Repair and Rehabilitation Project: **Pointe de la Prairie Lighthouse**

Rehabilitation of the
Pointe de la Prairie Lighthouse

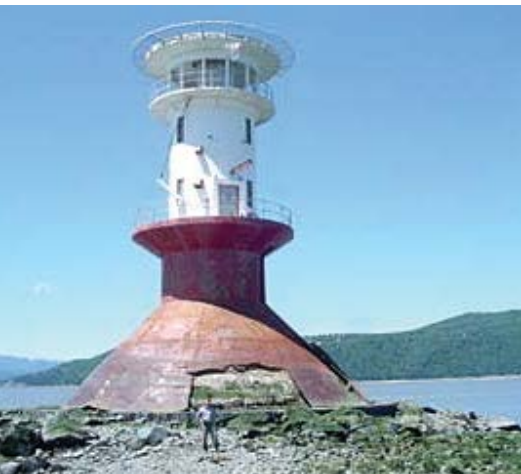
Pointe de la Prairie Lighthouse before reconstruction

The Pointe de la Prairie Lighthouse is located on the north shore of the Île-aux-Coudres Island across from Baie-Saint-Paul in the St. Lawrence River. Since its construction in 1972, the lighthouse has been exposed to extremely severe environmental conditions. Exposure to salt water, continuous freezing-and-thawing cycles, and impact from ice flows have contributed over the years to severe deterioration of the concrete that makes up the base of the lighthouse. A 1/4 in.

(6 mm) thick steel plate surrounding the concrete base was designed to provide added protection against impact from ice flows. In several areas, these plates were completely destroyed. The extent of the concrete deterioration behind these plates was so severe that in some areas it reached nearly 3 ft (915 mm) in depth.

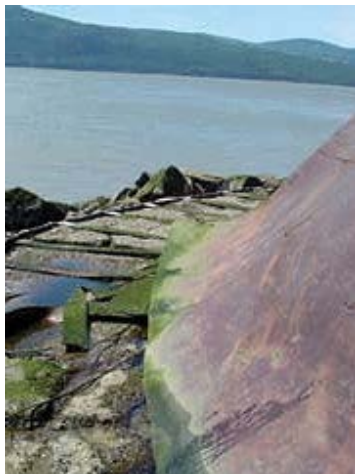
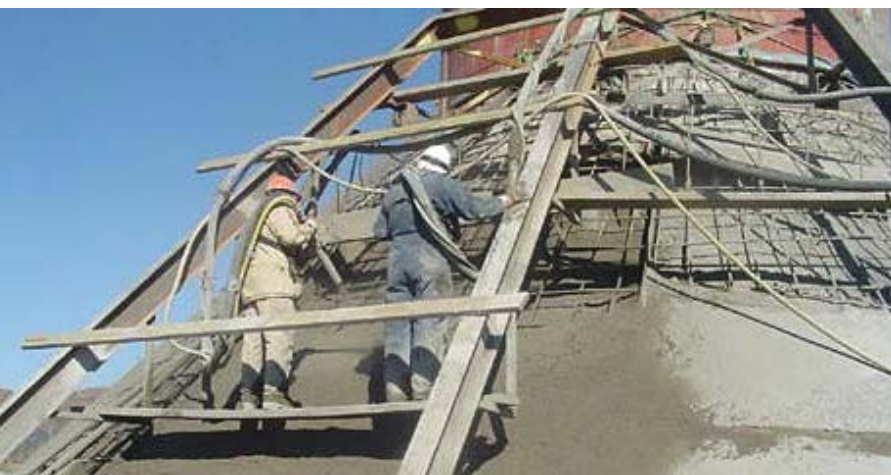
Nozzlemen shooting the base of the lighthouse

The concrete base of the lighthouse was divided into 14 triangular sections, each separated by a vertical construction joint. Each section was shot from the bottom of the section (at the base of the lighthouse) to the top to maximize the amount of material that could be applied before the action of the rising tides threatened to wash out the applied shotcrete. As the tide retreated, cleaning and preparation work was completed on the next section and the next shooting session began.

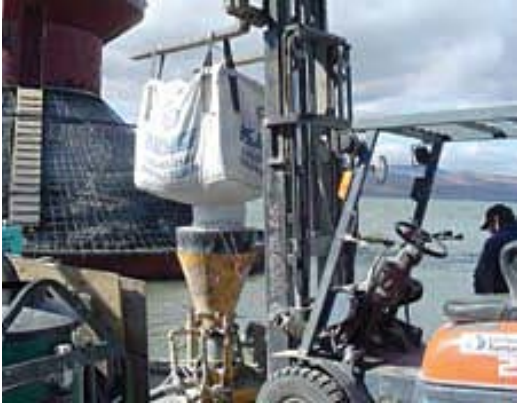
Shotcrete was supplied in 2200 lb (1000 kg) reusable, bulk tote bags

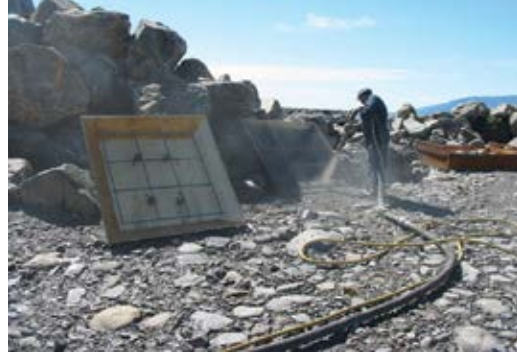
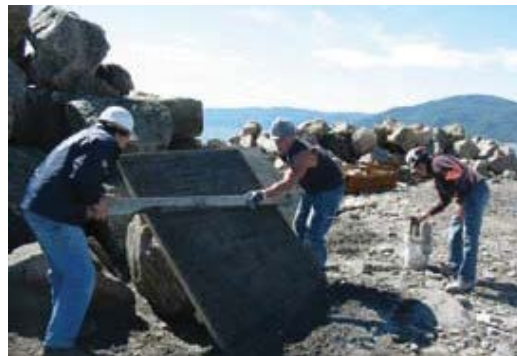
Test panels were shot to evaluate the competence of the nozzlemen and to confirm hardened properties of the mixture

Before beginning the shotcrete portion of the project, test panels were shot and mechanically finished to provide a representative sample of the finished product. The panels were left on site for 24 hours, after which time cores were taken to evaluate the compressive strength and quality of the shotcrete placement.

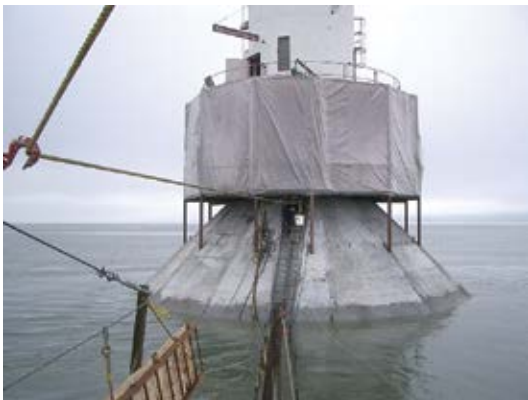
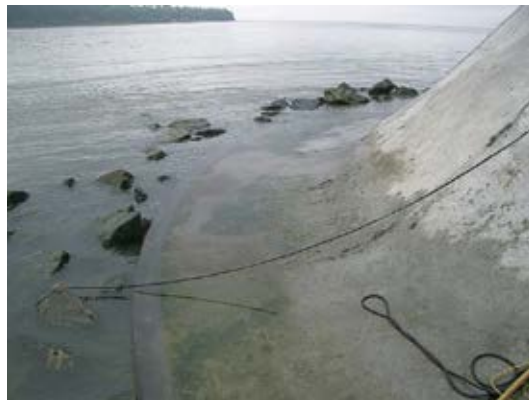
Completed shotcrete application at low tide

conditions that constantly disrupted shooting schedules. The skill of the Cimota Inc. certified nozzlemen and the quality of the specially designed King shotcrete mixture were evident by the overall quality of the completed project. After 2 years, the performance of the shotcrete has met all expectations and Public Works and Government Services Canada has expressed complete satisfaction with the performance of the product and the installation.
