The Energy Innovation Center

By Ted Sofis

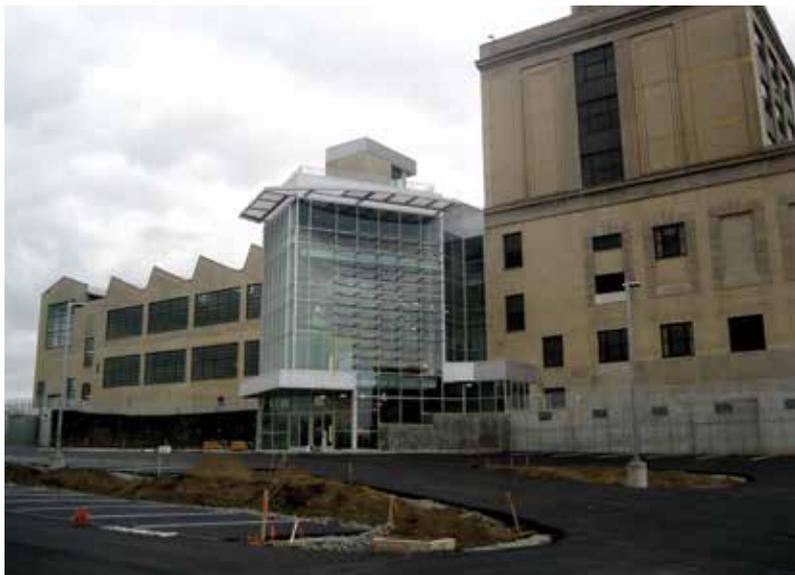
Fig. 1: The building complex has undergone extensive renovations to transform it into the Energy Innovation Center and will serve as an incubator for energy-based startups

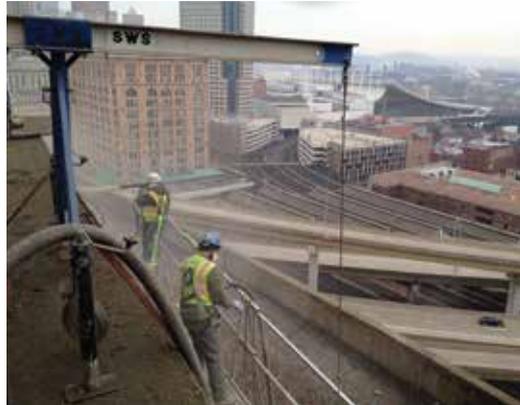
Fig. 2: Due to restricted access and nothing above to suspend cables from, outriggers were used to hang swing stages for the shotcrete rehabilitation work

Sofis Company was asked to look at the project and price a shotcrete repair. Again, the access presented problems. The slope was too steep for conventional scaffolding and there was no access around the building for equipment, so it would not be possible to use access equipment such as man-lifts. With nothing above to attach cables to, the best option was to use outriggers to hang our swing stages from. The outriggers with counter weights were carried down the building’s stairwells to a back door in the rear of the old school. After the outriggers were put in place with the appropriate counterweights, the swing stages were hung in place (refer to Fig. 2 through 5).

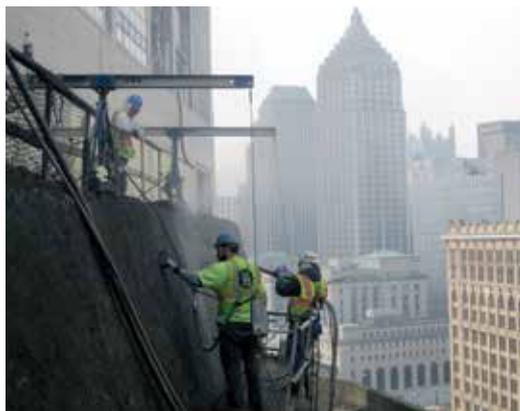
Fig. 3: Shotcrete is placed with Pittsburgh landmarks the Gulf Tower and Koppers Building in the background

The next step involved chipping out the deteriorated concrete, preparing the substrate, and installing anchors and mesh. By using dry-process shotcrete for the repair, we were able to efficiently transport material around to the back of the building. A prepackaged shotcrete repair mortar, Shotcrete MS, manufactured by Quikrete, was used on the project. With the logistical issues out of the way, the shotcrete placement work proceeded and the wall repairs were completed.

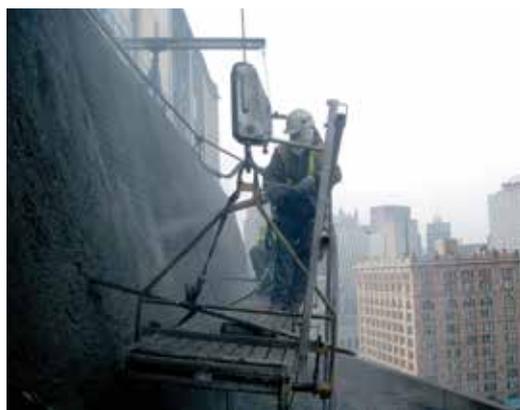
Fig. 4: Nozzleman on suspended swing stage, turning to his side, to get enough distance from the wall to get a good spray pattern

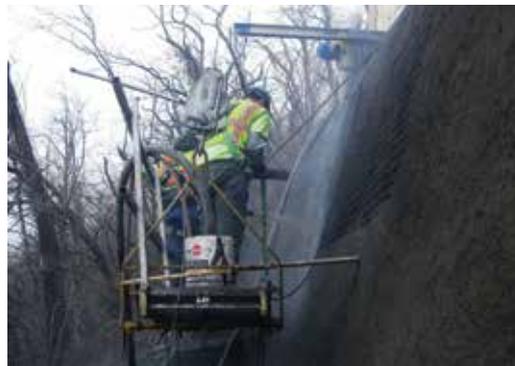
Fig 5: Nozzleman and cutdown man working together to complete upper areas of the eastern wall
