## Challenges on the Lagoon at Treasure Island Resort

By Zach Brazier

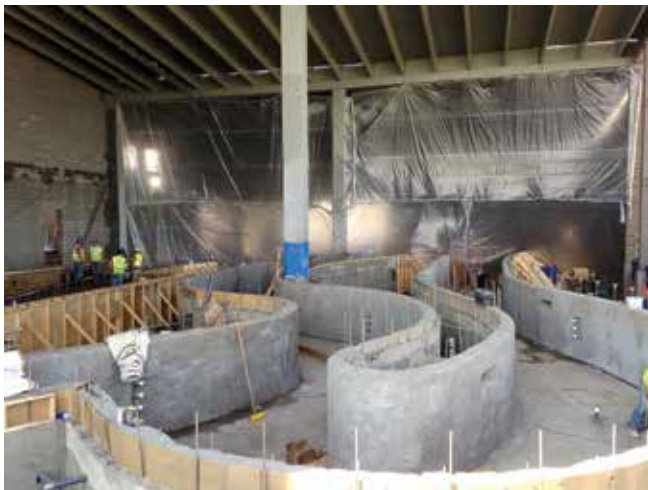
Fig. 1: First section of lazy river placed

river. The river is complete with rapids and waterfalls. Global placed 150 yd<sup>3</sup> (110 m<sup>3</sup>) of floor and wall. Once the work area was ready, they broke up the concrete placement in three sections. The Global Specialty carpenters paid extra attention to build proper joints to ensure watertightness.

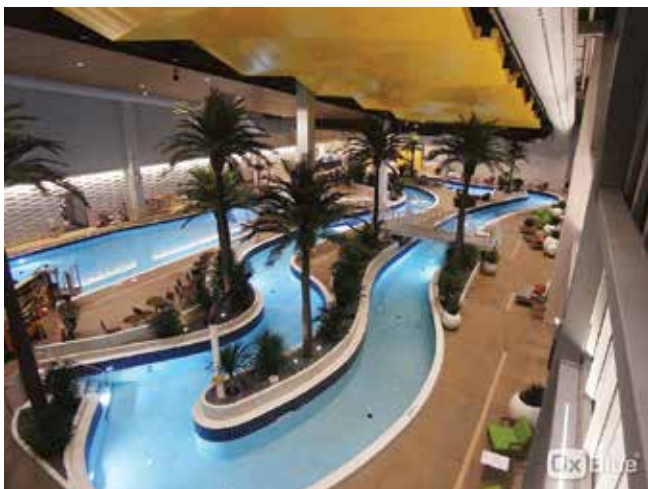
Fig. 2: Lazy river

Global Specialty was brought on site in late summer of 2015 and given a completion time of 5 months. The centerpiece of the new Lagoon project is the 325 ft (100 m) lazy

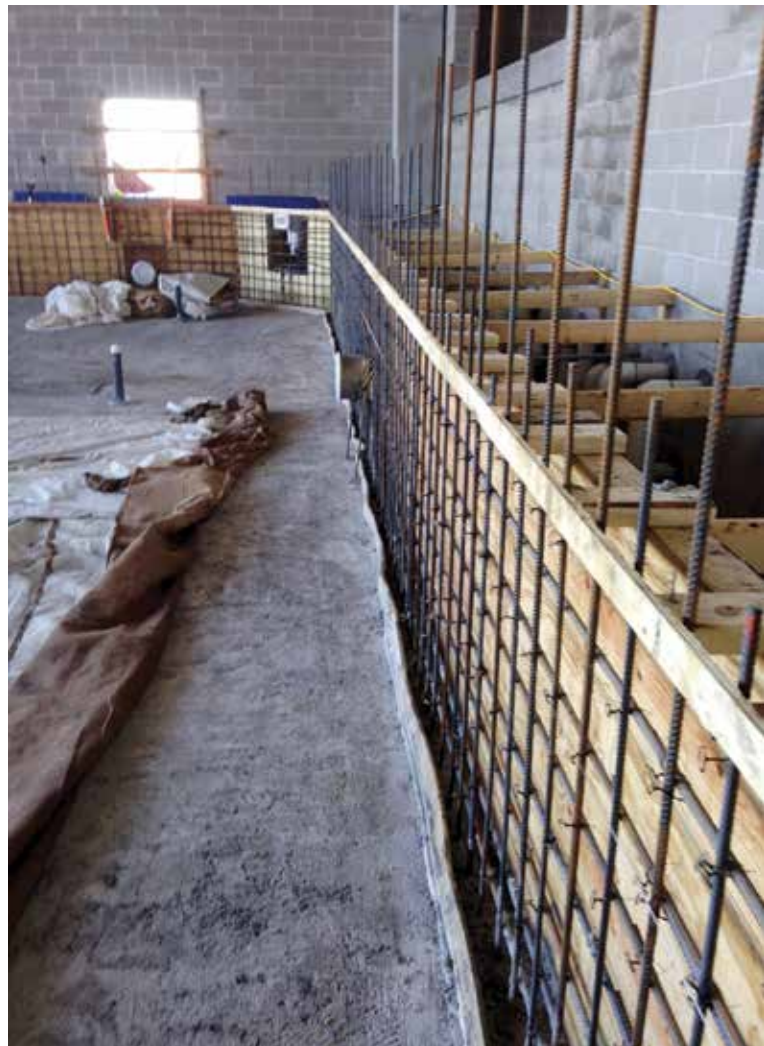
Fig. 3: Leisure pool ready for shotcrete application

The adjacent 2000 ft<sup>2</sup> (185 m<sup>2</sup>) leisure pool’s walls were placed with another 55 yd<sup>3</sup> (42 m<sup>3</sup>) of wet-mix shotcrete. At this point in the project, the building that included the Lagoon expansion had not been enclosed from the elements.

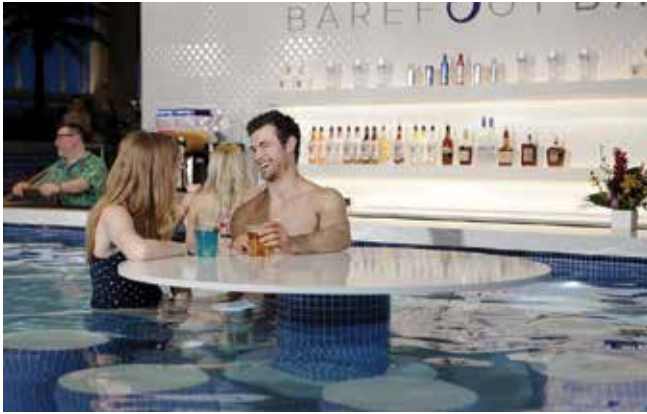
Fig. 4: Lounge pool

Not the largest vessel, but still complicated, was the aesthetically pleasing Lounge Spa. The monolithic shotcrete structure of 35 yd<sup>3</sup> (28 m<sup>3</sup>) was placed and carved by skilled workers. The formwork prior to shotcreting looked like a web of reinforcing bars, tubes, and water stops. It is often a challenge to fit enough workers to place, finish, and remove rebound in these smaller water features. After about a 14-hour day, a swim-up bar was easily recognizable.
