# Mexico City Deep Sewer Rehabilitation with Shotcrete

**Mexico City Deep Sewer Repair**

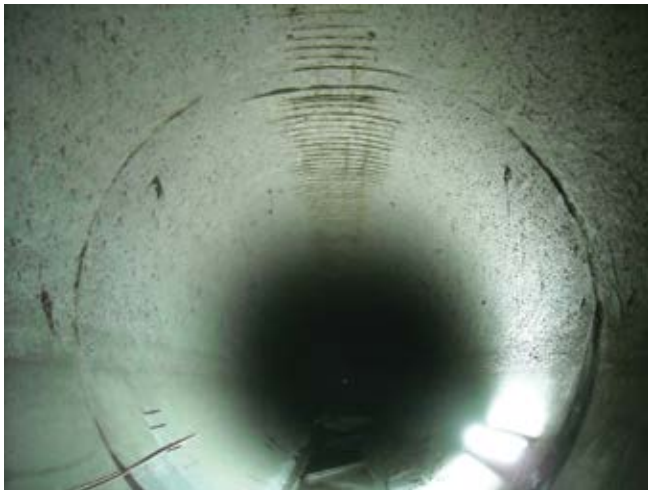
Fig. 1: Initial conditions—note deterioration at the top of the drainage tunnel

Evaluation of two of the interceptor lines found significant damage to this concrete tunnel primarily in the top quadrant of the tunnels. Exposure to corrosive gases from the sewage and storm water contributed to this damage. The two interceptor lines were 16 ft (5 m) in diameter and had 11 access “ports,” which totaled 11 miles (18 km) in length. Additional problems included thinning of the walls of the channel from chemical attack and corrosion from the reinforcing steel.

The repair process started with hydrodemolition to remove the damaged concrete, then preparing the remaining concrete surface, placement of a corrosion inhibitor on the existing reinforcing steel, placing a new layer of supplemental steel reinforcement, and applying a 6 in. (150 mm) thick shotcrete layer to reinforce the existing drainage sections in the upper middle of the tunnel.

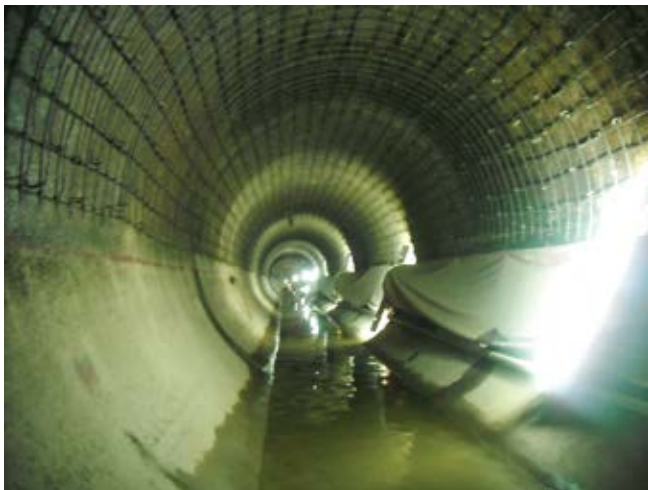
Fig. 2: Surface prepared and supplemental reinforcement in place ready to cover with shotcrete

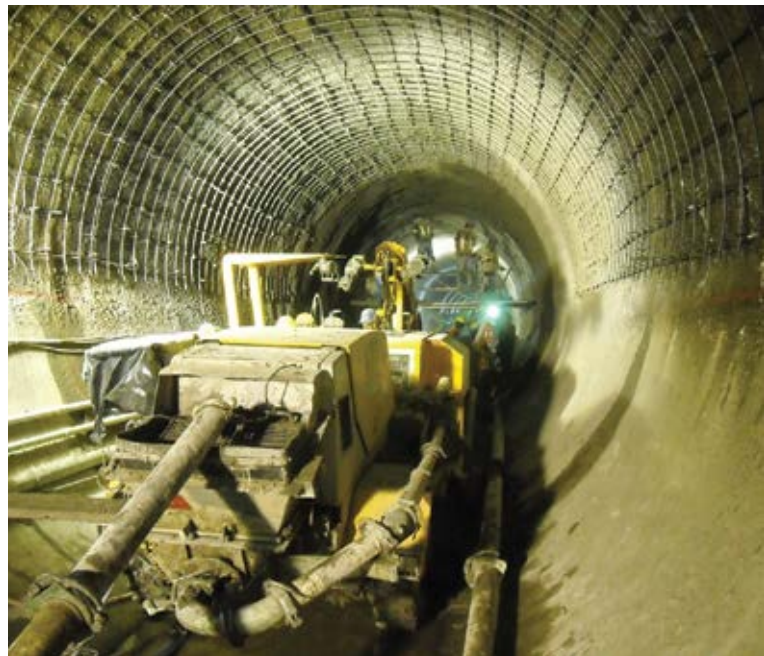
Fig. 3: Shotcrete equipment in position within the tunnel

For the placement of the shotcrete, we had a concrete pump at the ground surface to pump concrete from the surface up to 4900 ft (1500 m) below ground to a second pump that discharged to the final shotcrete delivery hose and nozzle. We opted for a robotic application to increase

In the below-ground locations, we used a Putzmeister Spraymobil PM400 with a diesel engine. The repairs were performed before the start of the rainy season and we worked 24 hours a day. Once the rains began, the tunnels would be flooded, regardless of equipment or materials. The ease of use and deployment of the shotcrete process, as well as proper surface preparation, allowed us to complete the job with a successful and durable application before the rains began.

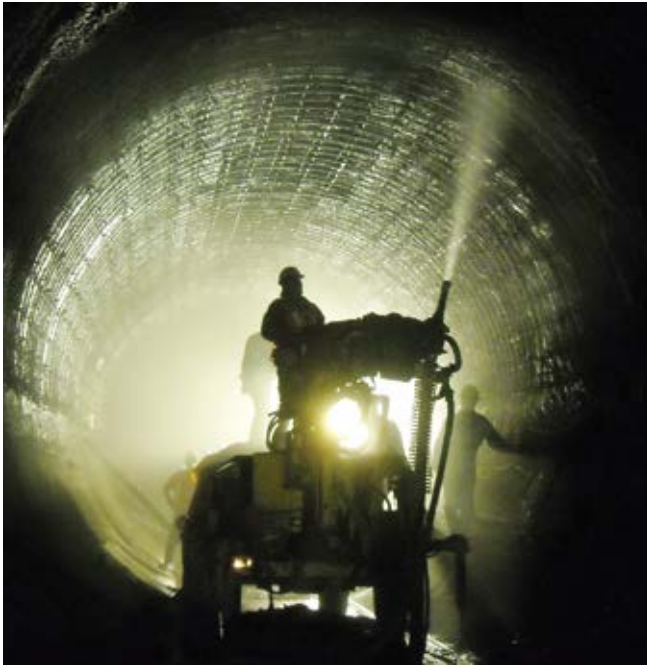
Fig. 4: Shotcreting operation

productivity and placed an average of 210 yd<sup>3</sup> (160 m<sup>3</sup>) of shotcrete daily.

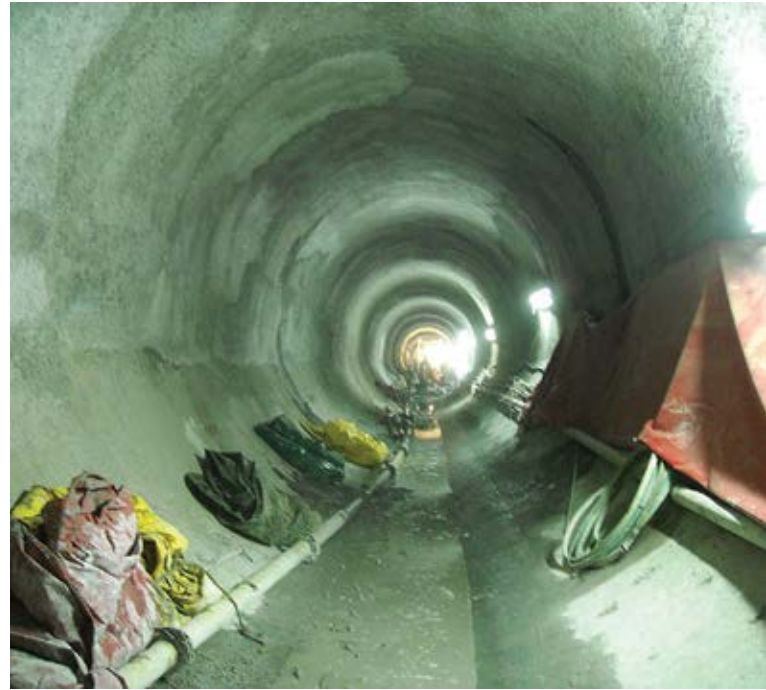
Fig. 5: Final job
