Tourism Versus Shotcrete

Fisherman's Wharf is one of the major tourist attractions in San Francisco, CA, and doing a shotcrete project underneath the hub of San Francisco's tourism is a unique challenge. Pier 31.5 sits between the tourism Mecca of Pier 39, the new cruise terminal at Pier 27, and the embarkation point for Alcatraz at Pier 33. When the rehabilitation of Pier 31.5 is complete, the next phase of the project will start making a new embarkation point for Alcatraz along with a civic plaza and historical area. Pier 31.5 was constructed in 1918 and has had many modifications and repairs over its decades of use. It was determined in 2015 that a major rehabilitation and repurposing was required of the Pier and of the entire Wharf area. During the investigation stage, it was found that major concrete repairs were required to the substructure and Dees-Hennessy Inc. (DHI) was chosen to perform the shotcrete portion of the project.

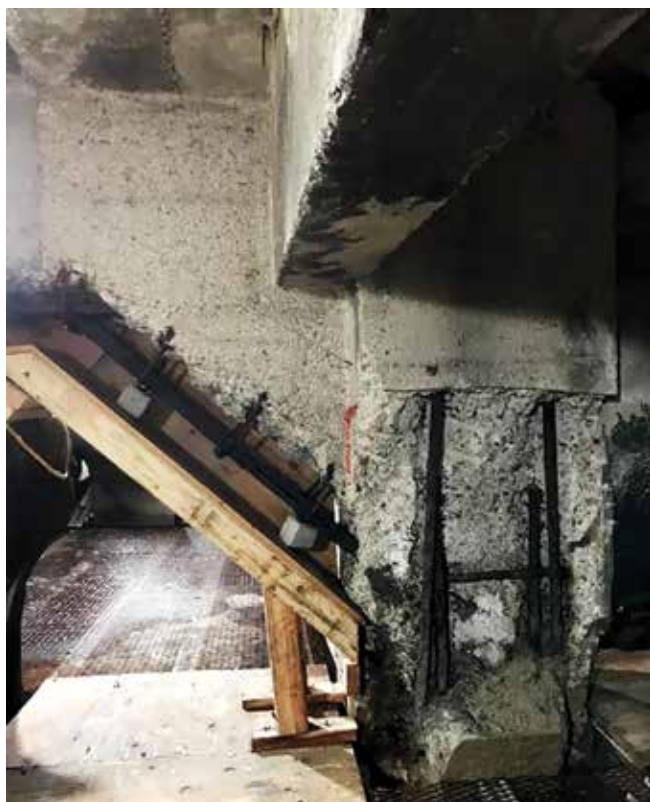
Fig. 1: Beam side prepared for shotcreting with minimal formwork

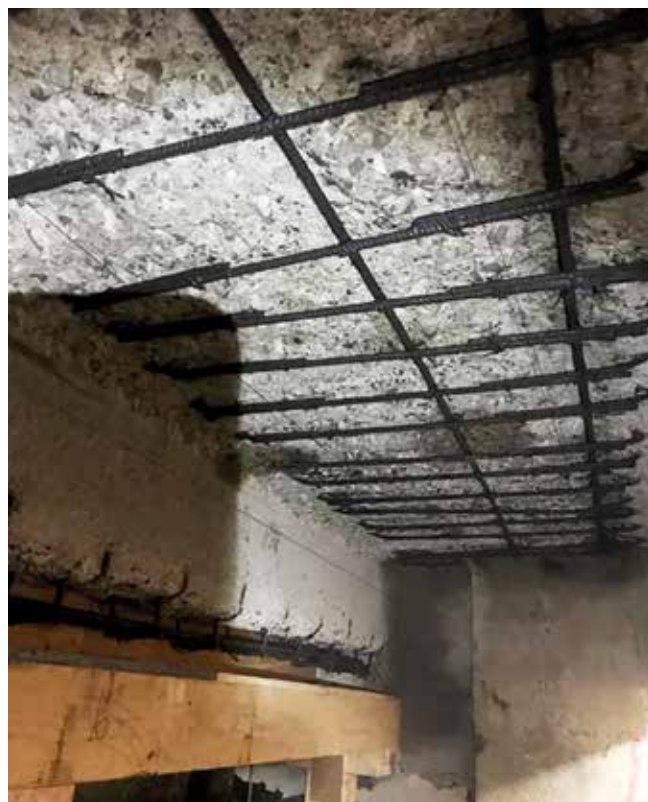
Fig. 2: Underside of pier ready for shotcrete

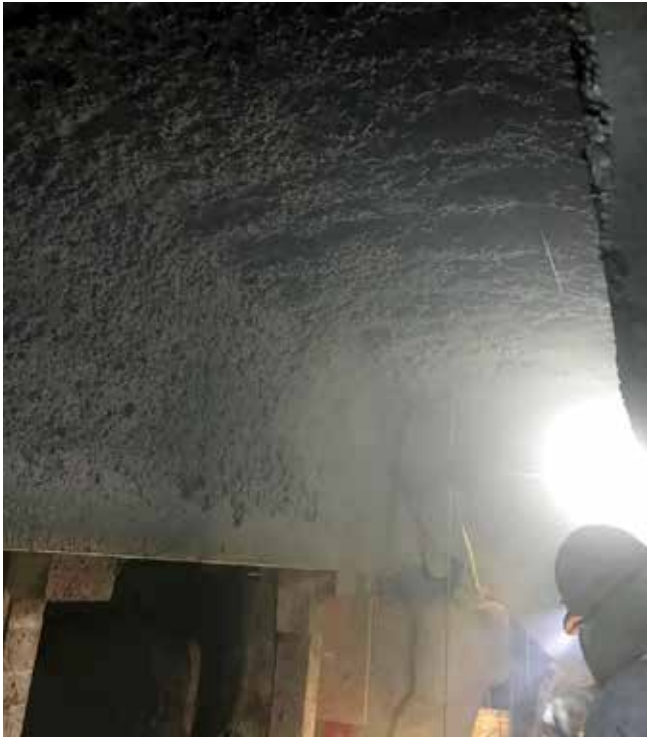
Fig. 3: Shotcreting in limited space under pier

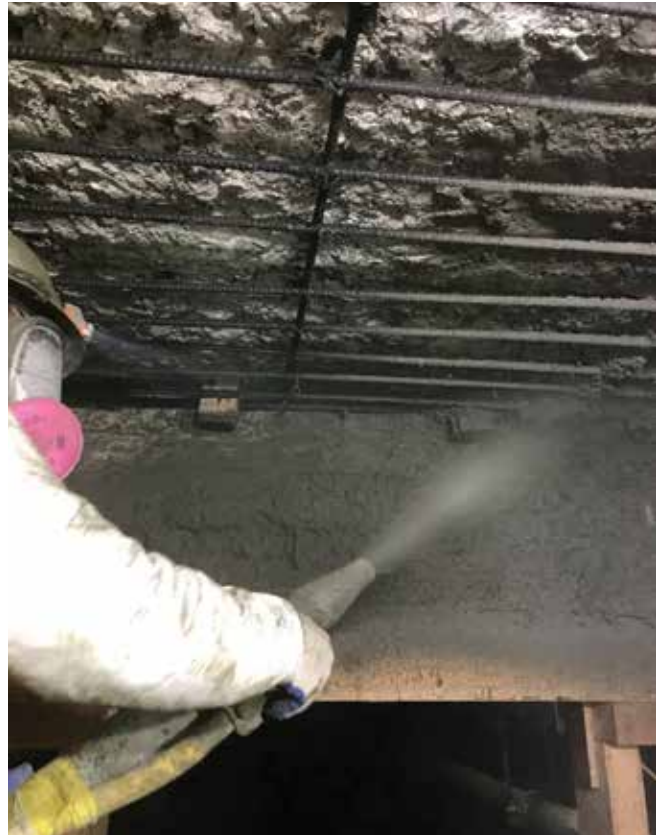
Fig. 4: Shooting on underside of pier
