10th Avenue SE Bridge Rehabilitation

By David Graham

2021 OUTSTANDING REPAIR & REHABILITATION PROJECT

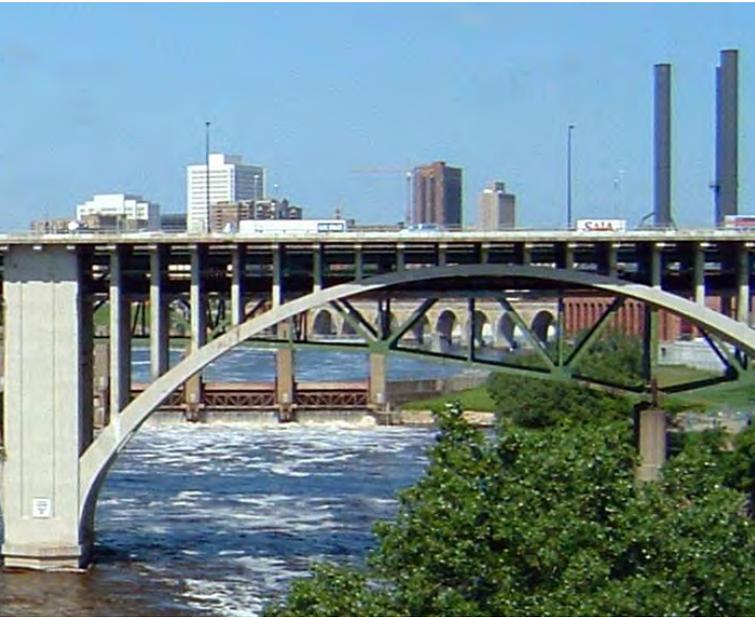
How does one best access the work areas to maximize concrete repair productivity and coordinate the removal and replacement sequence. Due to complex access requirements, including two 290-ft (88 m) major river spans, both rising 118 ft (36 m) above river elevation and multiple bike paths and roadways that were to remain open to the public,

we decided to use a suspended work platform system for access to the arch ribs and scaffolding for access to the piers and land based arch spans. The Safway QuikDeck® system provided a solid work platform from which we could erect supplemental scaffolding, as required, to access various elevations of curved arch rib elements including bottom, side and top surfaces, as well as various spandrel columns that required repair for the top of arch ribs.

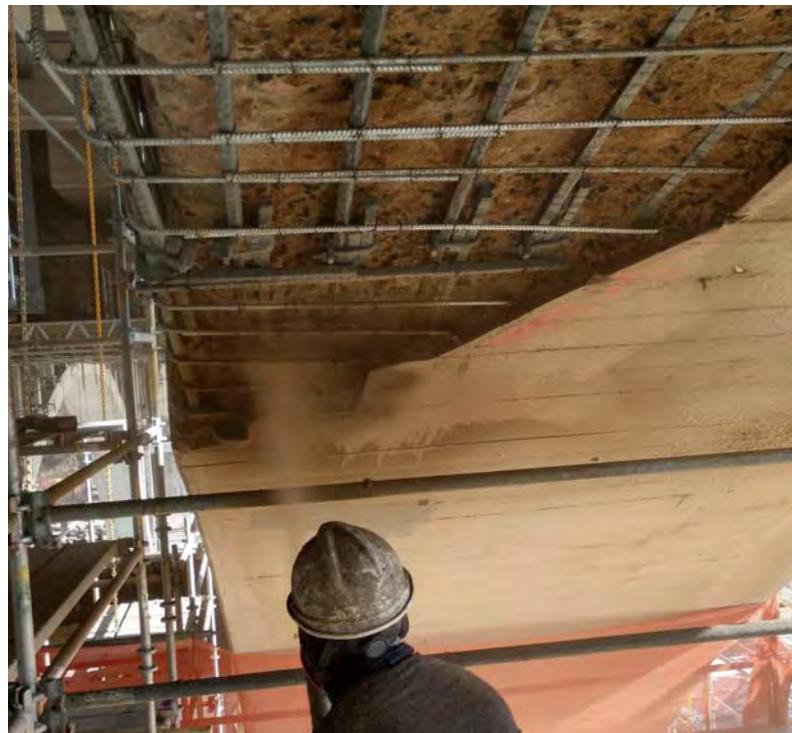
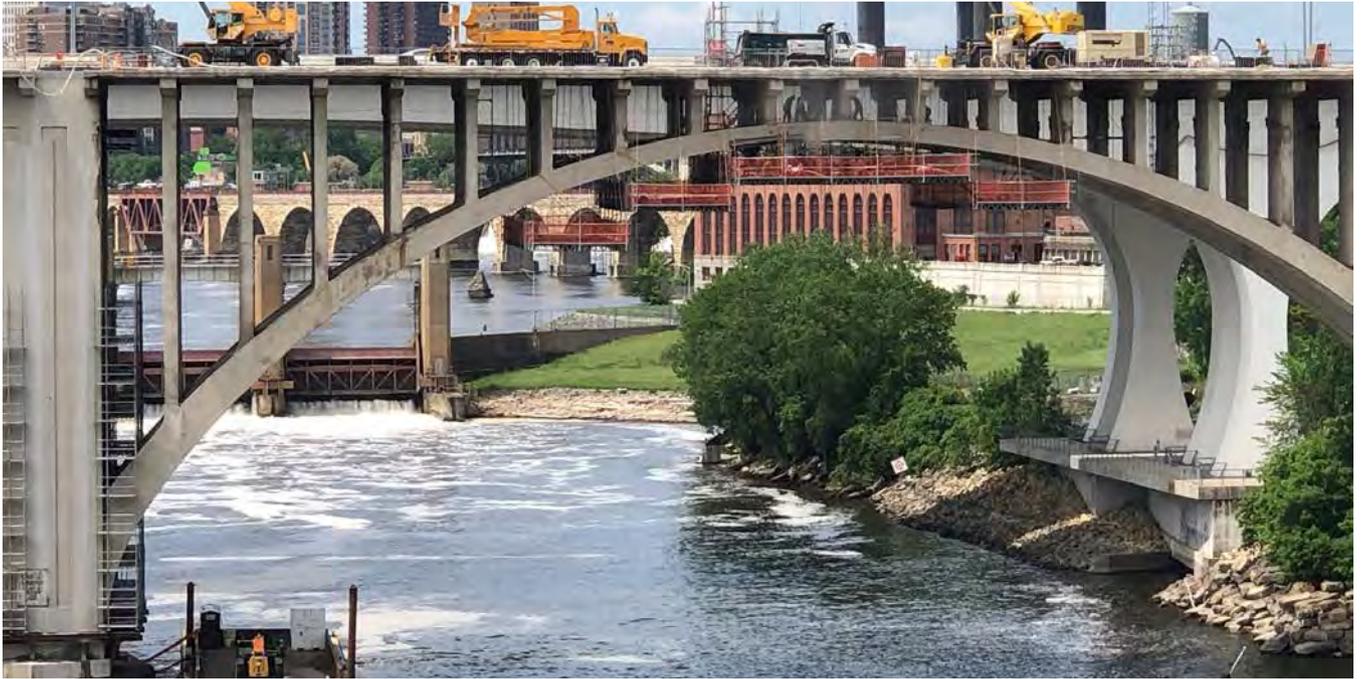
To duplicate the original 1929-era construction appearance, a board form finish was applied to 29,500 ft² (2740 m²) of the repaired surfaces. This historical finish was accomplished by one of two methods; hand tooling was applied to vertical non-formed surfaces or, where formwork was required, using rough sawn 2 x 10 construction lumber.
