Growing With the Times

KEEPING UP WITH SAFETY & EQUALITY CHANGES

By Stephanie Da Ponte

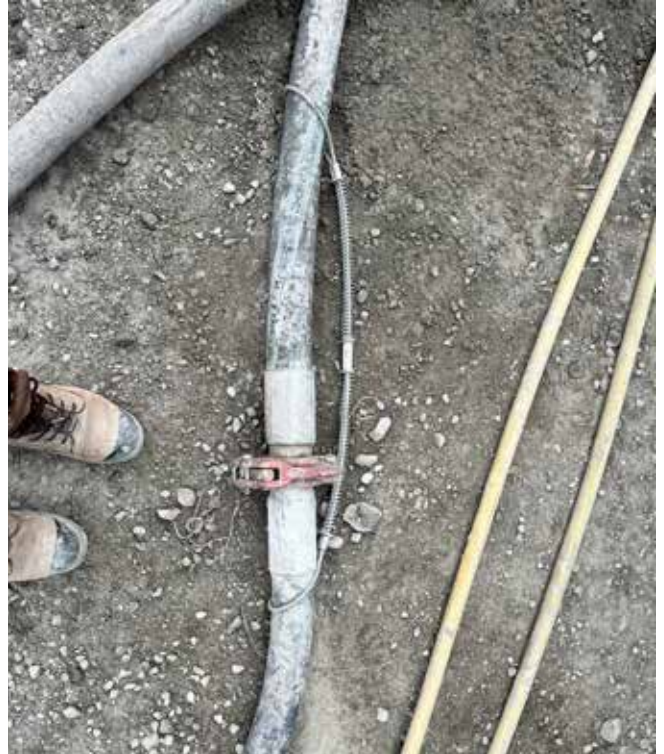
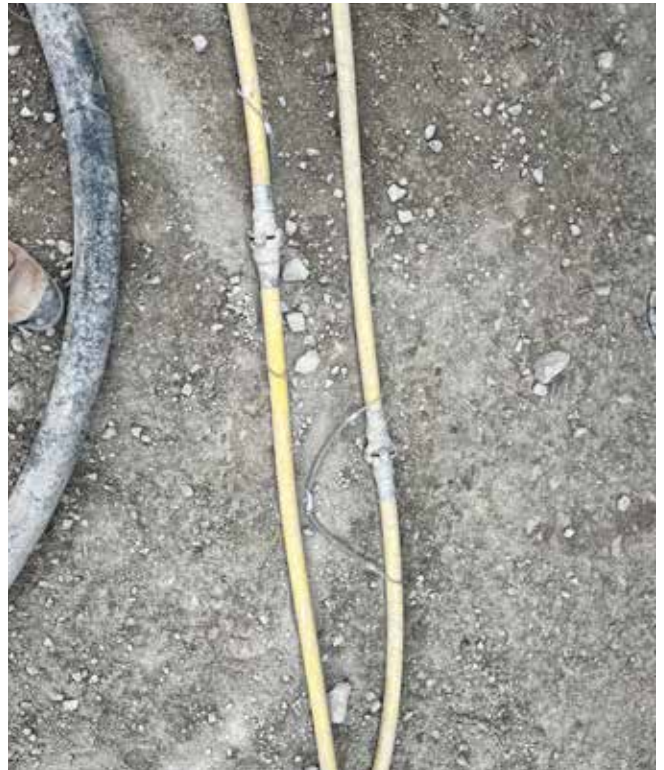
Figs. 1 & 2: Whip checks installed on material and airlines to restrain them in the event of a disconnection.

It's important to keep an eye on the condition of the lines (cracks, cuts, abrasions, flexibility, kinks, and/or exposed wire), inspect the fittings and connections for tightness, rust, and corrosion, and check to make sure the pressure of the air line and material line can withstand the pressure from the compressor and concrete pump. It's also crucial to ensure whip checks are installed properly: Too many times, I have come across an air line with a whip check installed incorrectly, with the loop section on the fitting instead of the air line. Whip checks play a critical role in shotcreter safety.

by preventing the lines from whipping around freely in the event of a disconnected fitting.

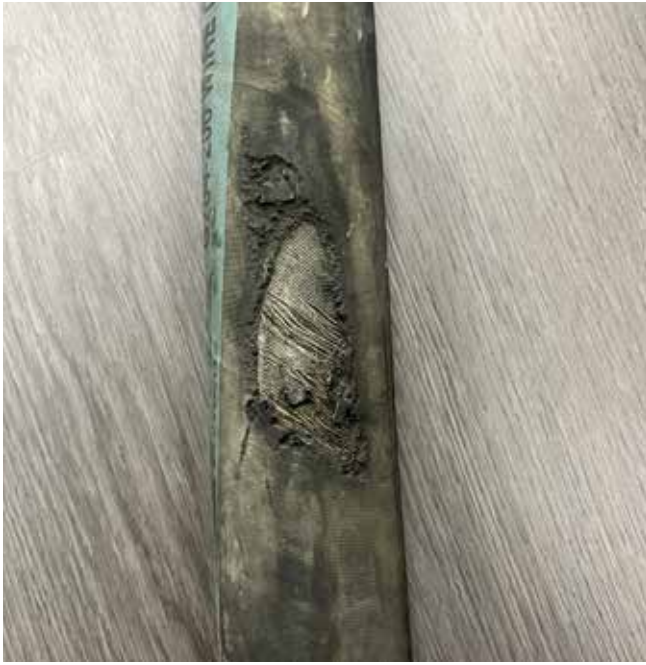
Fig. 3: 'Down line' hoses, which are connected to the reducer at the pump, are wire-braided to handle higher pressure. This particular hose shows a clearly worn area, likely caused by repeated contact with a soldier pile.

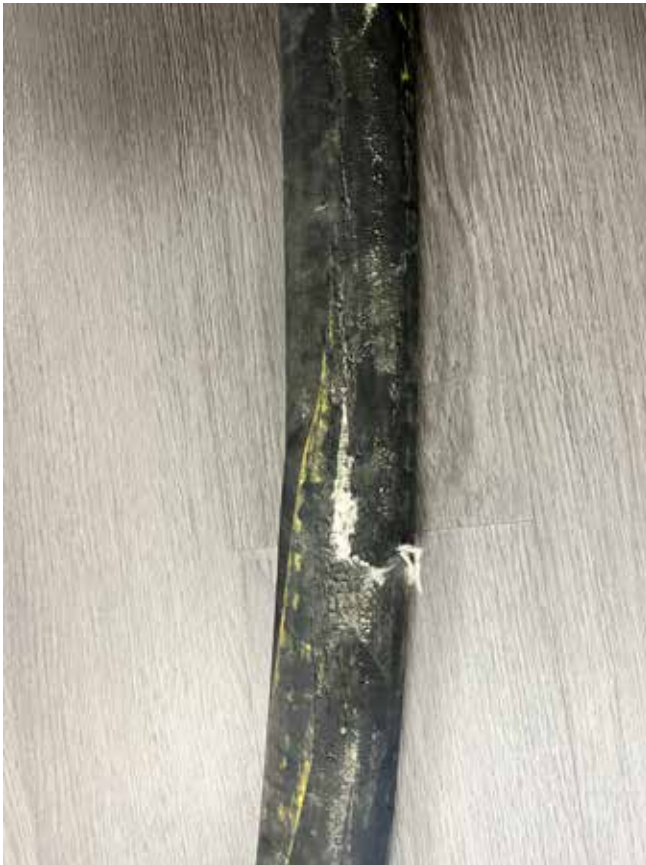
Fig. 4: This material line suffered a rupture; upon inspection it's noticed that this section was showing clear indentations. These were likely caused by repeated rubbing against rebar. This caused a weakened section in the line and ruptured during a plug.

One of the most common hazards associated with air supply hoses is when the Chicago fittings disconnect from the end of a live air line. This could cause the fitting to become a projectile: The escaping air will cause the air line to whip around violently, posing a hazard to anybody nearby. The same can be said about the material delivery lines — the bell ends can come off or ruptures can occur due to a blockage or rubbing against a protruding object, causing a tear. It is crucial to ensure that inspections are being completed every morning as the crew is unrolling and setting up the lines, as damaged sections will have less resistance to pressure.

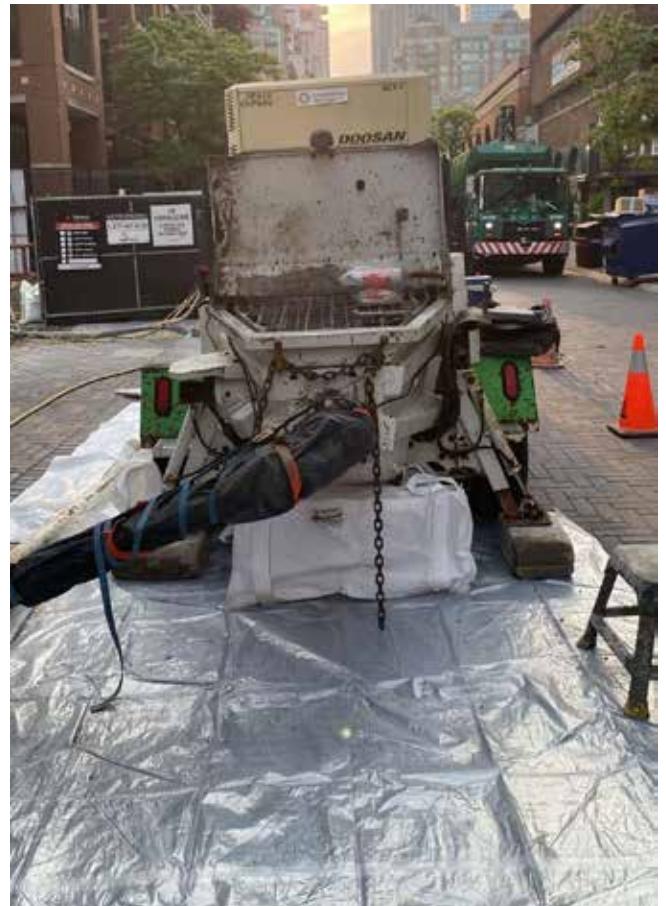
Fig. 5: Installing a 'Python' cover will confine concrete within the cover in the event of a rupture.

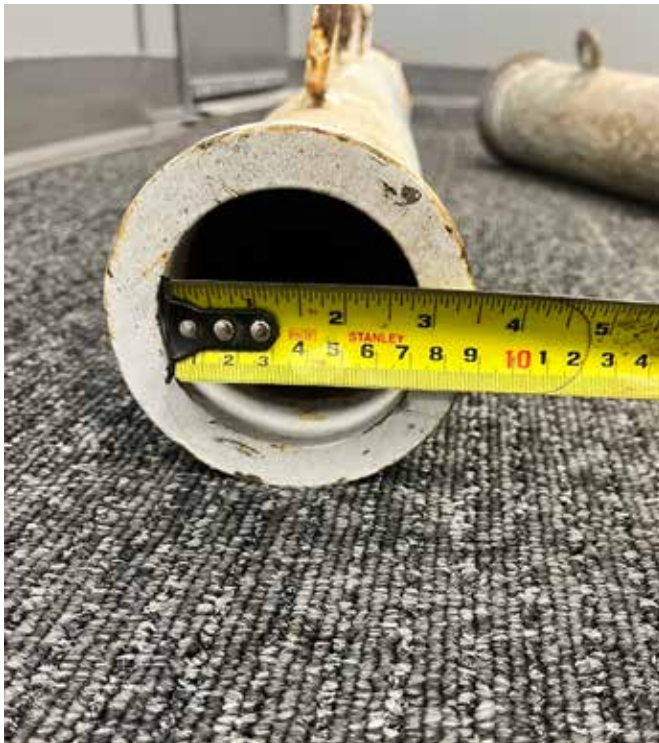
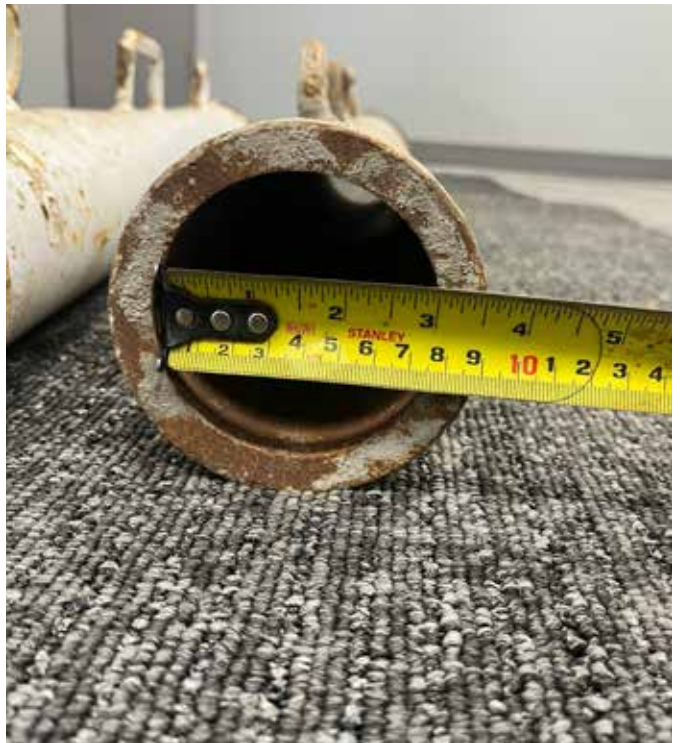
Figs. 6 & 7: When comparing the new and used pipes side by side, there's a noticeable difference in diameter. Upon measuring, it's clear that the used pipe is slightly larger.

Using an ultrasonic thickness gauge can help detect thinning and corrosion in your steel pipes. Measuring the openings of elbows, reducers, and material lines can indicate the extent of wear incurred. Typically, when the opening has expanded by 15%, they should be replaced. We developed an inspection tool to help determine when a pipe should be taken out of service, since there are no existing standards to guide this process.

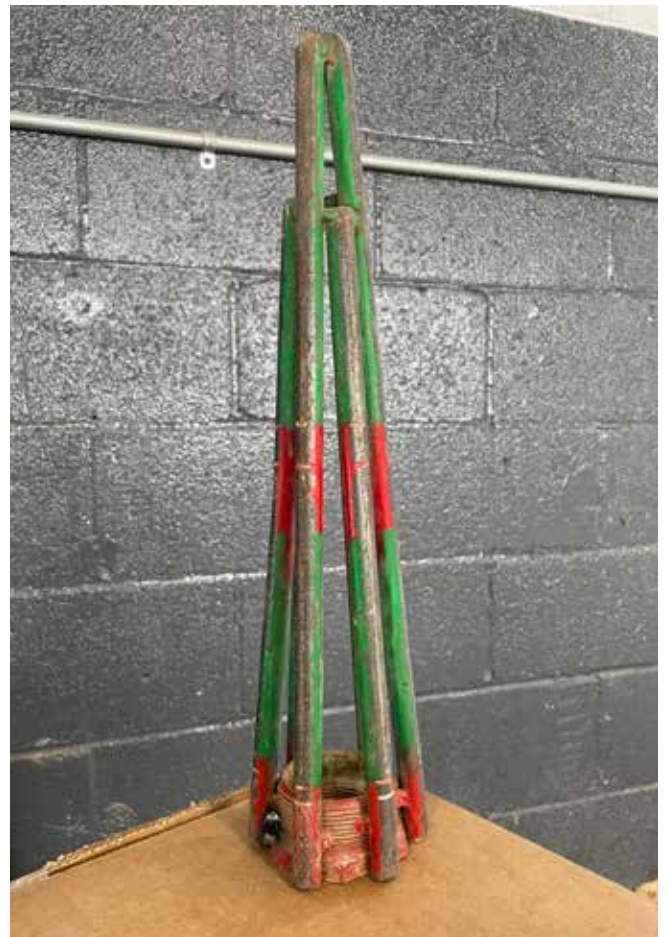
Fig. 8: Consolidated Shotcrete designed an inspection tool to evaluate pipe condition and determine end-of-life criteria.”

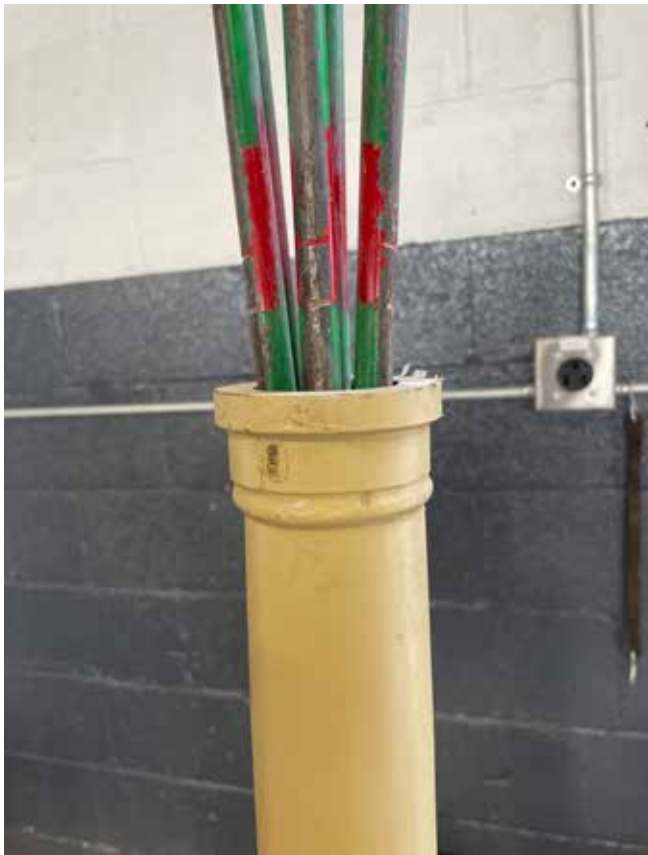
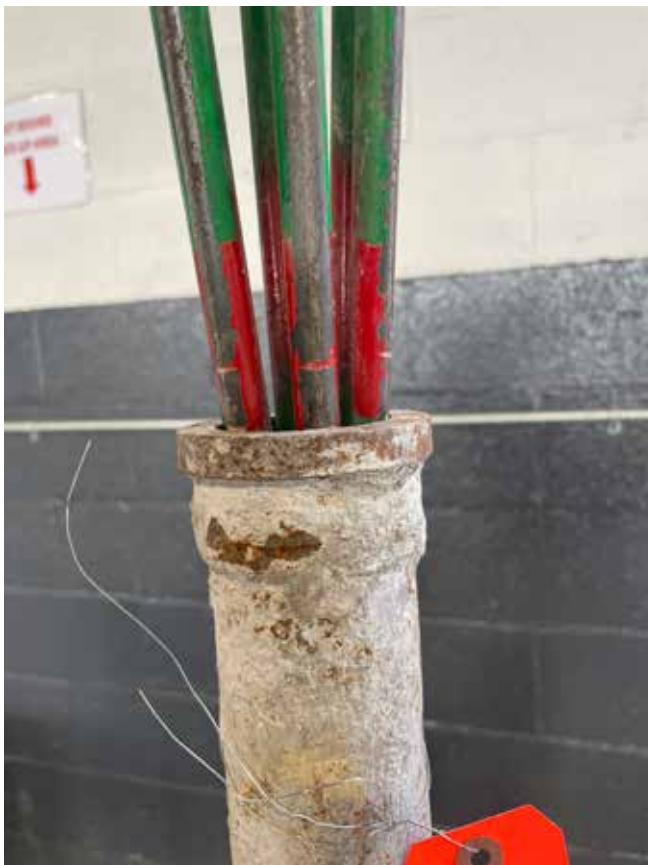
Figs. 9 & 10: Here we can see that the pipe that has been in service is now at the red marking, indicating no longer safe for use.
