## 2025 Outstanding Pool & Recreational Project

# Southern Living Pools

## YATES PROJECT

## 2025 OUTSTANDING POOL & RECREATIONAL PROJECT

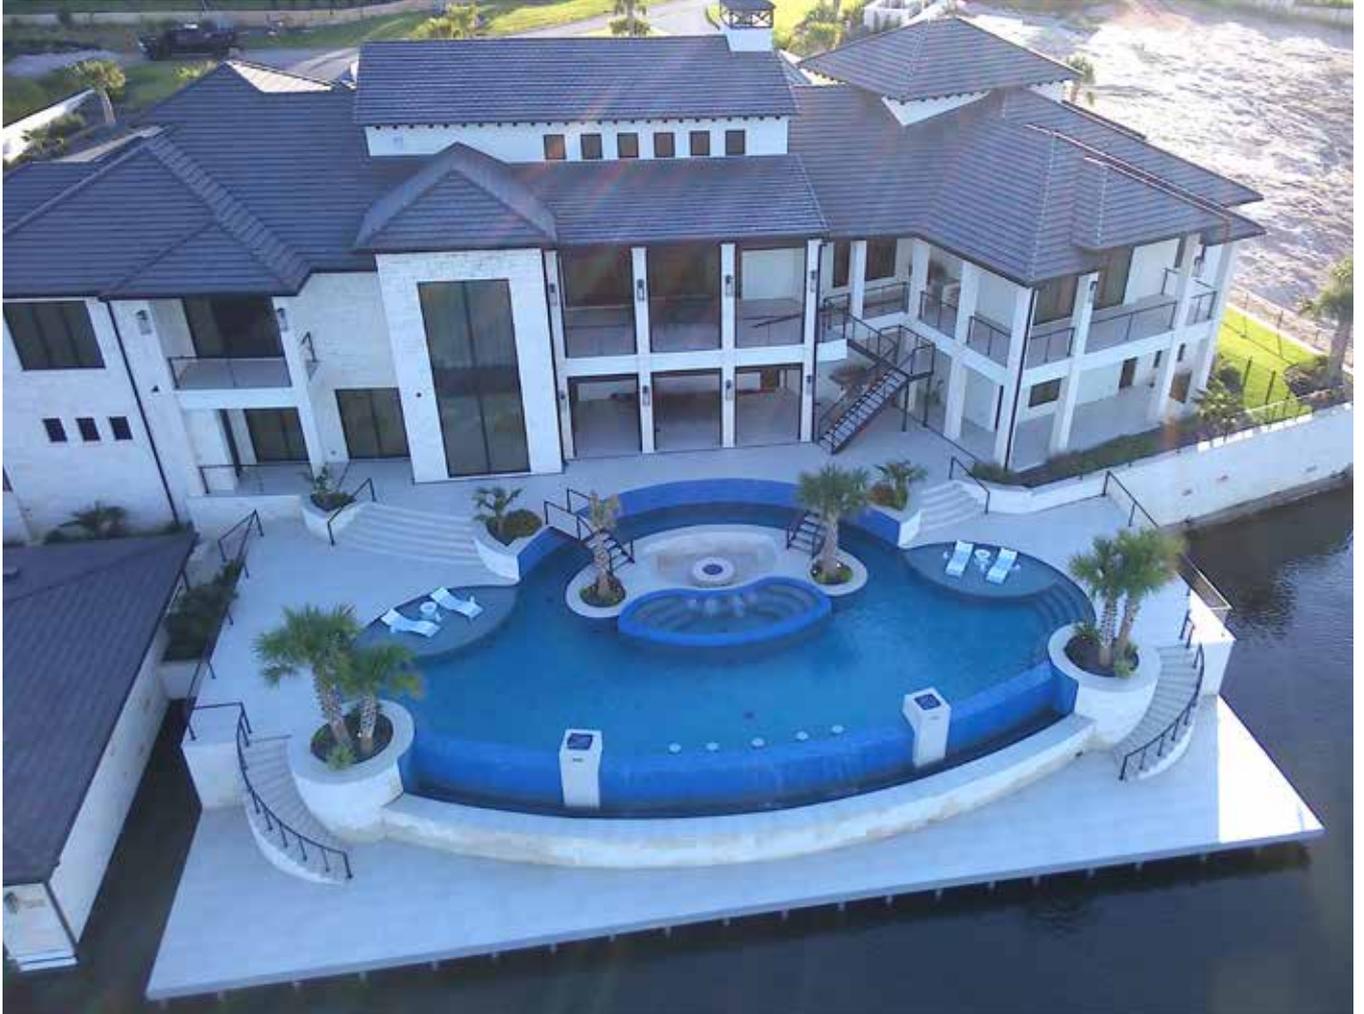
*Finished pool*

The interior of the pool was finished with an exposed pebble aggregate by Centex Plaster, and the pool was completed in October of 2025. This pool was an opportunity to showcase the various ways shotcrete routinely translates a vision into a concrete reality.

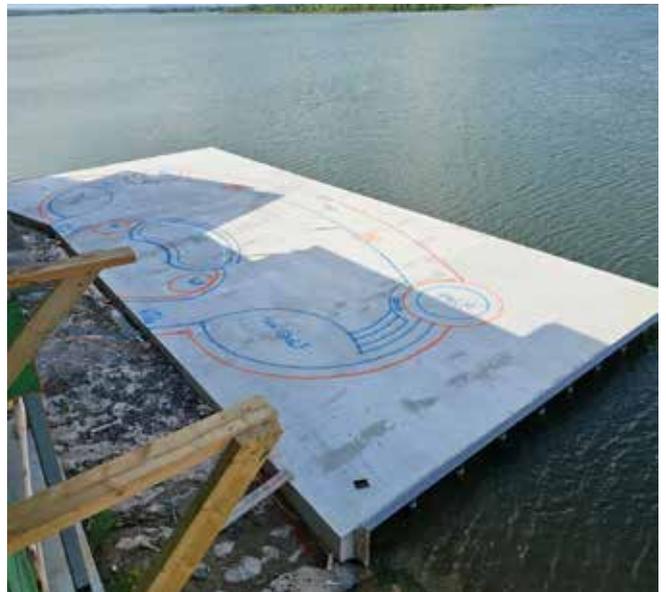
*Layout of pool on concrete slab suspended above water*

located on Apache Tears Road in the gated community of Escondido Lago. The lake that the project is in (yes “in”) is Lake LBJ, a man-made, controlled lake on the Colorado River — one of the most unique aspects of the pool is that at least two-thirds of the pool is suspended directly above the lake, off the shoreline.

Since the house was under construction when we did our first site visit (they had to drill the piers in granite and then form-and-pour the slab that the pool would sit on), we knew it wouldn't be a 'next week' kind of situation. This gave us plenty of time to plan and evaluate how we would shoot this project.

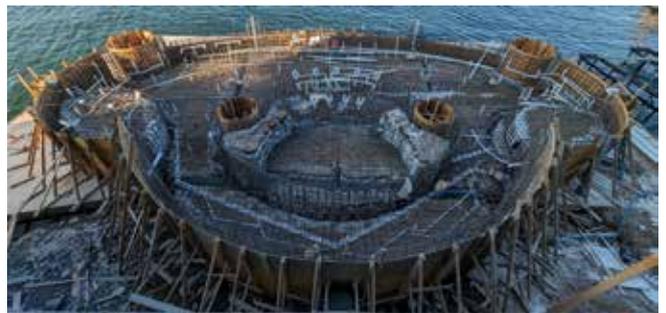
*The pool formed with reinforcing bar and plumbing installed*

Since minimal forms were used, we saved not only lumber but also significant materials and labor costs. Because minimal forms were erected, we were able to create the curvature as rendered, producing the stunning visual this pool demanded.

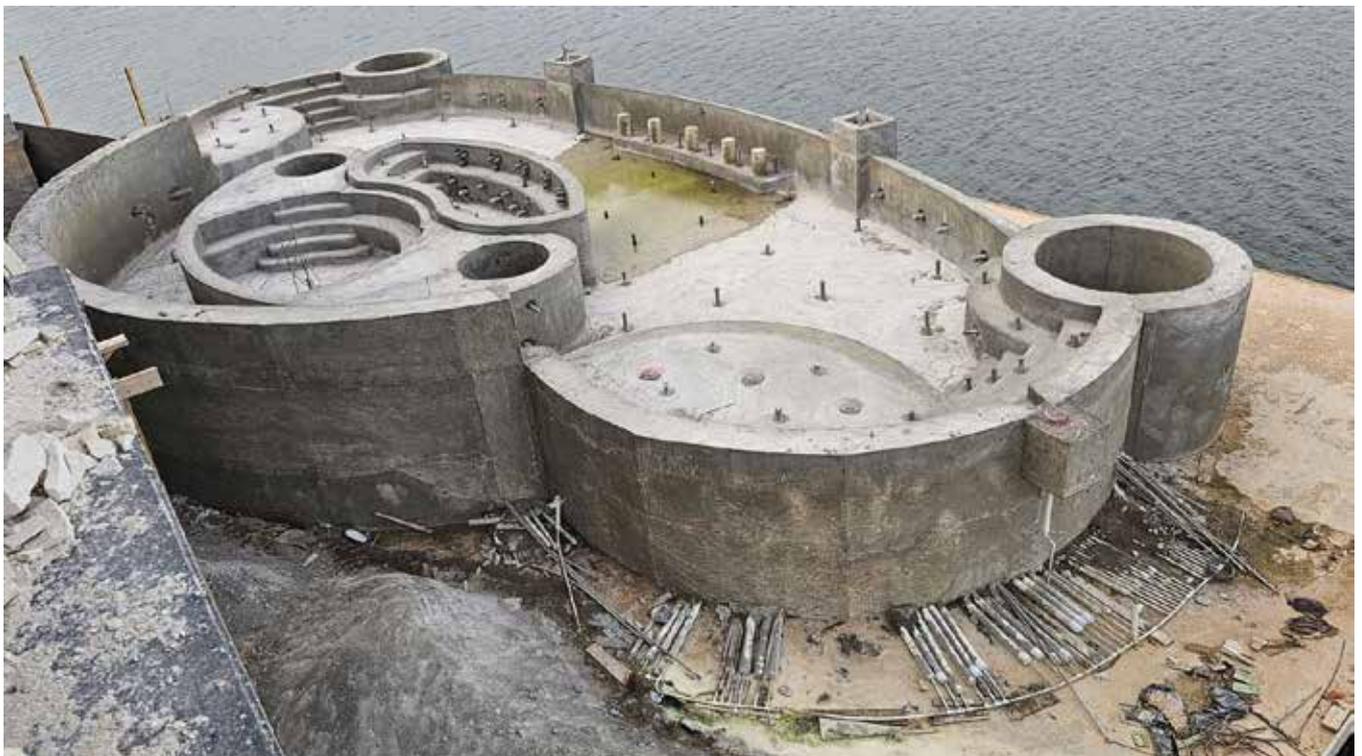
*Dry-mix shotcrete placement complete*

delays), and we shot 156 yd<sup>3</sup> (119 m<sup>3</sup>) of mainly footers. The second phase was over 5 days where we shotcreted the pool and ancillary features. This phase totaled 230 yd<sup>3</sup> (176 m<sup>3</sup>) of concrete. This was all shot in August of 2023 in the awesome Texas heat with the added humidity of the adjacent lake. The outside perimeter of this pool includes:

We used a 4:1 (sand:cement) concrete mixture design yielding a compressive strength over 4000 psi (28 MPa) with ASTM-C33 and TXDOT-certified sand and a Type I Cement. We had 8 crew members inside the pool and one outside running the Putzmeister AG-15 dry-mix gun. Compressed air was provided by an Ingersoll Rand HP915 and the dry-mix materials delivered from a truck-mounted volumetric mixer by Strong Industries, along with its driver. We were unable to set up next to the pool, so we set the gun in the front of the house, which was under construction at the time, and ran the dry-mix delivery hose through the house with all preventive safety measures in place. We reduced our carbon footprint by using on-site volumetric mixers rather than loading premixed concrete from a ready-mix plant.
