# The Art of Coastal Resilience

## SHOTCRETE RESTORATION AT THE GERALDINE R. DODGE ESTATE

This article details the technical restoration of a historic seawall in Rockport, Maine, designed to withstand intense Atlantic wave action. The project showcases how modern engineering can preserve coastal history while enhancing structural integrity.

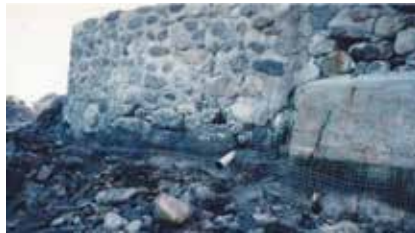
*Fig. 1: Cleaning the bottom of the seawall at low tide by fresh water blasting and securing a new "through drains" and placement of new galvanized 2 x 2 WWF, tied to epoxy set 6 in. galvanized anchor bolts on a 2 ft x 2 ft pattern*

Before any material was applied, the existing granite ledge had to be meticulously prepared. We utilized high-pressure water blasting to remove salt deposits and organic growth.

To ensure a strong bond between the geological substrate and the shotcreted concrete shell, we installed a comprehensive anchoring system. This involved drilling and epoxy-setting 3/8 in. (10 mm) stainless steel threaded rods 6 in. (150 mm) deep into the bedrock. These were placed on a 12 in. (300 mm) grid, creating a mechanical 'key' that prevents delamination under the immense 'pulling' force of retreating waves.

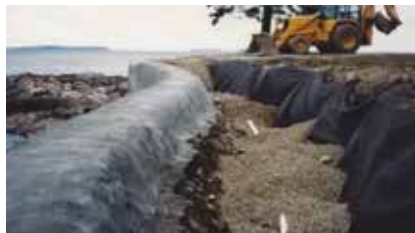
*Fig. 2: The final stages of completing the backside drain system up to the top of the seawall*

One of the leading causes of seawall failure is the buildup of water behind the wall. Without relief, this pressure eventually pushes the wall outward. We integrated a series of 2 in. (50 mm) PVC weep holes and a backing drainage composite mat. This allows groundwater and overwash to cycle back to the sea without compromising the structural integrity of the wall.

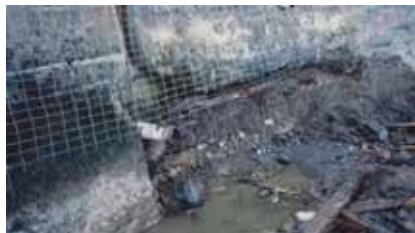
*Fig. 3: The same procedure as in #1 was all in preparation of the dry-mix shotcrete placement at various thickness to provide a reasonable looking non troweled finish*

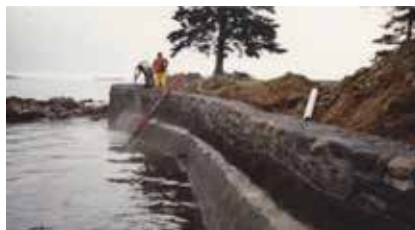
*Fig. 4: While working with the 8 ft (2.4 m) tides at various levels the shotcrete placement begins from bottom to top and over the wall down the backside to the newly installed filter fabric and crushed stone backside drainage feature to capture and safely remove the overwash drainage from extreme tides*

A critical component of the design is an integrated drainage system. This allows water trapped behind the seawall to escape safely, preventing the pressure build-up that often leads to blowouts or collapses.
